SERVICE BULLETIN

APPLICABILITY: 2025MY Forester

NUMBER: 09-133-25

SUBJECT: DTC P0890, P0700, U0100,
U1120, & C1935 / Service Procedure

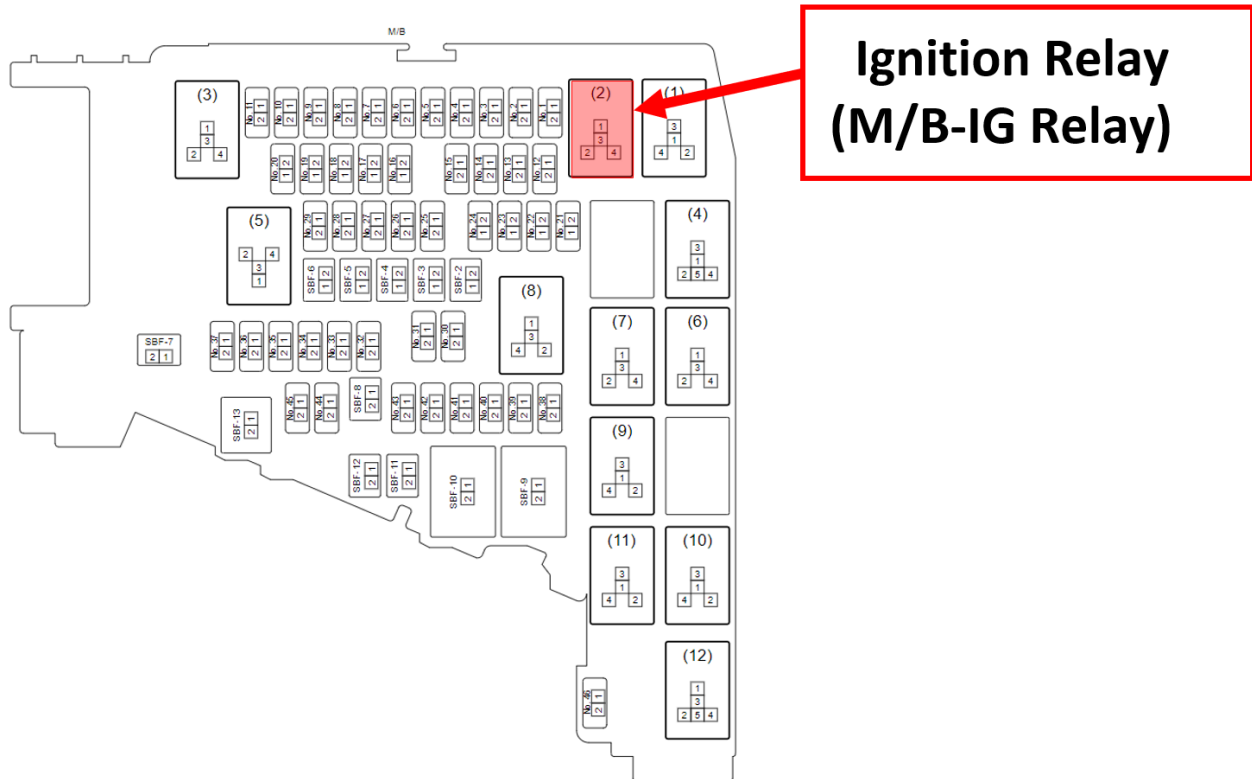
STEP 2: Inspect the ignition relay (M/B-IG Relay) located in the main relay box under the hood of the vehicle. See the judgement criteria below.

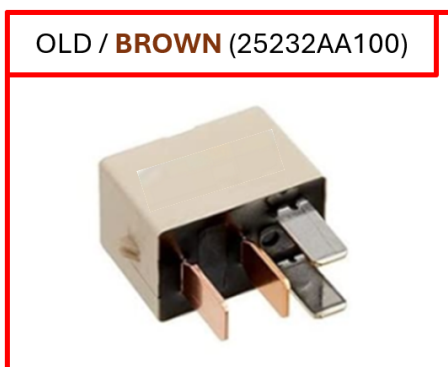
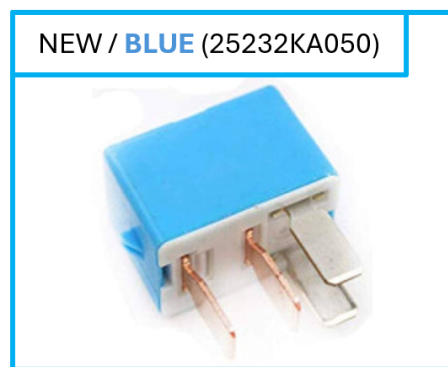
If the OLD **Brown** colored relay (p.n. 25232AA100) is currently installed, replace the relay with a NEW **Blue** colored relay (p.n. 25232KA050).

If the currently installed relay is the NEW **Blue** colored relay (p.n. 25232KA050), there is no need for relay replacement. The procedure is completed.

NOTE: The NEW **Blue** relay (p.n. 25232KA050) is **ONLY** to be used in this location and is not to be interchanged with other relays.
