## SERVICE BULLETIN

**APPLICABILITY:** 2020-24MY Legacy & Outback  
 2024MY Impreza & Crosstrek  
 2022-23MY WRX  
 2023-24MY Ascent

**NUMBER:** 15-323-25R

**SUBJECT:** CID Displays Incorrect Fuel Economy Value

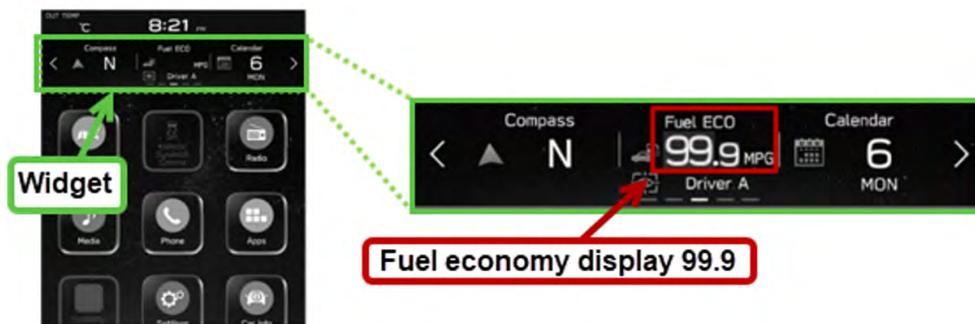
This bulletin announces availability of new combination meter reprogramming files developed to address cases of inaccurate fuel economy displayed on the Center Information Display (CID). A customer may experience a fuel economy value of 99.9mpg or 99.9kml displayed on the CID when the driver is registered with the Driver Monitoring System (DMS). The conditions listed below **MUST** be fulfilled for this scenario to occur:

**DESCRIPTION OF FAILURE:**

**NOTE:** When the Fuel ECO Widget is displayed, 99.9 will always be the value.

The new files contain enhanced combination meter logic to prevent this condition but if it is experienced, reprogram the combination meter using the service procedures outlined in this bulletin.

- Reprogram the Combination Meter following the normal SSM5-R procedure.
- Detailed information regarding the SSM5-R reprogramming procedures can be found in TSB **14-28-21R**.
