Technical Service Bulletin

Mazda North American Operations Irvine, CA 92618-2922

Subject:		
OIL SEEPAGE OR LEAKS AT ENGINE FRONT COVER	Bulletin No.: 01-002/25	
	Last Issued : 03/06/2025

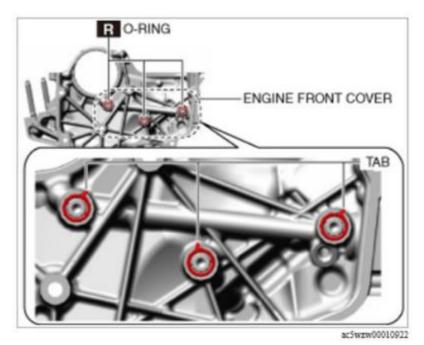
- Install the O-rings so that the tabs of the O-rings recede into the notches.
- DO NOT use any sealant on the O-rings.

4. Install new O-rings to the engine front cover.

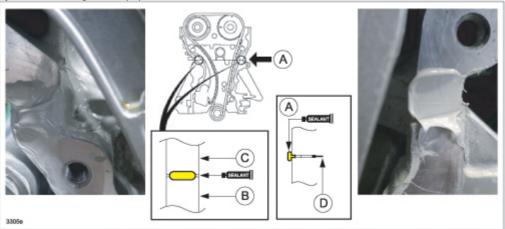
CAUTION: Apply the silicone sealant to the area (A) between the cylinder block (B) and head (C) so that it goes into the cylinder head gasket (D).

5. Apply silicone sealant (TB1217D or equivalent) to the engine front cover, as shown below.

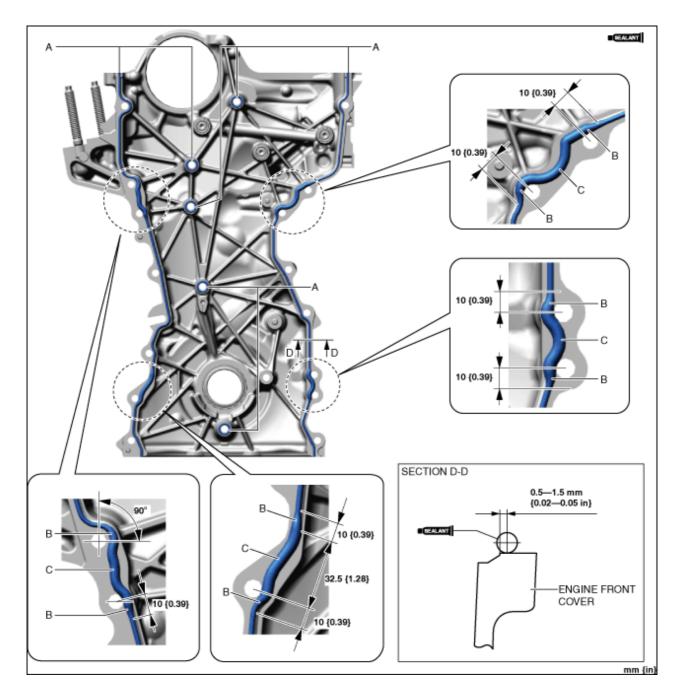
Bead thickness

A: 2—6 mm {0.1—0.2 in}

B: 4—6 mm {0.16—0.23 in}

C: 4—8 mm {0.2—0.3 in}

- Apply the silicon sealant in a single, unbroken line.
- To prevent silicone sealant from hardening, adhere the engine front cover and engine block firmly within 10 minutes after applying silicone sealant. After adhering them, tighten the installation bolts immediately.
- Mazda Sealant has an expiration date, check the tube to be sure it has not been opened and it has not expired.

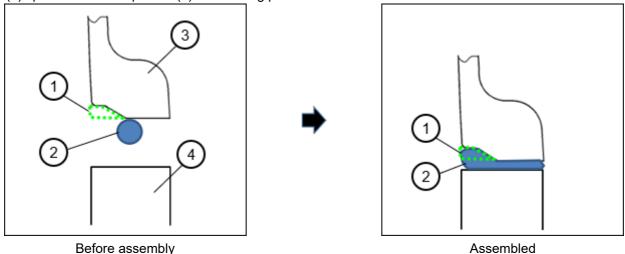
Sealant (2) spreads to the step bead (1) and sealing performance is ensured.

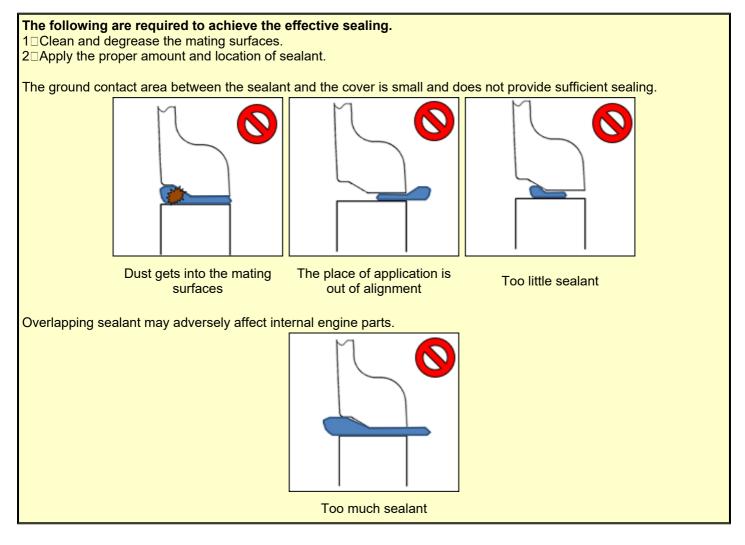
The following areas (1) have a smaller step bead (2), so be careful about the amount and location of sealant application.

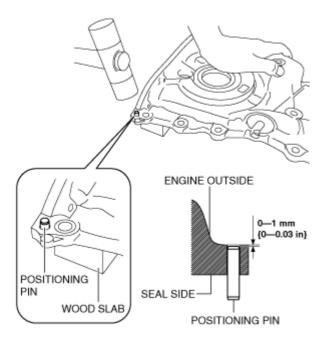
NOTE: For a new engine front cover, the positioning pins in the two locations shown below project to the outside of the engine.

NOTE: If the engine front cover is newly replaced, tap the positioning pins in the two (2) locations to the seal surface side.

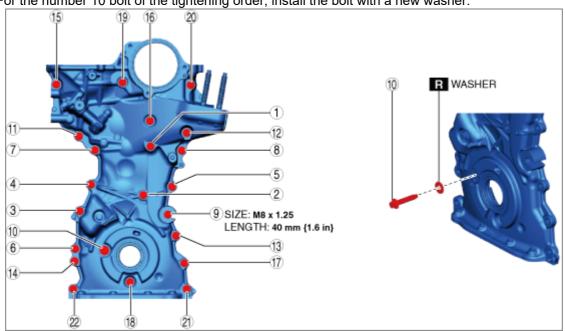
CAUTION: For the number 10 bolt of the tightening order, install the bolt with a new washer.

7. Tighten the engine front cover installation bolts in the order shown below.

Tightening torque 20—26 N·m {2.1—2.6 kgf·m, 15—19 ft·lbf}
