Technical Service Bulletin

Subject: SUNVISOR(S) DO NOT STAY IN FULLY RETRACTED POSITION	Bulletin No.: 09-012/25
	Last Issued : 03/10/2025

2020-2025 CX-30 (Mexico built)
2019-2025 Mazda3 (Japan built)
2019-2025 Mazda3 (Mexico built)

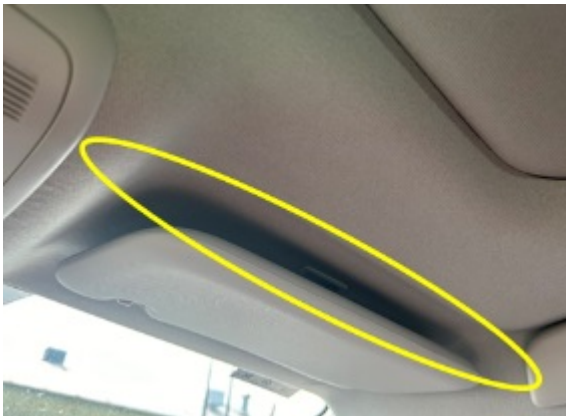
Some vehicles may experience a sunvisor that does not stay in the fully retracted position (as shown below). The left and/or right side sunvisor may lower slightly due to its own weight. The part where the sunvisor connects is broken, so the spring cannot hold the sunvisor in the fully retracted position.

To eliminate this concern, the stay holder and spring holder have been reinforced.

1. Verify customer concern.
2. Replace the affected side sunvisor with the modified part according to the instructions on MGSS.
 - Mazda3: SUNVISOR REMOVAL/INSTALLATION
 - CX-30: SUNVISOR REMOVAL/INSTALLATION
3. Verify the repair.
