Technical Service Bulletin

LIFTGATE LOCK SWITCH OR PLG SWITCH DOES NOT WORK,
MAY CAUSE BATTERY DRAIN

Bulletin No.: 09-013/25

Last Issued : 03/13/2025

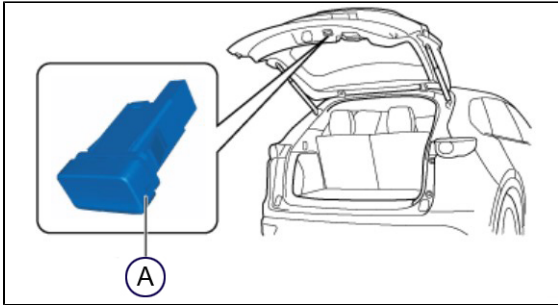
Some CX-5 and CX-30 customers may find that the liftgate does not close when pressing the power liftgate (PLG) rear switch (A) located on the interior liftgate trim. This may be caused by PLG switch corrosion. Water from a high pressure car washer and/or condensation may drip onto the switch connector and cause corrosion.

NOTE: CX-5 shown below

To eliminate this concern, the PLG rear switch has been modified with a waterproof connector.
