SERVICE BULLETIN

APPLICABILITY: 2019-22MY Forester
2019-22MY Ascent
2020-22MY Legacy & Outback

NUMBER: 12-257-25R

SUBJECT: Windshield Warranty Extension / Inspection

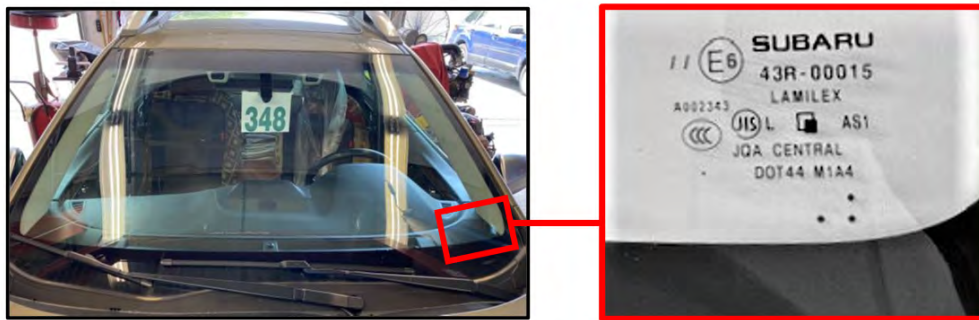
STEP 1: Locate the Subaru marking on the lower portion of the driver side of the glass. Confirm the windshield is a genuine Subaru part. If the marking cannot be found and / or the vehicle has been fitted with a non-Subaru windshield, the Warranty Extension does not apply.

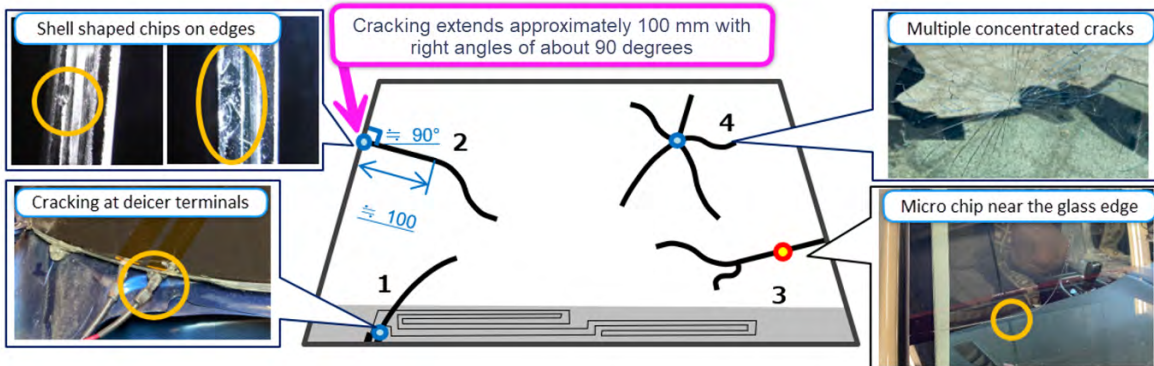
STEP 2: Inspect the damaged area(s) of the windshield and determine what type of damage is present. See the example images below for Warranty qualifying and non-qualifying windshield damage criteria. This damage described in Type 2 and 3 is not specific to one side of the glass and may occur in the upper or lower sections.

Type	Descriptions	Presumed Cause	3/36 Coverage	Warranty Extension Coverage
1	The straight section extends to the edge of the glass with cracking starting from the deicer terminal.	Unrelated cause	COVERED	NOT COVERED
2	The straight section extends to the edge of the glass with the chip(s) along edge of the glass.	Unrelated cause	COVERED	NOT COVERED
3	A chip can be found within the straight section of a crack.	Cracking is presumed to have been caused by continuous stress starting from a small chip. Refer to APPENDIX A for details	COVERED	COVERED
4	Multiple cracks are concentrated at one center point of a damage area. (spider web or star pattern)	External factors are presumed. Refer to APPENDIX B for details.	NOT COVERED	NOT COVERED

STEP 3: Is the windshield damage covered by the Warranty Extension (Type 3)?

YES: Replace the windshield as per the applicable Service Manual and process the claim using the Warranty Extension claim information supplied in this bulletin. Refer to STIS: Body & Electrical/WIRING SYSTEM.

NO: Consult with customer regarding replacement/repair options.

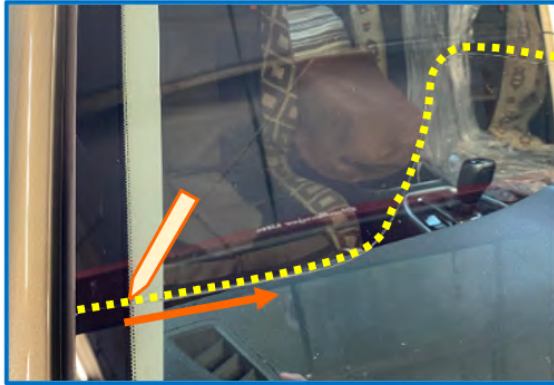
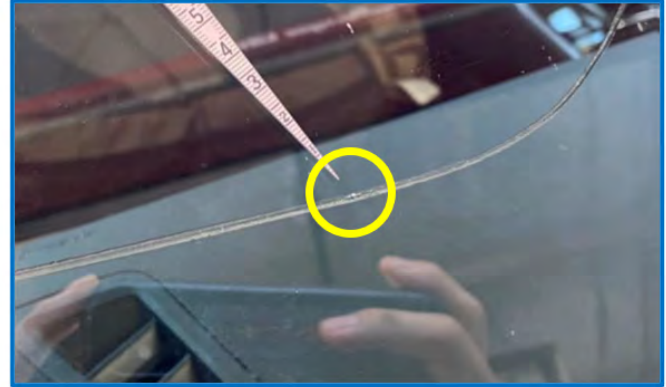
TIP 1: A ballpoint pen can be used to help identify any chip along the cracks. CAREFULLY guide the tip of the ballpoint pen along the crack to feel for any snags. DO NOT apply excessive pressure as this may cause further damage and make any chips harder to detect.

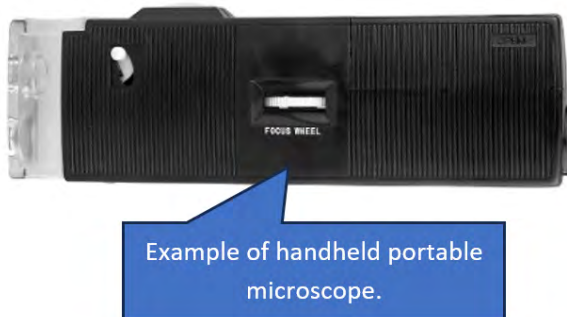
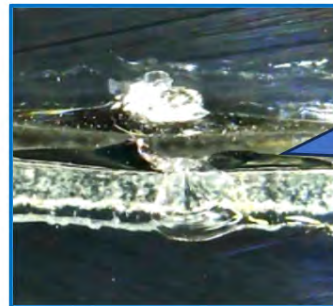
TIP 2: A handheld portable microscope can also be used to help find any crack starting points.

Example image taken with handheld portable microscope.

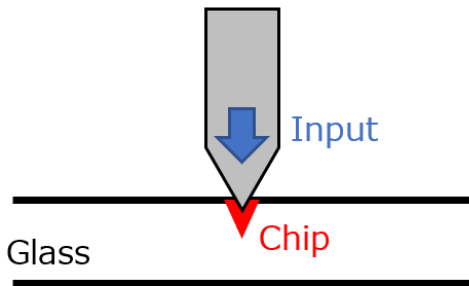
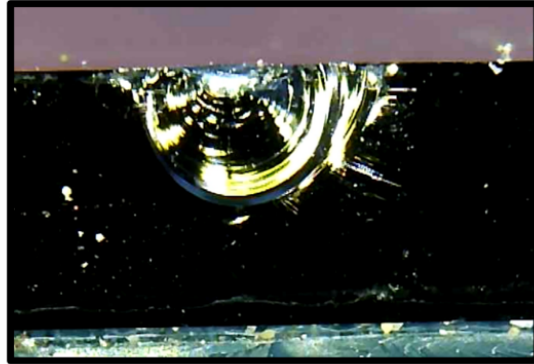
Small External Damage

Type 3 damage results from the combination of small external damage and continual stresses generated by body structure movements (e.g. twist, shock, etc.) during vehicle operation. Type 3 damage is covered under the Warranty Extension.

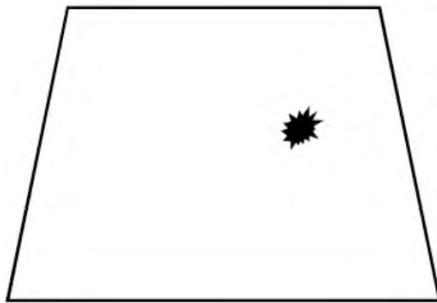
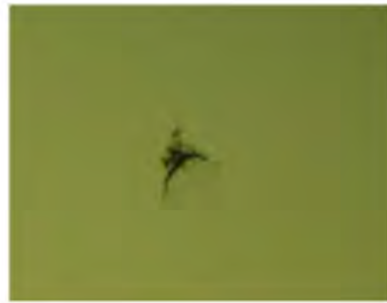
Example A

Scratches & Cracks Caused by Flying Objects (Rocks, Road Debris):

- Caused by impact from moving or falling foreign object
- Size may vary from less than 0.1mm to 5mm (Example A).
- Will result in cracking in most cases (Example B)
- In cases when no granular scratches are found, impact marks may still be observed (Example B).
- Often has radial cracks starting from the point of impact (Example C).

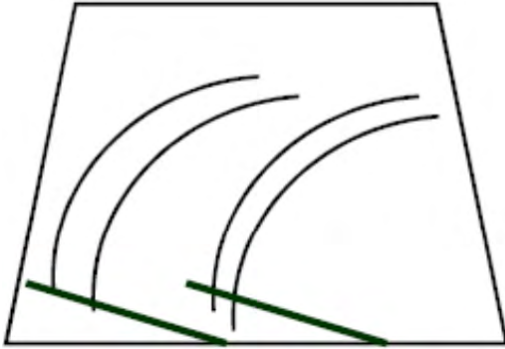
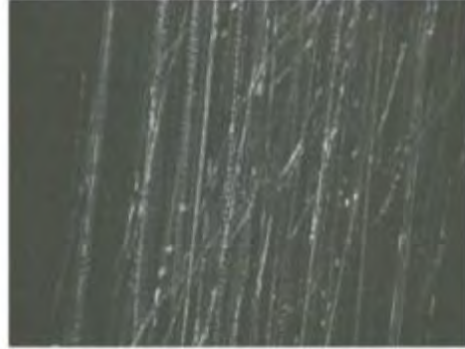
Example D

Scratches Caused by Windshield Wipers:

Sand & Other Particles Get Stuck Between the Wiper Rubber & Glass Causing Scratching During Wiper Operation:

- Will occur in the area of wiper operation
- Can be one or more lines parallel to each other
- The scratch lengths can vary in size.

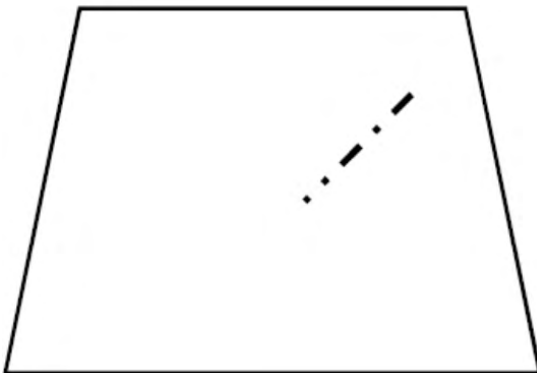
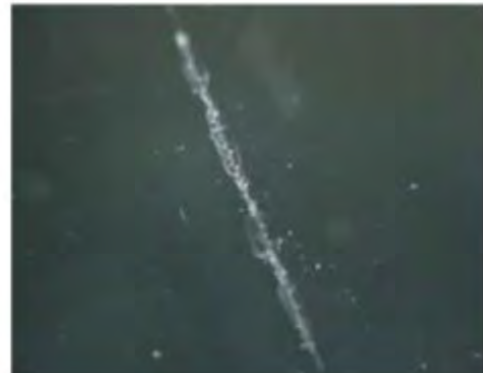
Example E

Scratches Caused by Metal Contact:

- May be caused by contact with car keys, metal buttons attached to clothing, umbrellas, etc.
- These scratch types are generally sharp and can occur in any angle.
- The length is random and is often in a single line.

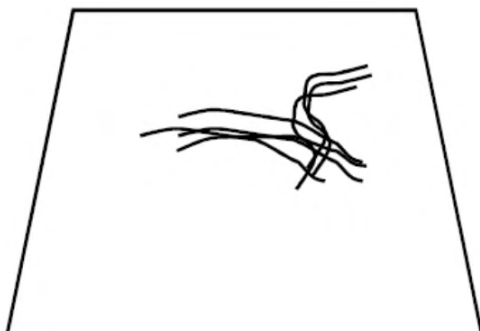
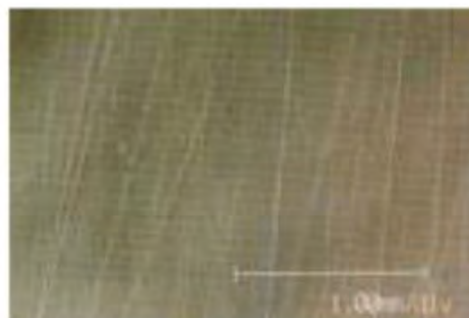
Scratches Caused by Wiping or Cleaning:

- May occur when the glass is cleaned with a contaminated cloth or towel
- Relatively long scratches and are often gathered
- The scratches tend to overlap each other randomly and draw arcs following the wiping pattern.
