Technical Service Bulletin

Subject: NOISE FROM FRONT MAP LIGHT SURROUNDINGS	Bulletin No.: 09-015/25
	Last Issued : 03/25/2025

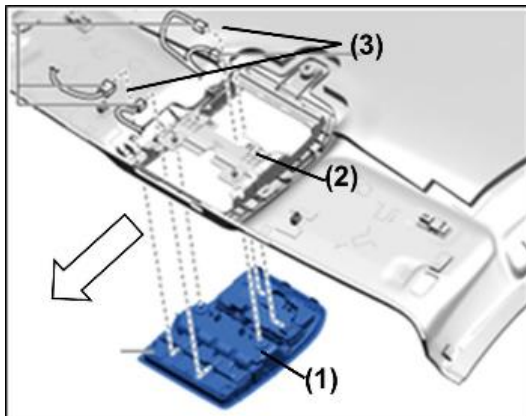
Some customers may complain about a rattle or vibration noise coming from front map light surroundings when driving on a rough road. This may be caused by the bracket for the map light. Due to heat or vibrations, the fastener fixing the front map light to the bracket may deform, making the joint loose. In such case, when the vehicle bounces, the bracket may oscillate and produce a rattling noise. To eliminate that concern, non-woven fabric will be attached to the headliner.

1. Front map light
2. Bracket
3. Connectors

The arrow is pointing to the front of the vehicle.

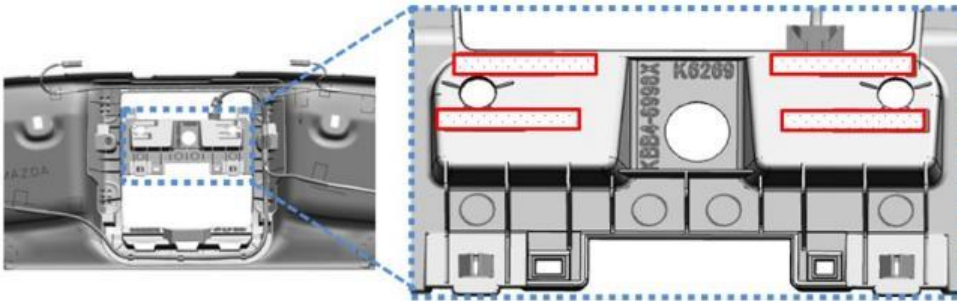
NOTE: Photo shown below is of the inside view of the headliner.

5. Attach the 4 pads on the inside of the headliner bracket as shown below.
