Subject: ENGINE NO START / NO CRANK WITH DTC P0615:12 AND/OR B112A:12 STORED	Service Alert No.: SA-014/25
	Last Issued : 03/06/2025

2017-**2025** CX-5

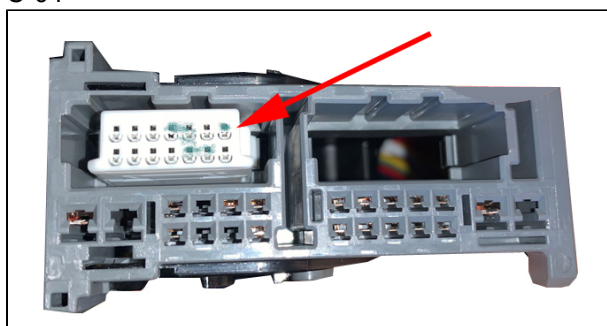
This may be caused by water contamination/corrosion at electrical connector C-04 due to:

- Windshield tint installation:
 - Windshield tint installed to block UV light. The water used during the installation of the tint may run down behind the dashboard. Carefully inspect the windshield to see if window tint has been installed or not. Some window tint film appears clear and is for UV light only.
- Windshield repair/replacement:
 - Poor windshield sealing during installation can cause an internal water leak. Water may run down behind the dashboard.

1. Verify customer concern.
2. Inspect electrical connector C-04 for water contamination/corrosion. Is water corrosion present?
 - Yes - Repair or replace connector C-04.
 - No - This service information does not apply. Go to MGSS:
 - [DTC P0615:12 \[START STOP UNIT\]](#)
 - [DTC B112A:12 \[START STOP UNIT\]](#)
3. Verify repair.
