## SERVICE BULLETIN

**APPLICABILITY:** 2019-24MY Ascent  
2019-24MY Forester

**NUMBER:** 12-265-25

**SUBJECT:** Power Rear Gate Drive Unit Design Change

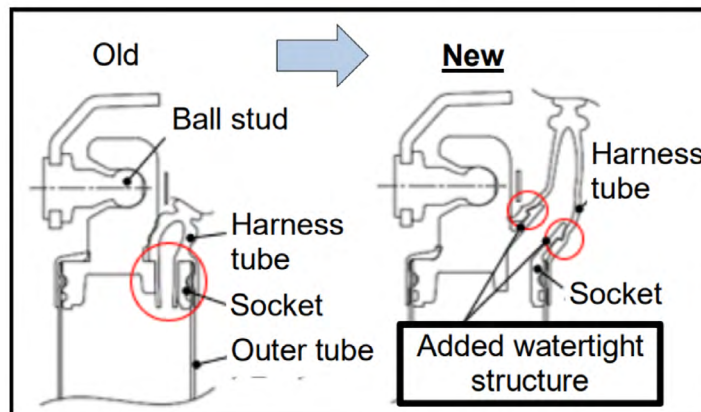
### DESCRIPTION OF DESIGN CHANGE:

This bulletin announces design changes made to the Power Rear Gate Drive (PRG) Unit to address concerns of the power rear gate being inoperative. Customers may report various concerns with the PRG operation such as beeping without operation, erratic gate functionality, and incorrect stopping points. The shape of the harness tube and socket joint has been changed to enhance the water sealing performance eliminating corrosion buildup inside the unit.
