Subject: HANDS-FREE LIFTGATE POOR PERFORMANCE AFTER TRAILER HITCH INSTALLATION	Service Alert No.: SA-015/25
	Last Issued : 03/10/2025

APPLICABLE MODEL(S)/VINS

2024-2025 CX-90 equipped with hands-free liftgate function and Mazda genuine trailer tow hitch
2025 CX-70 equipped with hands-free liftgate function and Mazda genuine trailer tow hitch

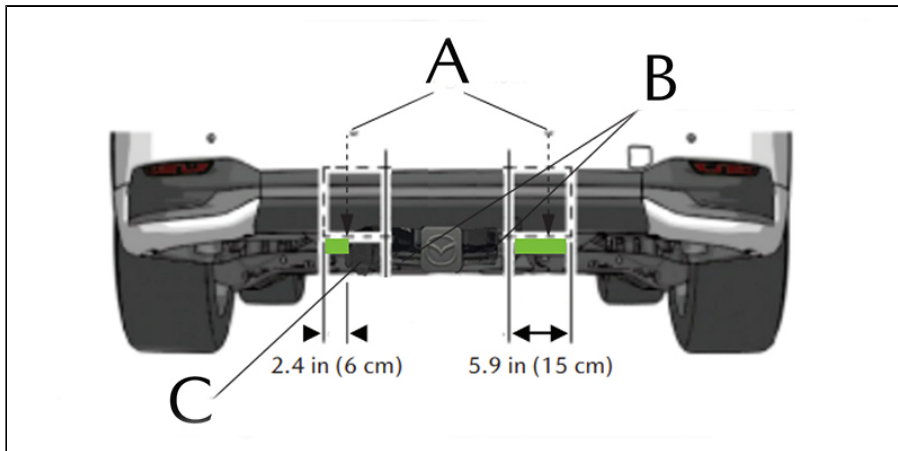
**Foot Sensing Area
Equipped with Mazda genuine trailer tow hitch**

Sensing areas are outside of the chain plates (B) and 7-pin socket (C), and approximately below the parking sensors (A) (if equipped).

- A. Parking Sensor (if equipped)
- B. Chain Plate
- C. 7-Pin Socket

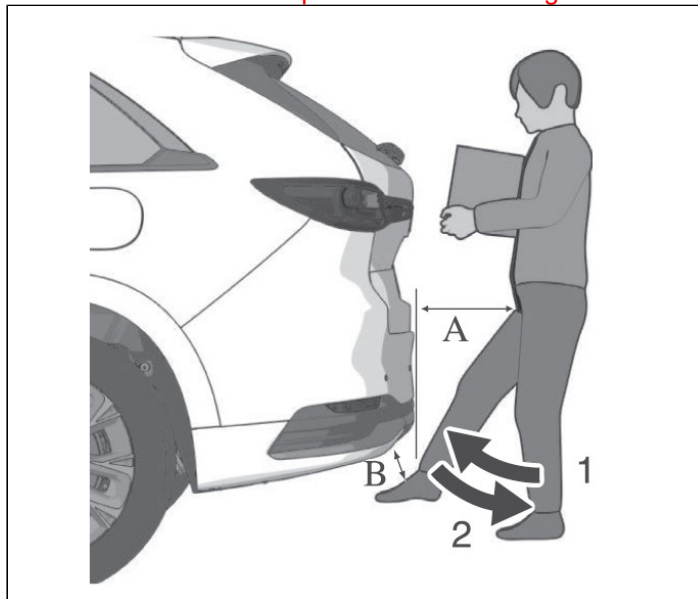
Quick KICK* within 1 second.

About 3/4 in (2 cm) or less from the bottom of the bumper within the sensing areas.

- A : About 30-50 cm (12-19.7 in)
- B : About 20 cm (3/4 in) or less

* DO NOT swing or swipe.
