REFERENCE:	TSB: 08-089-25 GROUP: 08 - Electrical	Date:	March 28, 2025	REVISION:	—
VEHICLES AFFECTED:	2024 (GG) Dodge Hornet This bulletin applies to vehicles built on or before June 07, 2024 (MDH 0607XX) equipped with a 2.0L I4 DOHC DI Turbo Engine w/ESS (Sales Code EC1).	MARKET APPLICABILITY:			
		<input checked="" type="checkbox"/> NA <input type="checkbox"/> MEA <input type="checkbox"/> SA <input type="checkbox"/> IAP <input type="checkbox"/> EE <input type="checkbox"/> CH			
CUSTOMER SYMPTOM:	<p>Customers must experience a Malfunction Indicator Lamp (MIL) illumination and the vehicle must exhibit/set one or more of the following Diagnostic Trouble Codes (DTCs):</p> <ul style="list-style-type: none"> • P0010 - Bank 1 Camshaft 1 Position Actuator Circuit Open. • P0013 - Bank 1 Camshaft 2 Position Actuator Circuit Open. <p>Customers may also experience the following:</p> <ul style="list-style-type: none"> • The vehicle will not start.

This bulletin involves replacing the G902A ground bolt.

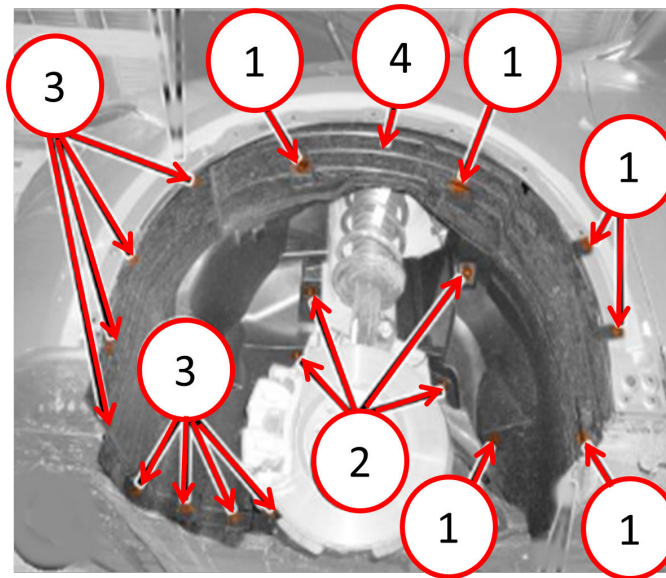
**Fig. 1**

Left Front Splash Shield Fasteners, Nuts And Screws

3. Remove the left front splash shield fasteners, nuts and screws from the splash shield [Fig. 1](#).

5. Install the left front splash shield fasteners, nuts and screws [Fig. 1](#). Tighten all screw and nut fasteners securely.
6. Install the left tire and wheel assembly. Refer to the detailed procedures available in DealerCONNECT > Service Library> under: 22 - Tires and Wheels / Installation.
7. Lower the vehicle.
8. Clear all DTCs that may have been set.

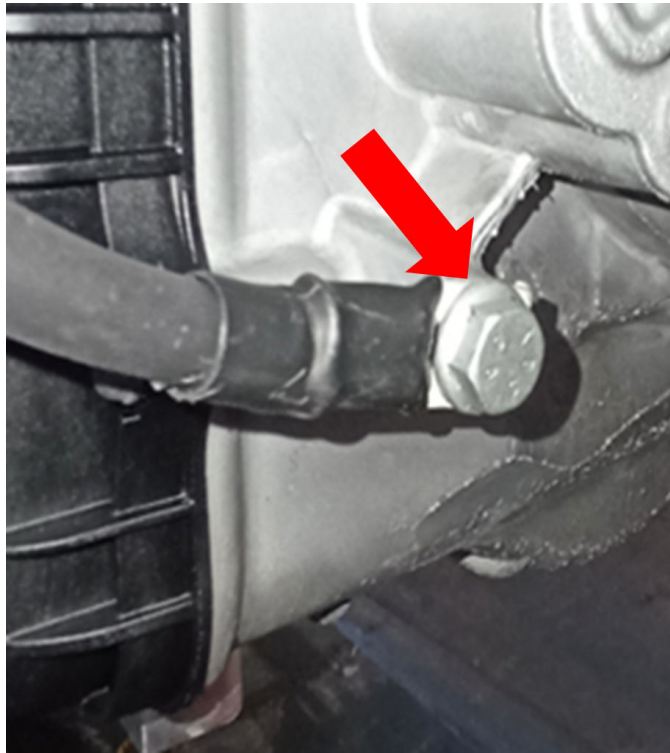
CAUSE:	Ground issue

Fig. 2
G902A Ground Bolt

4. Replace the G902A ground bolt [Fig. 2](#). Tighten the bolt to 15 N·m (11 Ft. Lbs.).
