**Technical Service Bulletin (TSB)**  
**Irregular Gap Between Headlight And Fender**

<b>REFERENCE:</b>	<b>TSB:</b> 23-014-25 <b>GROUP:</b> 23 - Body	<b>Date:</b>	March 29, 2025	<b>REVISION:</b>	–
<b>VEHICLES AFFECTED:</b>	<b>2024 - 2026 (M1) Jeep Compass</b> This bulletin applies to vehicles built on or after July 01, 2024 (MDH 0701XX) and on or before March 15, 2025 (MDH 0315XX).			<b>MARKET APPLICABILITY:</b>	
				<input type="checkbox"/> NA	<input type="checkbox"/> MEA
				<input checked="" type="checkbox"/> SA	<input type="checkbox"/> IAP
				<input type="checkbox"/> EE	<input type="checkbox"/> CH
<b>CUSTOMER SYMPTOM:</b>	<b>Customers may experience the following:</b> <ul style="list-style-type: none"> <li>Excessive gap between the headlight and the fender.</li> </ul>				
<b>CAUSE:</b>	Change in production methods

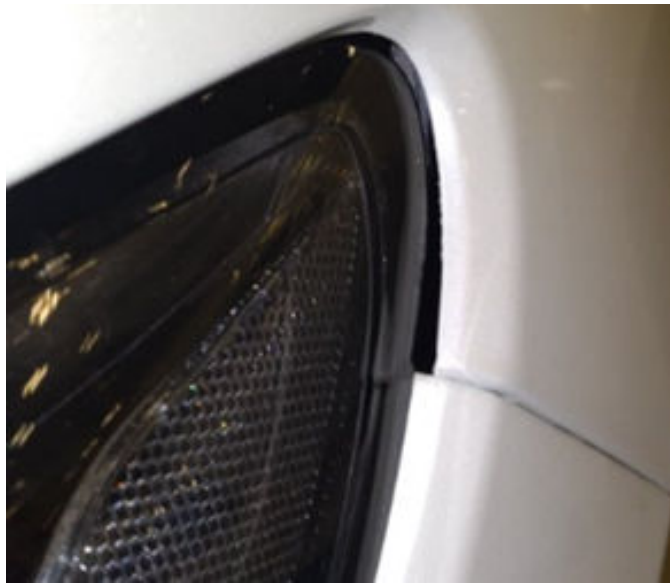
**Fig. 1**

1. Inspect the fender to headlight gap [Fig. 1](#).

Area To Check

2. Is there an excessive gap between the headlight and the fender?
  - YES >>> Proceed to [Step 3](#).
  - NO >>> This bulletin does not apply. Use Inspection LOP (13-20-01-97) to close the active RSU.
3. Remove the Front Wheelhouse Splash Shield. Refer to the detailed service procedures listed in DealerCONNECT>Service Library under: 7055B90 - Protecao suplementar da caixa de roda dianteira esquerda (locary) - remocao/recolocacao.
4. Loosen the top screw on the side fender [Fig. 2](#).

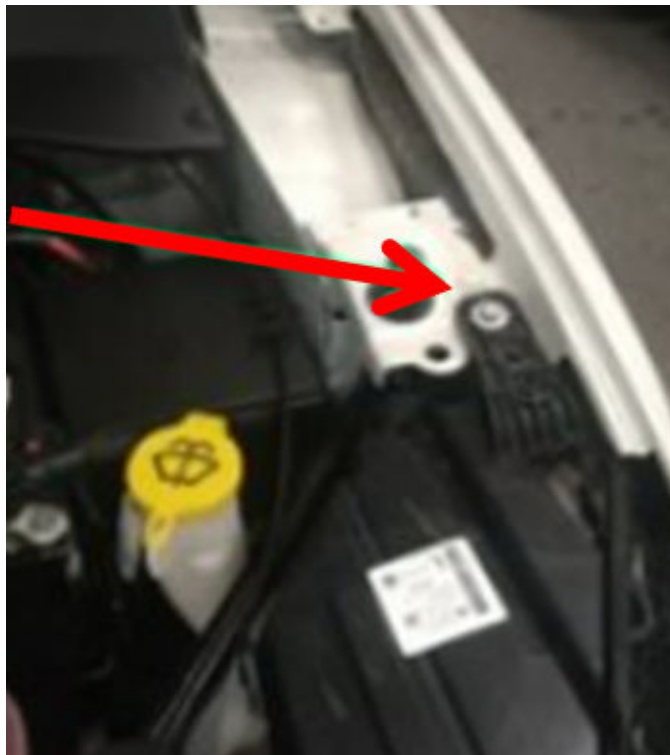
**Fig. 2**

Fender Top Screw

7. Loosen the screws and align the fender to the headlight, then tighten.
8. Tighten the top screw on the side fender [Fig. 2](#).
9. Attach the front fascia to the fender [Fig. 4](#).
10. Attach the front wheel opening molding to the fender [Fig. 3](#).
11. Install the Front Wheelhouse Splash Shield. Refer to the detailed service procedures listed in DealerCONNECT>Service Library under: 7055B90 - Protecao suplementar da caixa de roda dianteira esquerda (locary) - remocao/recolocacao.

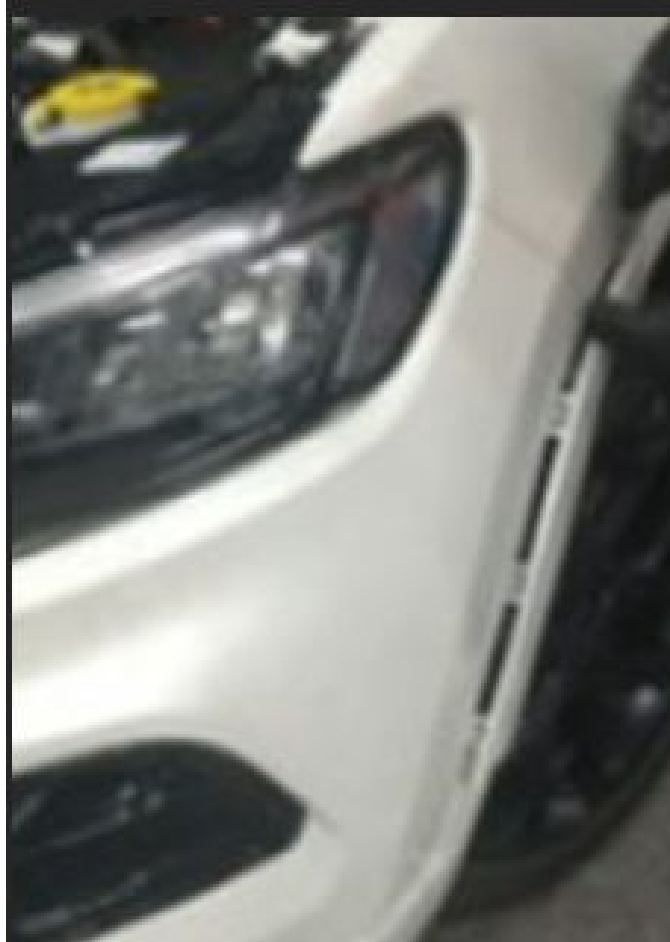
**Fig. 3**  
Front Wheel Opening Molding

5. Using a trim stick, detach the front wheel opening molding [Fig. 3](#).
