2024 CX-90 - ABNORMAL NOISE FROM VEHICLE FRONT

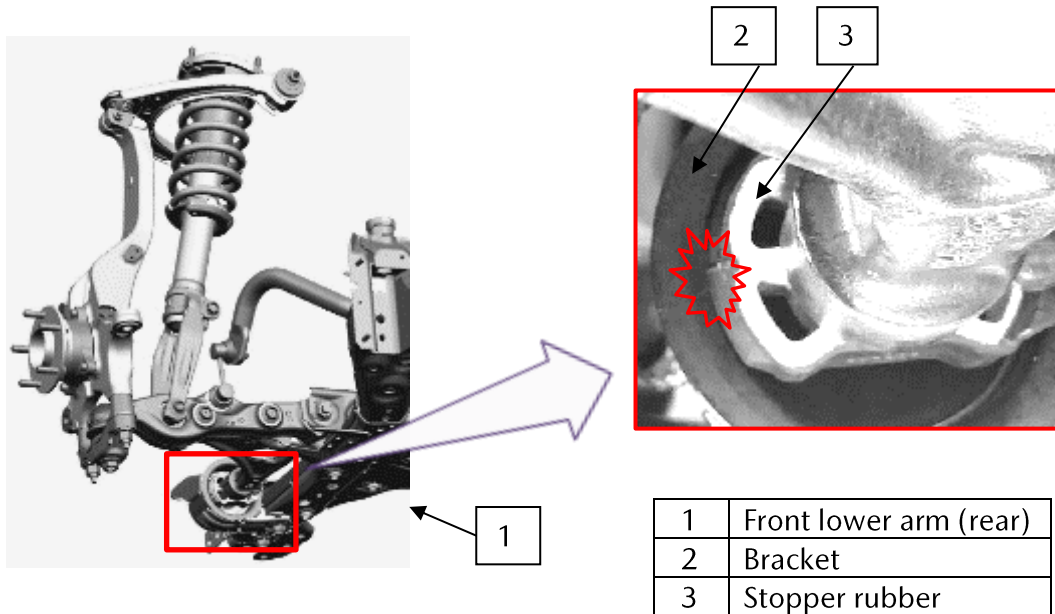
Certain subject vehicles may exhibit a creaking or squeaking noise from the lower arm at the front suspension when traveling over a bump while turning at low-speed.

Causal factor: A stick-slip phenomenon may occur between the stopper rubber and the bracket in the front lower arm (rear).

- 1) (Only vehicles with dust covers) Remove the dust covers from the lower arms (on both sides).
Note: Certain vehicles may have had dust covers installed in past repairs. This operation is required only for such vehicles.
- 2) Clean the lower arm stopper rubbers and apply the appropriate grease to the lower arm stopper rubbers (on both sides).
- 3) Install the new dust covers to the lower arms (on both sides).
