Problem Details:

- There is a known software bug on vehicles built with an ICC5 and software packages **81Z-008, 81Z-308 or 81Z-808** related to fault code **23/523021/31-The list of ECUs stored in the warning database (WDB) does not match the list of ECUs parameterized in PID 0x20**. Typically, this code would only display active with another active code. If this code is being displayed by itself, it should be considered a Nuisance code and no troubleshooting for the code is required.

- All P4 and Western Star X-Series vehicles built with an ICC5 and **software package 81Z-008, 81Z-308 or 81Z-808**
- This affects roughly 7359 vehicles

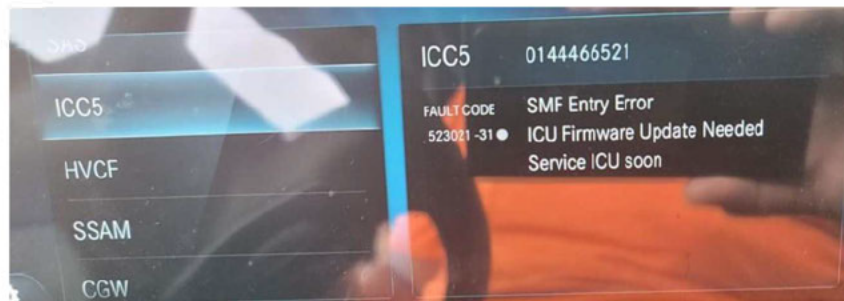
[UDS-23] ICC501T - Instrument Cluster 5

The list of ECUs stored in the warning database (WDB) does not match the list of ECUs parameterized in PID 0x20 523021 31 active

- Publish a Western Star and Freightliner Service Bulletin **TSB-54-096-WST and TSB-54-372-FTL on 2/4/2025** bringing awareness to the Nuisance code **23/523021/31**, in hopes of eliminating troubleshooting / diagnostic time.
