FRACAS 14036 – WHEEL SEALS

Background & Root Cause

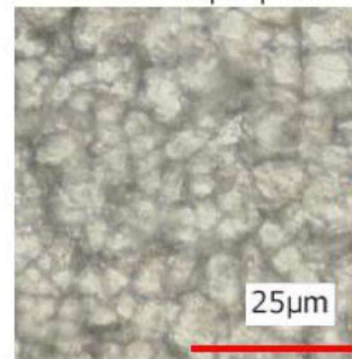
2022 unused seal
correct micro-phosphate

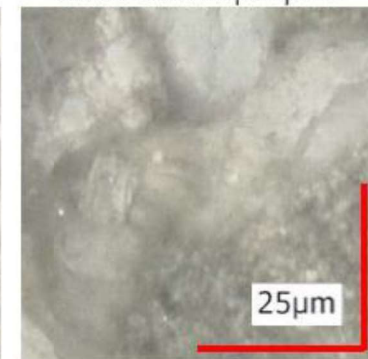
- DTNA & ConMet recently identified a wheel seal manufacturing defect which has caused an increase in seal failures due to oil leakage
 - **Affected hub build date range is May 2023-July 2024**
 - FF & R premium wheel seals only
 - Peak failure rate is <0.9% in the first year of service
- Root cause determined: excessively large phosphate crystals on seal sleeve
- The defect affects the seal's internal running surface and reduces the ability of the seal main lip to contain the hub oil
 - Majority of these failures occurring within the first months of service

2024 failed seal
unwanted macro-phosphate

- Inspected seals on-hand at supplier and CMI plants
 - **Clean date for new DTNA truck builds: 1/1/25**
- Provided SID's for inspected shipment clean dates for each DTNA plant
- Seal supplier has instituted additional process controls
 - Magnified visual inspection of 3 samples per phosphate rack
 - Tightened control limits for phosphate bath
