SS 782-WST ICC5 B-Panel Gauges Intermittently Not Being Displayed

47X, 49X, 57X With ICC5 Cluster

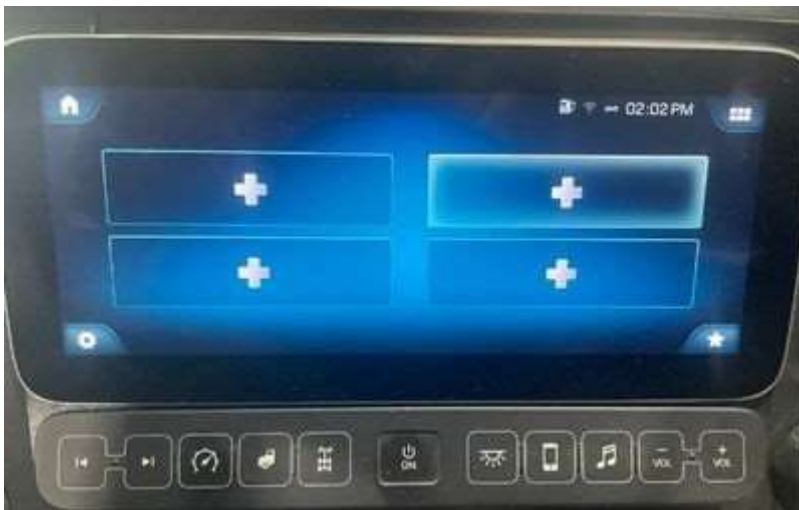
Intermittently during first start the custom gauges in the B-panel are not being displayed. Subsequently trying to add them in again will not work. The B-panel could also become unresponsive to different inputs. This can also cause your SiriusXM to stop outputting audio. Below is an example picture of what it could look like.

The symptoms resemble an issue with the the way the memory is being loaded. Currently it is under investigation.

The solution is to key cycle the truck and if that does not work then pull the F16 fuse to the Connect5 ECU wait 10-15 seconds before reinserting. This will typically reboot the ICC5 module restoring normal functionality to the B-panel.
