SF712 A

**Subject: Air Compressor Discharge Line**

On behalf of the entity listed below, Daimler Truck North America LLC (DTNA), is initiating Field Service Campaign SF712 to modify the affected vehicles.

**PROBLEM:** The wire braid hose section of the air compressor discharge line may contact the equalizer.

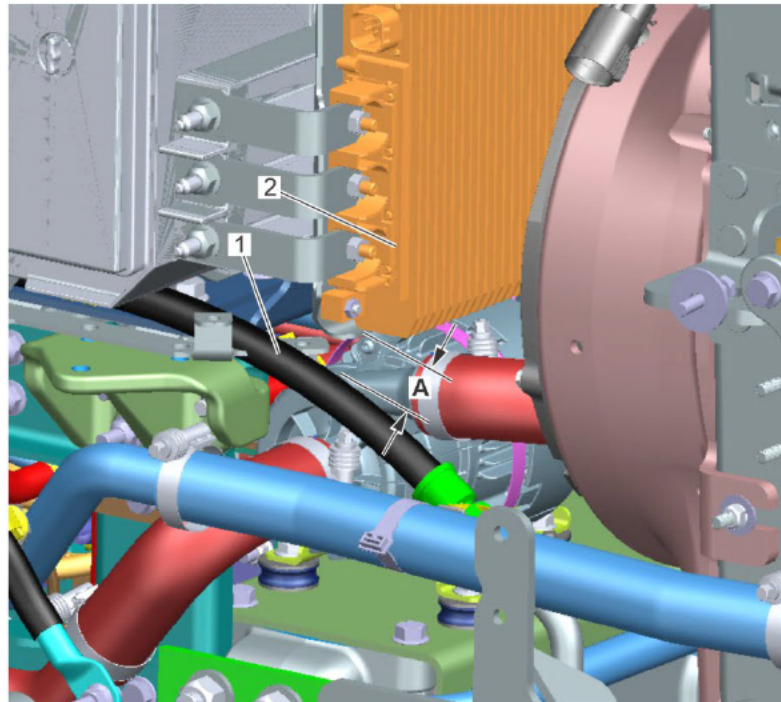
**Fig. 1, Gap Between the Discharge Line and the Equalizer**

4. Measure the gap between the discharge line and the equalizer, as shown in **Fig. 1**. The gap should be a minimum of 10 mm.
  - If contact is found between the discharge line and the equalizer, or if the gap is less than 10 mm, proceed with the **Replacement of the Discharge Line** procedure (on page 7).
  - If the gap exceeds 10 mm, close the hood. Clean a spot on the base label (Form WAR259), and attach a campaign completion sticker for SF712 (Form WAR261), indicating this work has been completed.

A. The gap between the equalizer and the discharge line should be more than 10 mm.
