Ford Motor Company
PO Box 1904
Dearborn, Michigan 48121

March 7, 2025

SUBJECT: Update Prior to Sale 24U12
Certain 2024 Model Year Ranger Vehicles
Inspect/Replace Restraint Connectors

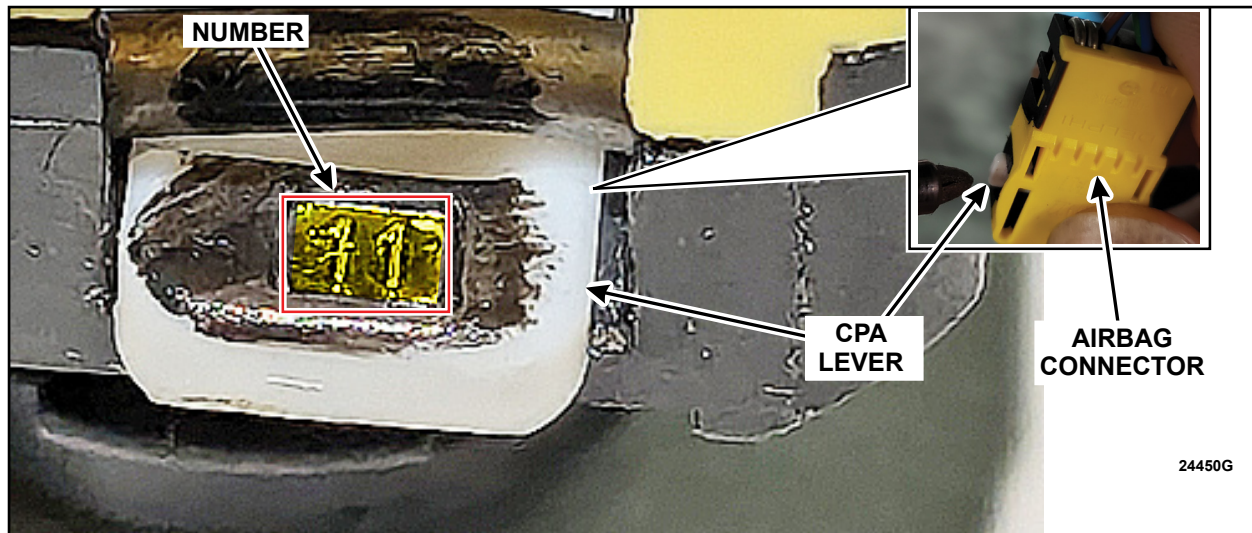
FIGURE 3

On some of the affected vehicles, customers may have an airbag warning light that is illuminated on the instrument panel cluster due to an out-of-specification connector. The airbags will still deploy during a crash event if that event meets the deployment threshold.

6. Using a magnifying glass or quality camera with a zoom feature, inspect the previously marked airbag electrical connector CPA levers in the area shown in Figure 3 for the following numbers:

- 02
- 03
- 09
- 11
- 14

NOTE: The number 11 is shown on the CPA lever in Figure 3. All others similar.

7. If any of the CPA levers have number(s) called out in Step 6, replace that electrical connector pigtail. Follow the repair procedures in Cell 005 of the Wiring Diagrams on Professional Technician System (PTS), using the soldering, butt connectors and shrink tube method.

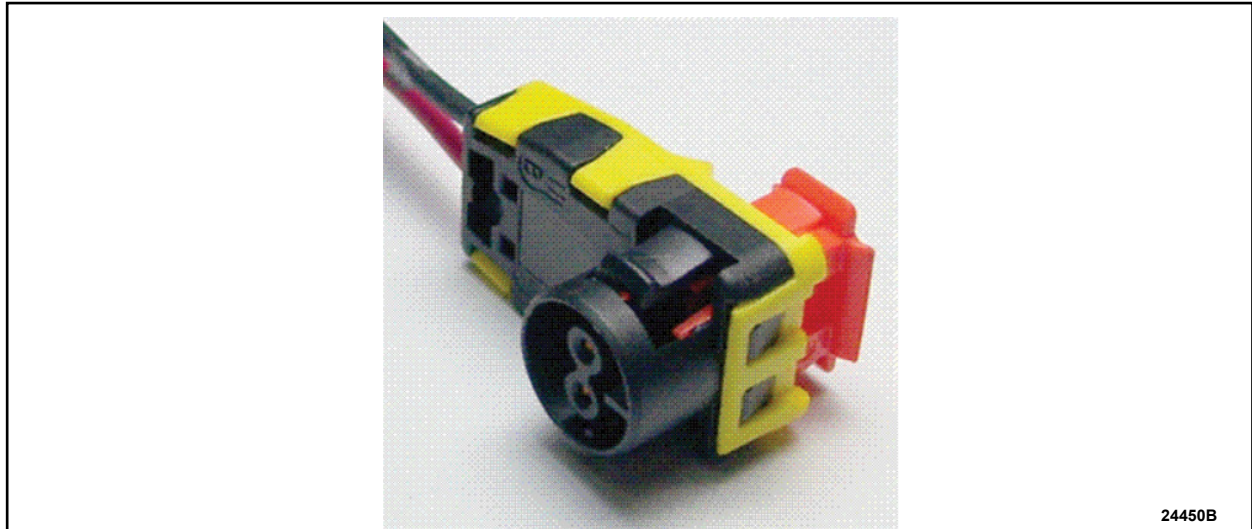
FIGURE 4

NOTE: The service airbag electrical connector may differ from the original. See Figure 4 for an example of the service pigtail.
