Technical Service Bulletin

Topic	Oil leaking from tell tale hole - CDA actuator fixings or Fuel rail fixings or Vaccum assembly fixings - V8 Kovomo
Market area	Australia E04 Bentley rest Asia and Australia (6E04),China 723 Volkswagen (Anhui) Automotive CO (6723),China 796 VW Import Comp. Ltd (Vico), Beijing (6796),Germany E02 Bentley rest Europe (6E02),Japan E03 Bentley Japan (6E03),Korea, (South) E08 Bentley South Korea (6E08),Russian Federation 935 Volkswagen Group RUS (6935),United Arab Emirates E06 Bentley Middle East and Africa (6E06),United Kingdom E01 Bentley UK (6E01),United States E05 Bentley USA and rest America (6E05)
Brand	Bentley
Transaction No.	2064679/5
Level	EH
Status	Released for publishing
Release date	Mar 4, 2025

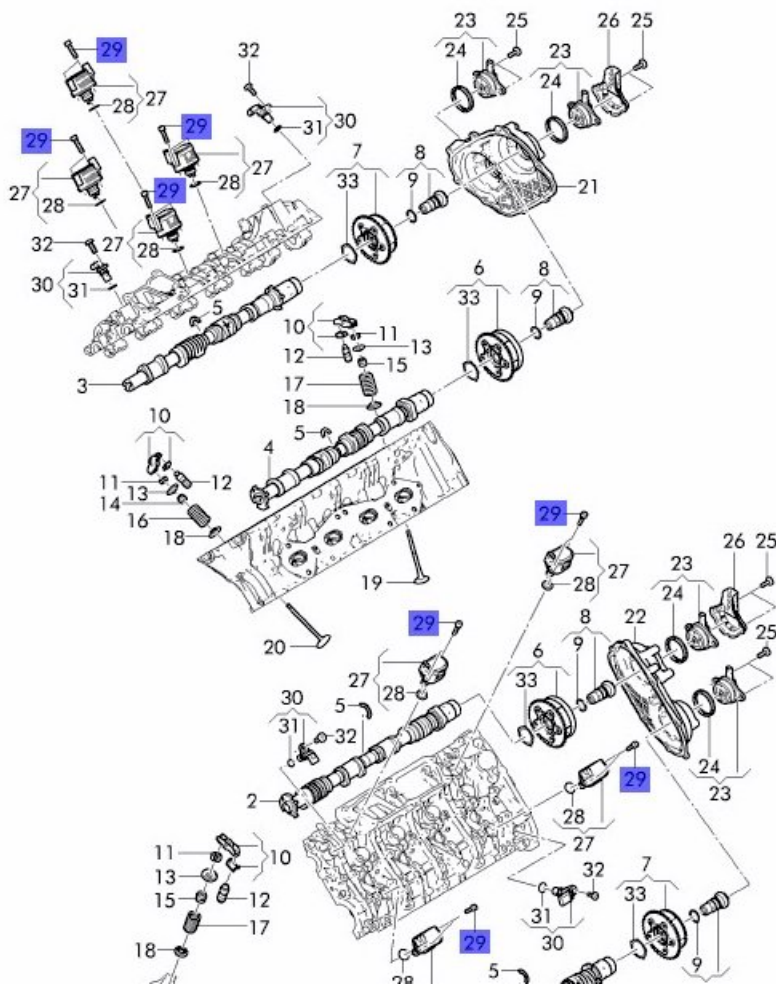
- CDA activation/ deactivation solenoid fixings - Figure 1 (Item 29 - Quantity of 16 in total)

- In the event that x1 (or more) of the CDA solenoid fixing/s are leaking – **All 16 CDA solenoid fixings MUST BE REPLACED as a complete set** - Refer to Rep.Gr 15 - Ensuring the procedure is followed to enable access to all CDA solenoid fixings

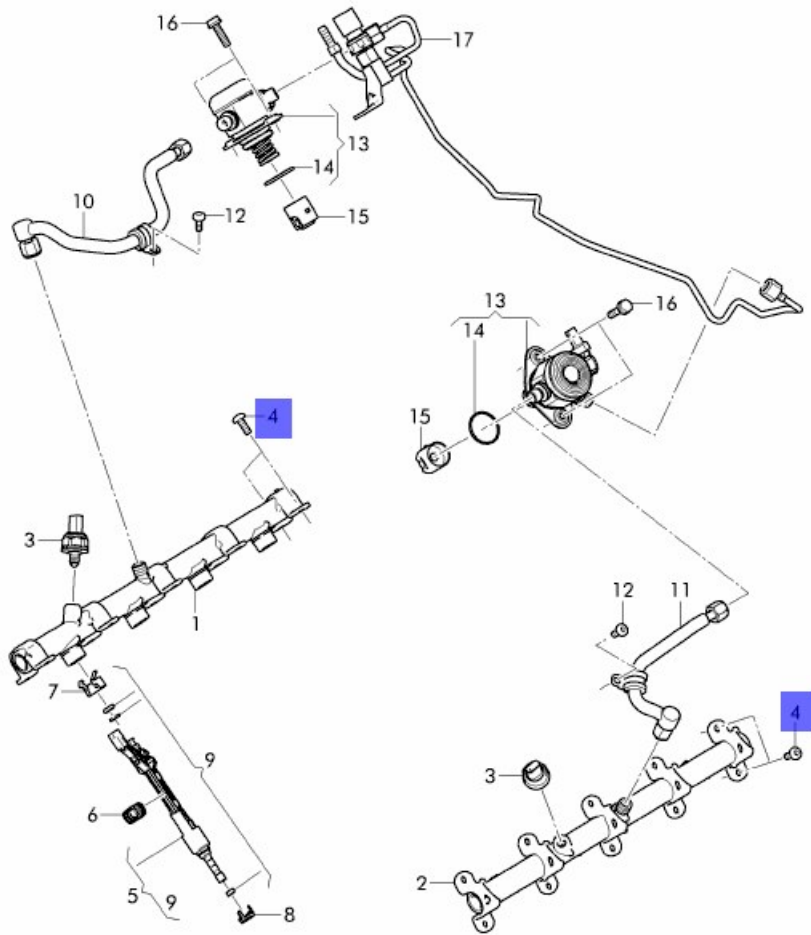
- Fuel rail fixings - Figure 2 (Item 4 - Quantity of 20 in total)

- Refer to Rep.Gr 24 - Fuel rails to remove and refit - Ensure the procedure is followed to enable access to the fuel rail fixings on both Banks 1 and 2 - Replace all 20 fixings

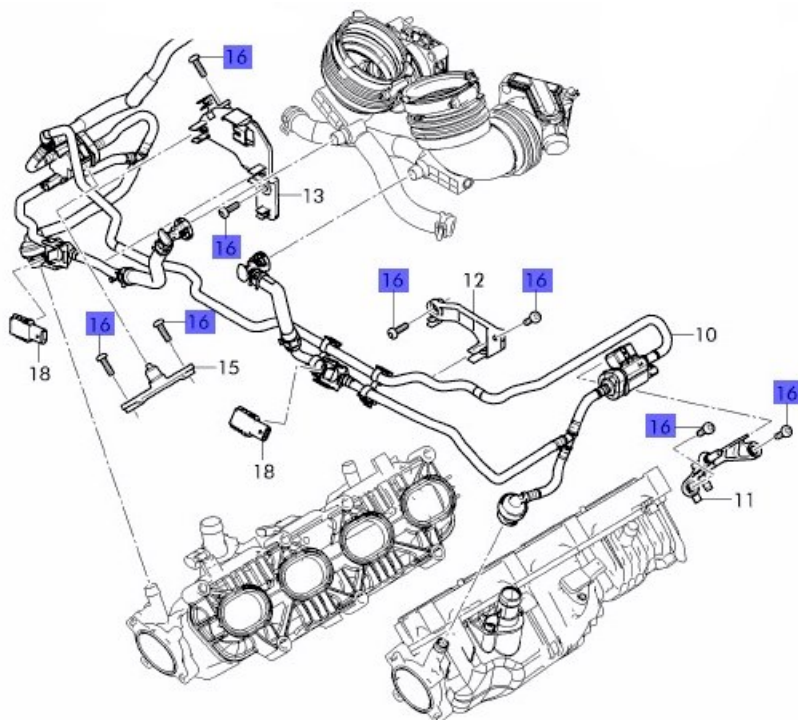
- Fixings for the vacuum system assembly - Figure 3 (Item 16 – Quantity of 8 in total)

- Remove the front end module - Refer to "Front end module - to remove and fit"
- **All models continued**
- Rep.Gr 20 - Evaporative Emission Purge Valve and Rep.Gr 28 - Ignition coil replacement to gain access to the fixings
- Replace all Vacuum assembly fixings
- Refit all previously removed parts

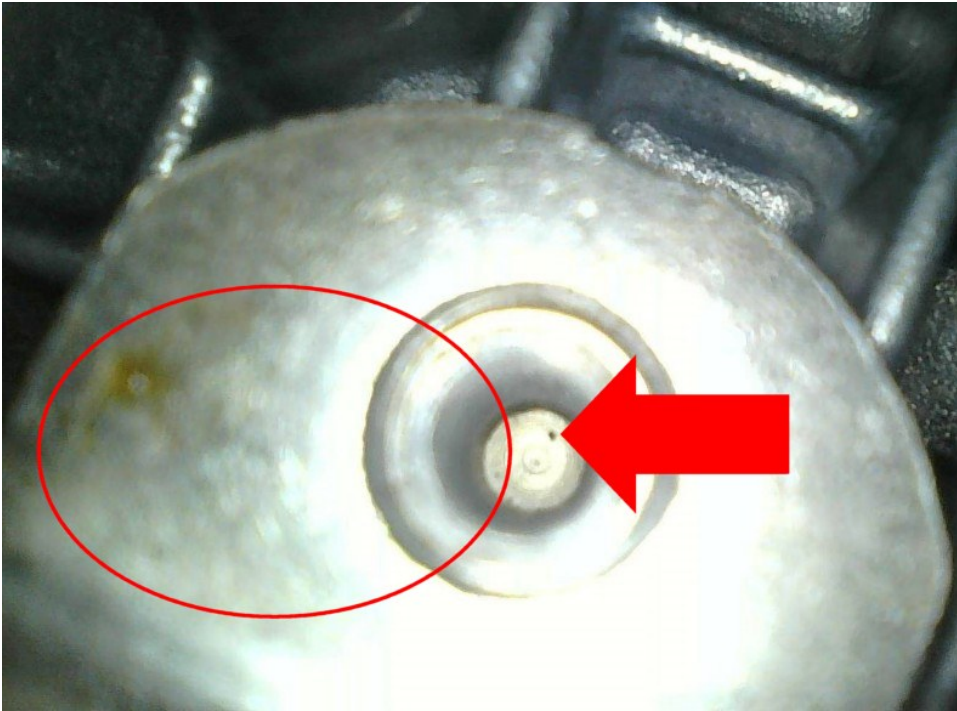
Figure 4 shows oil leaked which had leaked from the tell tale hole at the top of the fixing (Arrow)

Upgraded fixings prevent oil leaks from the tell hole
