IAUPS004203

Update Prior to Sale

Authored Date	07/03/2025	
Doc No.	IAUPS004203	
Title	Removal of the Towbar	
Affected Vehicle(s)	Grenadier	SF023580 – SF023792
Prior to starting any reworks, please make sure you check the vehicle is affected by checking the VIN using Vehicle Simple Search in the Warranty System.

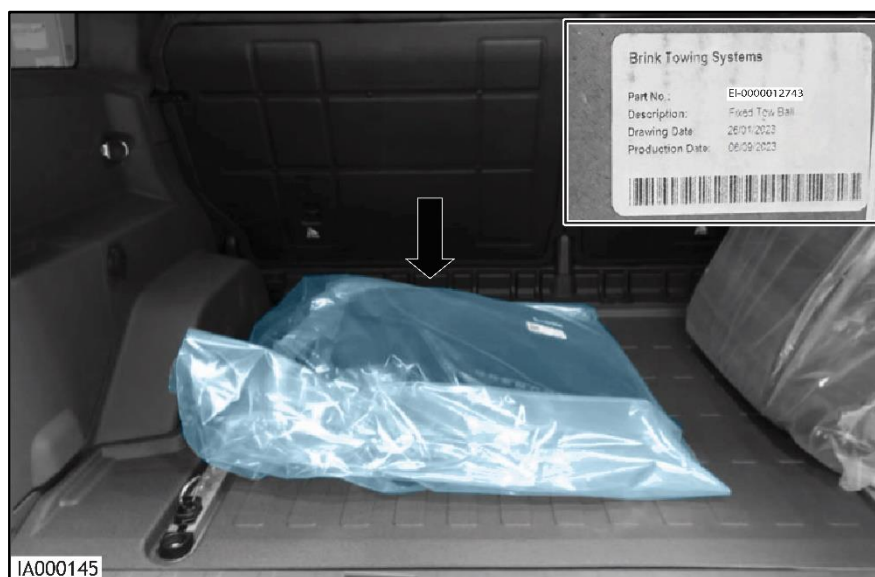
2.

Check the part number on the box and make sure the towbar removed is EI-0000012743

Remove the towbar.
