SIB 17 01 24

COOLANT LEAK AT CHANGEOVER VALVE

This Service Information Bulletin (Revision 3) replaces SI B17 01 24 **dated April 2024**.

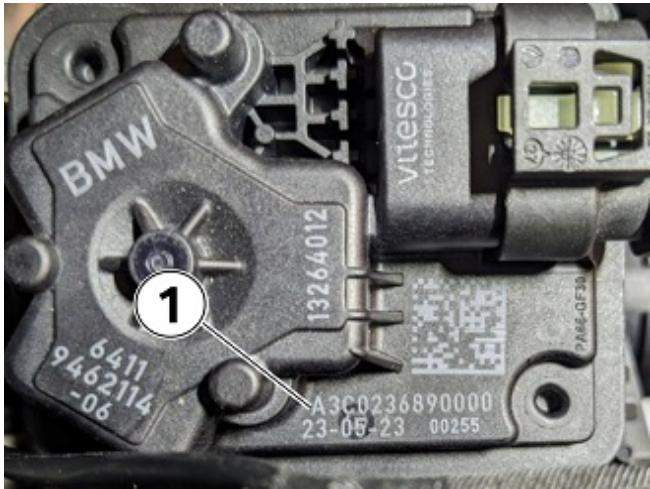
Check all the changeover valves (if vehicle has more than one*) for a coolant leak (active) or previous coolant leak (valve has residual coolant dried around it).

Check the production date of the remaining changeover valves (1). Improved valves were produced 18.1.2024 (January 18, 2024) and later.

Replace any* changeover valves PN 64 11 9 462 114) with a production date older than 5.1.2024 (January 5, 2024).
