EGR Valve Diagnosis and Cleaning Procedure using TUNAP 926® on 906, 907 Sprinter with OM642 Diesel Engine

Topic number	LI14.20-N-073867
Version	7
Function group	14.20 - Exhaust gas recirculation
Date	3/10/25
Validity	906, 907 Sprinter with OM642 V6 Diesel Engine
Reason for change	LI Takeover

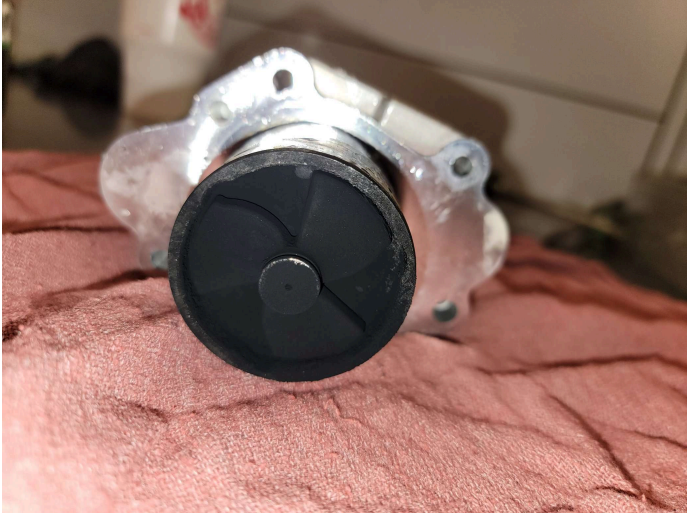
Attachments	
File	Description
OM642 EGR Valve before 1.jpeg

Soot deposits between the EGR Valve blade and seat leading to the EGR Valve no longer being able to meet the desired target of the EGR Valve position controller.

Bottom of sooted EGR Valve.
OM642 EGR Valve before 2.jpeg

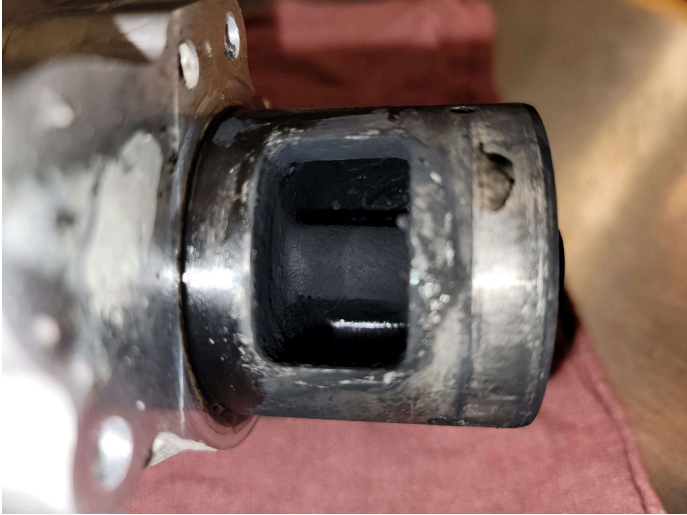
Side view of sooted EGR Valve.
