Fuel Level Unchanged After Refueling

Topic number LI47.00-N-069565

Validity MODEL 907 with OM654, OM651, or OM642

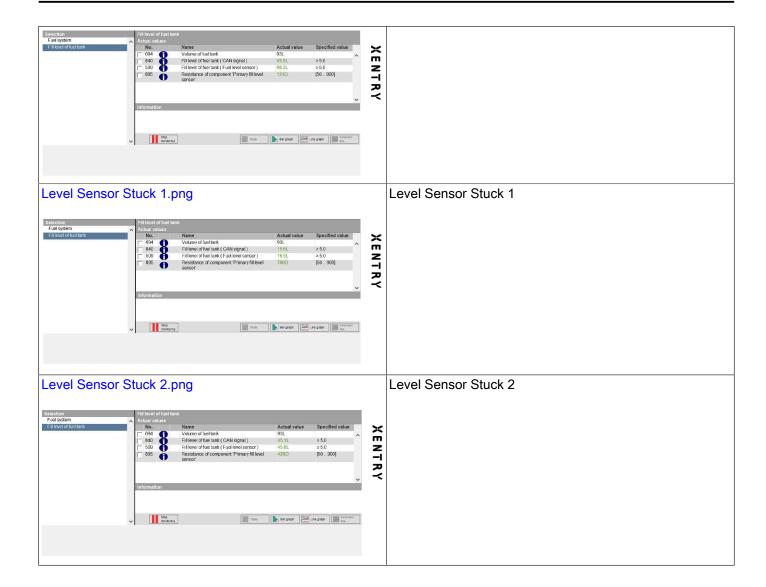
B. The Fuel Level Sensor provides incorrect readings.

Attachments File Description Stuck Level Sensor.jpg Level Sensor Stuck on Pickup Tube FSCU Calculation Error.png PSCU Calculation Error

- 1. Remove the fuel tank.
- 2. Carefully take off the Low-Pressure Fuel Pump lock ring for inspection.
- 3. Examine the fuel level sensor for any signs of sticking, a bent pickup tube, misrouted wiring, or hoses. Refer to the attachments for examples.
- 4. Remove the low-pressure fuel pump and test the resistance of the level sensor from minimum to maximum.
- If any issues are found during the above inspections, replace the Low-Pressure Fuel Pump along with the Level Sensor.
