# Check engine light or Adblue warning with fault codes P206B31, P203B31, or P300494 when outside temperatures are below 32 degrees Fahrenheit. SCR Gen4 (KP7)

Topic number LI49.20-N-078838

Function group 49.20 - Exhaust gas aftertreatment

Validity Model 907 with SCR Gen4 (KP7)

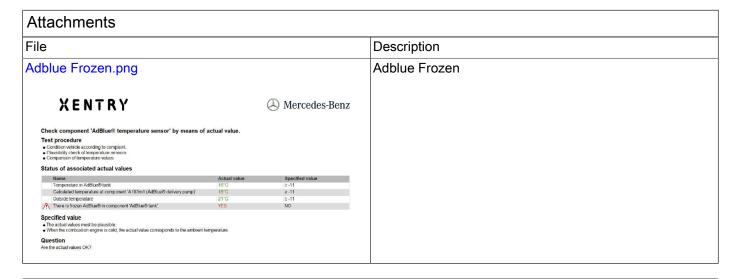
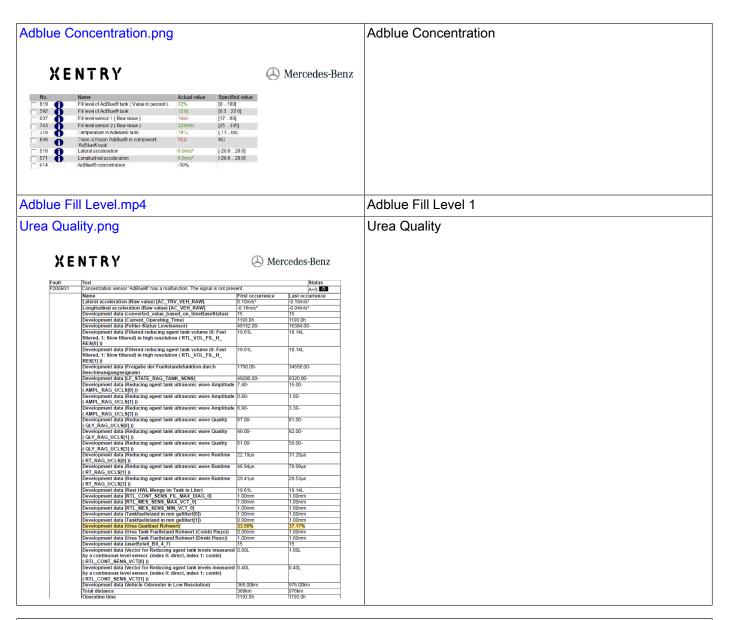
- --NOTE-- The Fill Level Sensor 1 functions as the "empty sensor." It accurately measures the bottom 60 mm (2.3 inches) of the AdBlue tank. Once the tank is filled beyond the 60 mm (2.3 inch) mark, the sensor may not read accurately, and you might notice the displayed value fluctuating. This behavior is normal, see attachment 'Fill Level 1'.

- 5. Reset the Adblue Tank fill level via XENTRY. Please print the XENTRY pages that indicate the AdBlue tank fill-up was completed successfully.
- --NOTE-- If the XENTRY still shows that there is frozen Adblue or the concentration is still inaccurate after draining and filling, please refer to the attachments 'Adblue Frozen' and 'Adblue Concentration' and proceed to step D.
