## STAR ONLINE PUBLICATION

**Case Number:** S2523000015 Rev. A

**Symptom/Vehicle Issue:** Replacement Exterior Mirror Glass Connector Does Not Match For Blind Spot.

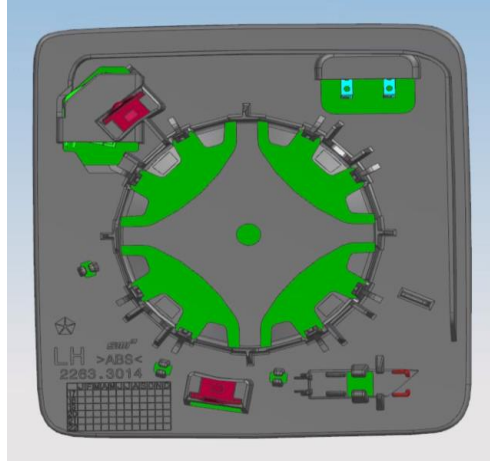
Fig 1.

### Early Mirror Glass Design

Requires Adapter Jumper Harness When Installing New Design Mirror Glass.

- If you have an old mirror and need replacement glass (Fig 1) – order a service glass + a JUMPER to allow a connection to the old mirror wiring. Jumper 68673054AA
- If you have a new mirror that needs replacement glass (Fig 2) – order a service glass only - no jumper needed.

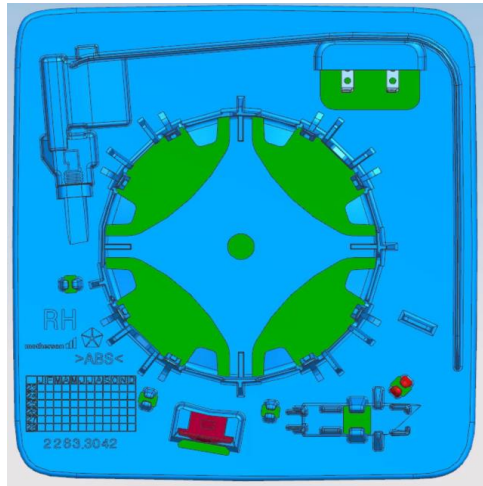
Fig 2.

### New Mirror Glass Design Adapter Jumper Not Needed.
