SIB 52 19 23

SECOND ROW 60/40 SEAT RAIL FLEX CABLE REPLACEMENT

2025-03-27

G07 (X7) SECOND ROW 60/40 SEAT RAIL
ATTACHMENT TO SERVICE BULLETIN 52 19 23 – DECEMBER 2024

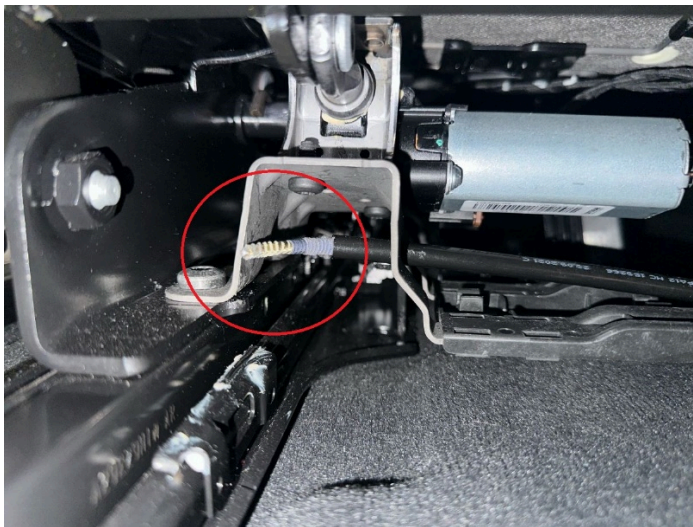
In vehicles equipped with the second row 60% / 40% split seat, the flex cable assembly can come out of the seat rail mechanism (circled). This stops the forwards and backwards travel of the seat.

Something has mechanically jammed the seat movement on one or both sides of the seat.

Locate and remove the foreign object, if still present.

Determine the extent of the damage per the various Situations below, then make the appropriate repair. There are numerous parts kits available, so you don't have to replace the entire seat rail assembly.

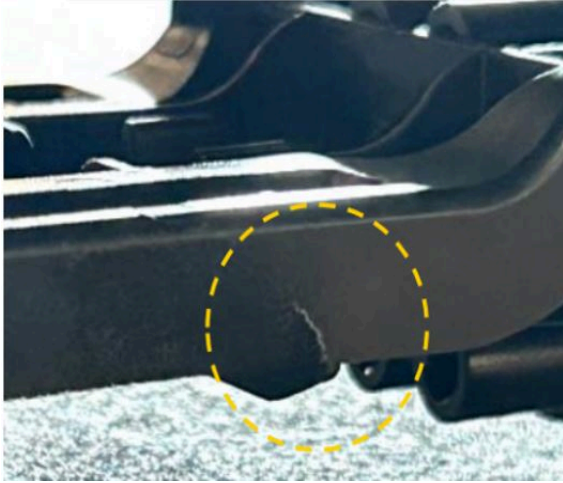
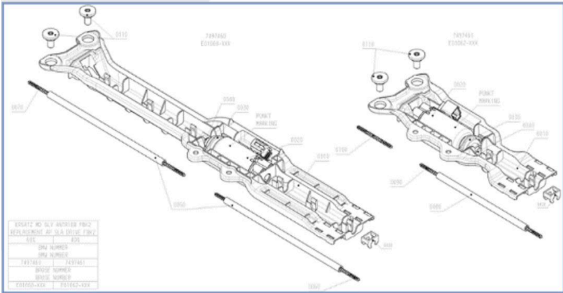
SITUATION 1

The plastic SLV Motor Carrier tray is broken.

The plastic SLV Motor Carrier tray is available with flex shaft kits.

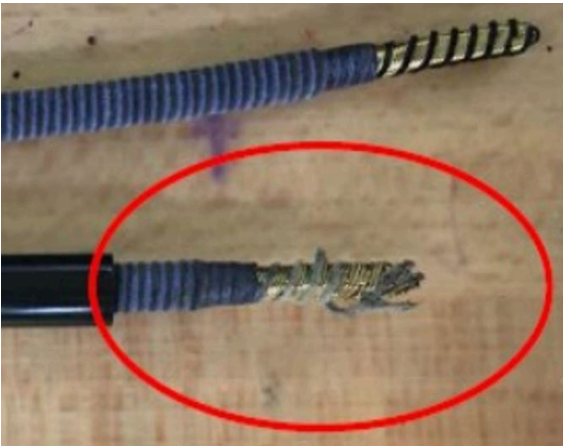
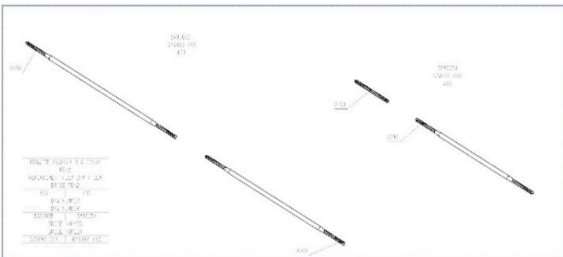
**SITUATION 2**

The flex cable is damaged.

If the flex cable end has been damaged, do not reuse it.

Replace only the damaged flex cable assembly instead of entire seat rail assembly. Install a new locking clip as per situation 3.

NOTE: The locking clip will be available in July 2025. **Until then reuse the existing locking clip.**

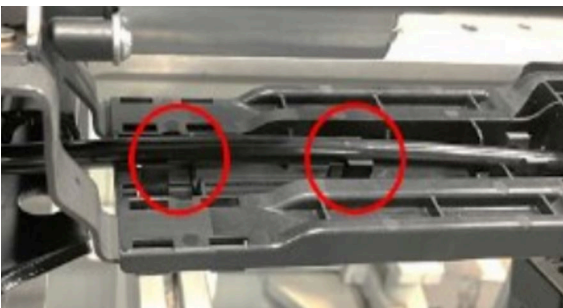
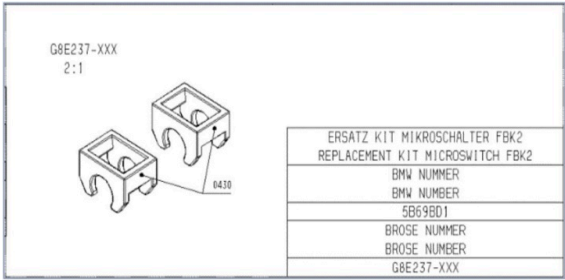
**SITUATION 3**

The Flex Cable has popped loose from the U-shaped flex shaft hooks. If the flex cable end is not damaged, check the U-shaped hooks on the plastic carrier.

- If the U-shaped hooks are damaged, replace SLV Motor Carrier tray (see situation 1)
- If the U-shaped hooks are not damaged, reinstall flex cable into U-shaped hooks and replace locking clip

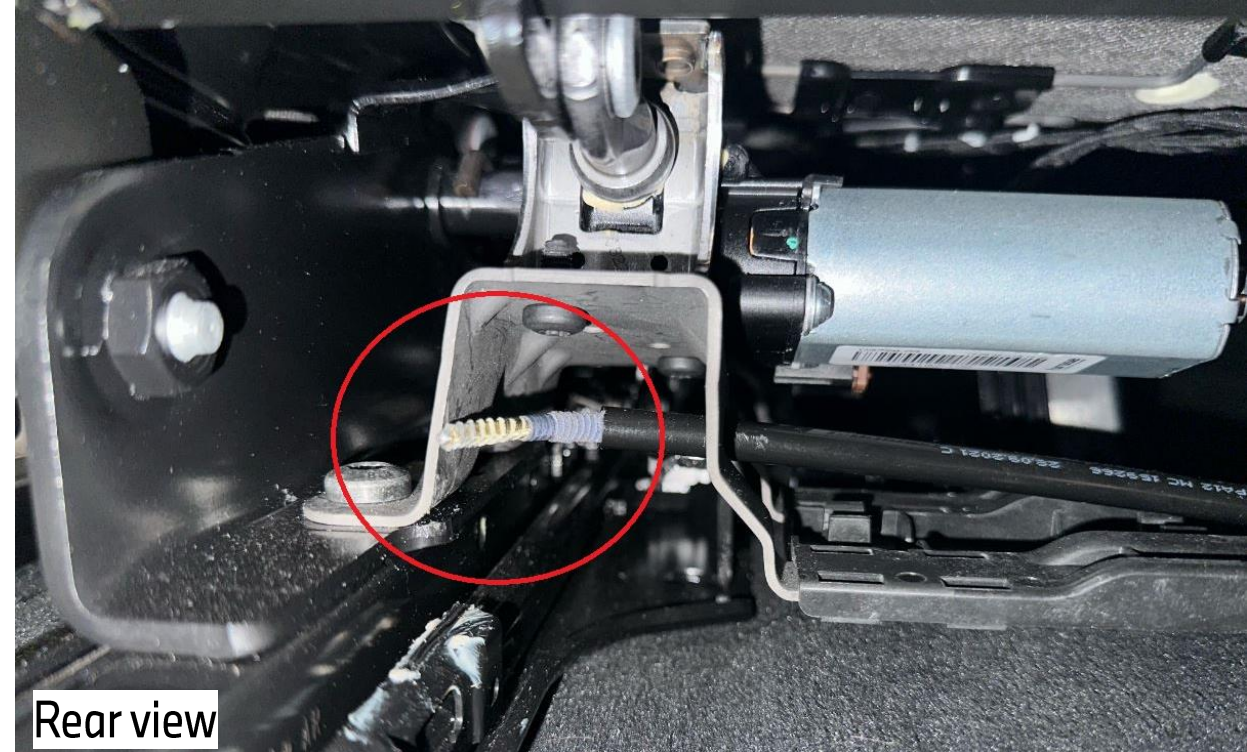
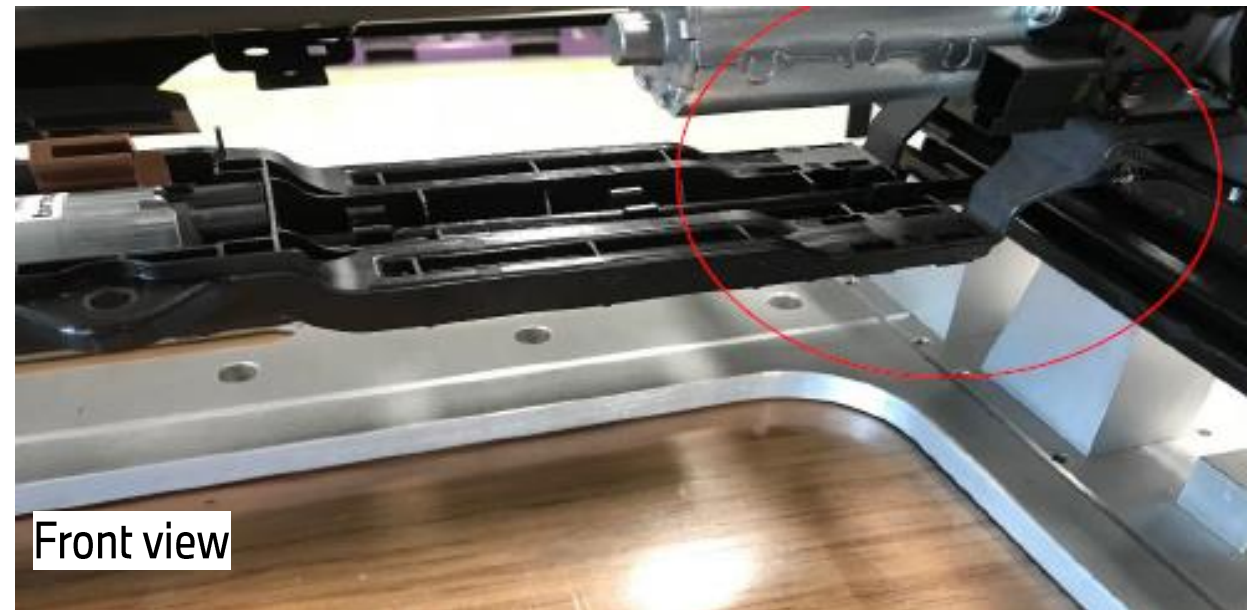
In this example the 60% seat inboard flex cable has come out of the seat rail gearbox.

This will stop the seat from moving forwards and backwards on the rails.

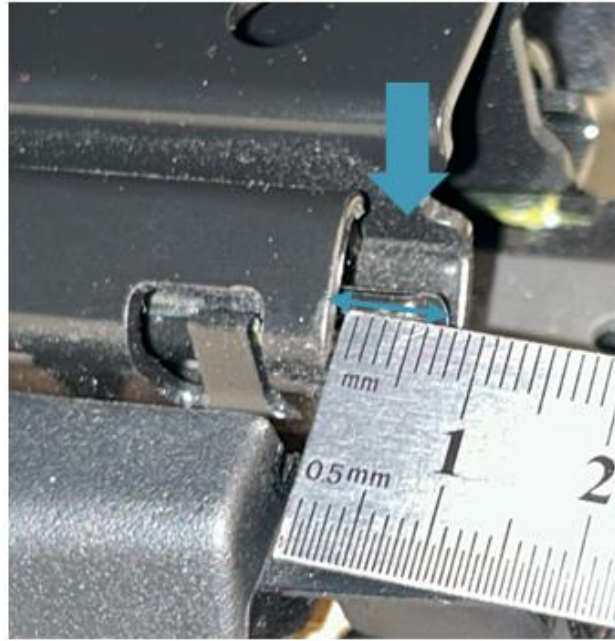
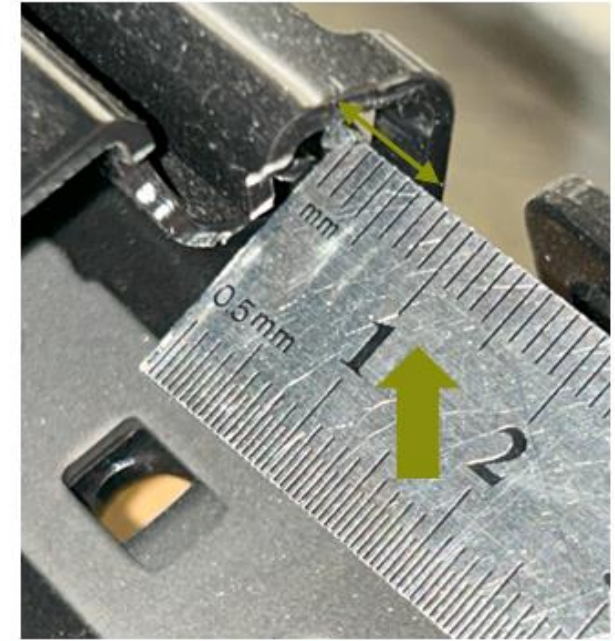
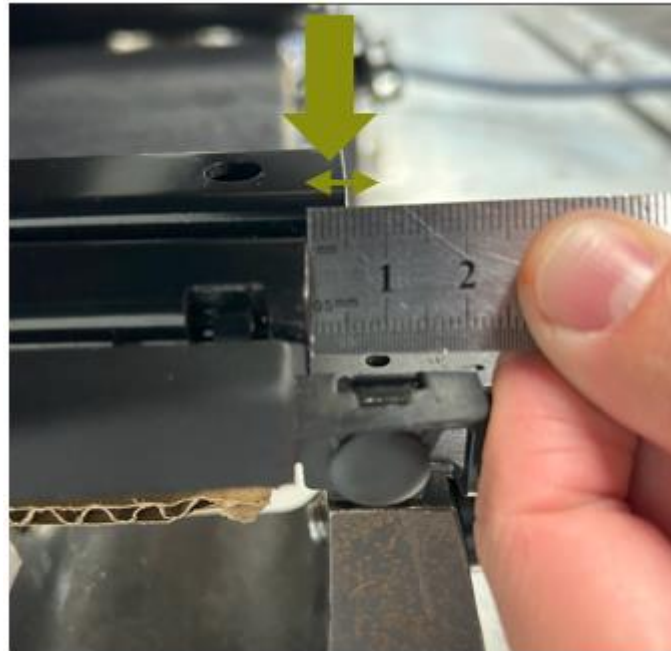
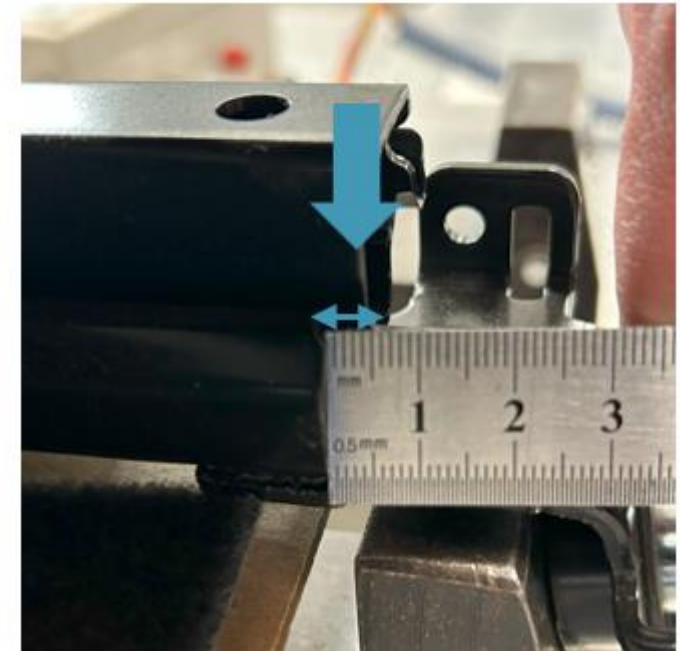
Left Rail: 8 mm outside Frame

Right rail: 6 mm Inside Frame

Considering that the right flex shaft is out of position, the left one must move the necessary distance so that it is aligned with the right one.

3. Measure the misalignment on both rails and compare how much the difference is. Note: Do the same process for the right side and the left side.

After aligning rails side to side remeasure before flex cable installation.

Now both rails are at 4 mm
