SIB 54 02 25

CLICKING SOUND HEARD FROM THE CONVERTIBLE TOP FRONT BOW/COWL PANEL AREA

E-Series	Model Description
G29	Z4 Roadster

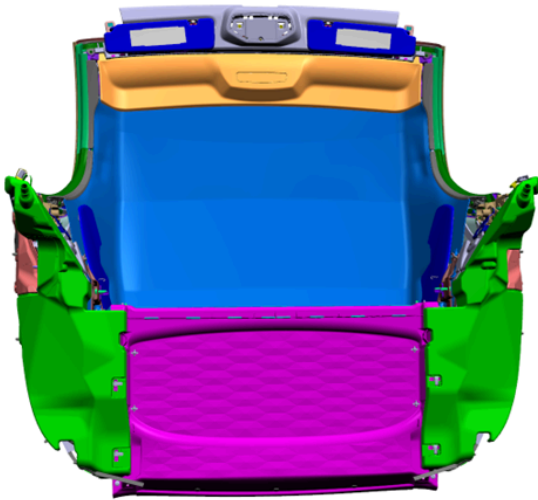
While driving on an uneven road, a “clicking” sound is heard from the front bow/cowl panel area of the convertible top.

The clicking sound is emanating from the orange panel in this illustration.

Mounting clips for the front bow panel are worn. The clips are circled in red.

Replace the four mounting clips that secure the front cowl panel to the convertible top.
