SIB 66 03 25

2025-03-26

PARKING ASSISTANCE LIMITED CHECK CONTROL MESSAGE DUE TO PDC SENSORS

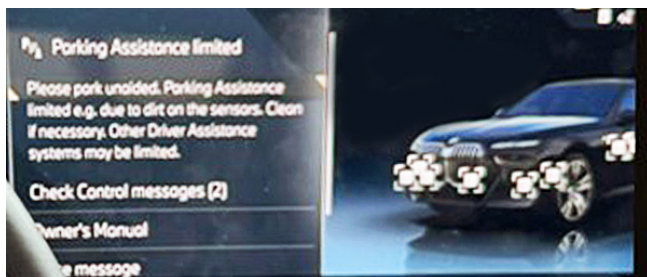
A check control message is displayed, indicating that the parking assistance systems have limited functionality due to errors detected within PDC sensors. The warning indicates parking assistance features have limited functionality while the errors continue to be detected. Following faults may be stored

The parking assistance limited check control message can be related to environmental influence, component degradation, or unfavorable UCAP (ultrasonic camera automated parking) module software.

Example of Check Control message displayed.

If the root cause is not determined to be related to environmental influence (specific locations, roads, etc..), or component failures, reprogram the UCAP module with the required I-level **25-07-510** or higher.
