Service Action

Code: 19N8

After-Run Coolant Pump

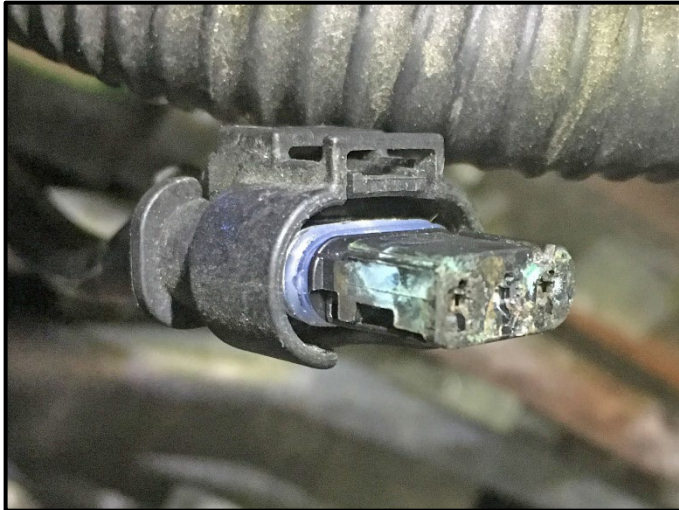
Inspect connector to after-run coolant pump -V51-:

- Check the wiring connector AND the coolant pump connector housing for the following:
 - Signs of overheating
 - Pin corrosion
 - Coolant intrusion
- The wiring connector housing, pins and seals must be replaced if the connector housing is found damaged at the time of repair.

Qty.	Part Number	Part Description
1	000-979-940	Butt connector for 0.5 mm wire
2	000-979-941	Butt connector for 1.0 mm wire
1	000-979-034-E	0.5 mm wire
1	000-979-159-E	1.0 mm wire
3	3C0-972-741	Wire seal
1	4H0-973-703	Connector housing
