## Technical Service Bulletin

<b>Topic</b>	35 Leaks from transmission
<b>Market area</b>	United States 444 Volkswagen of America, Inc. (6444)
<b>Brand</b>	Audi
<b>Transaction No.</b>	2028085/7
<b>Level</b>	EH
<b>Status</b>	Released for publishing
<b>Release date</b>	Mar 17, 2025

### S4, S5, RS5, S6, and S7 vehicles with S-Tronic 7 speed 0B5

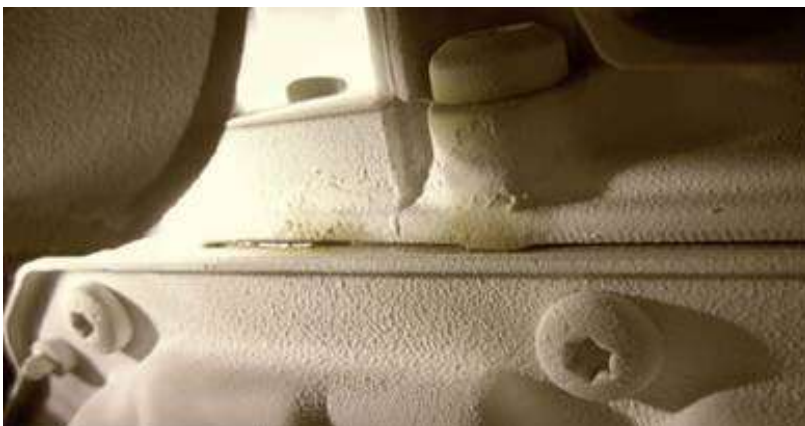
**Figure 1.** Leak located with talcum spray.

- Locate the leak by first thoroughly cleaning the stained area and allowing it to dry fully. Then, apply talcum spray (or similar) to the area that was stained with oil (Figure 4).
- Warm up the vehicle with a test drive then re-check for leaks. Upload images to Doc-IT.
- A clear identification with vehicle identification number for every photo is necessary (e.g. adhesive tape with the VIN on the part to be documented).

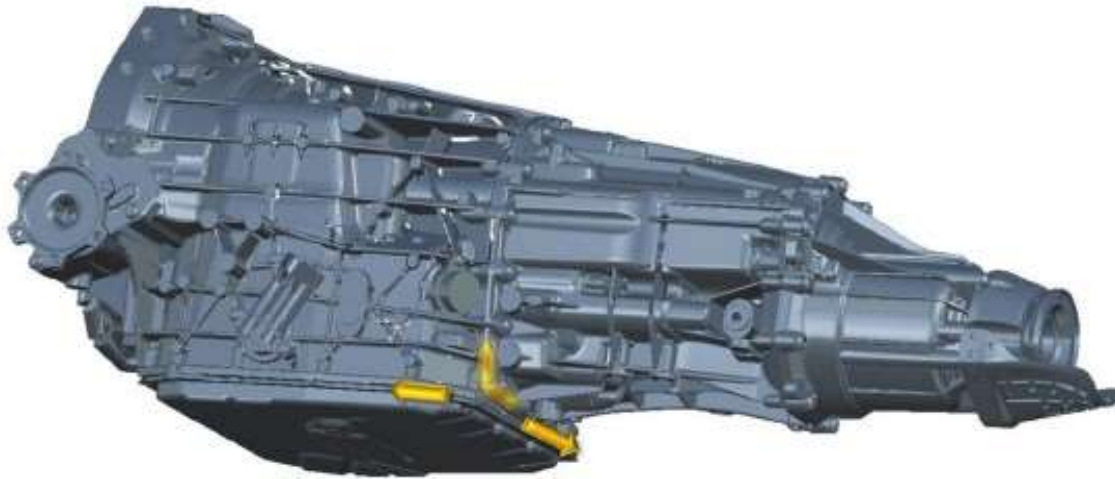
**Leak is found between the gearbox housing and intermediate housing:**

In the case of a leak from between the gearbox and intermediate housing, oil can migrate into the gap between the transmission oil pan and gearbox housing. This oil can spread over the complete pan area. A visual check can suggest a leaking transmission oil pan or seal. Therefore, the check below must be carried out to avoid repeat repairs.

If a leak is found between the transmission housing and intermediate housing, seal off the gearbox according to the repair manual.

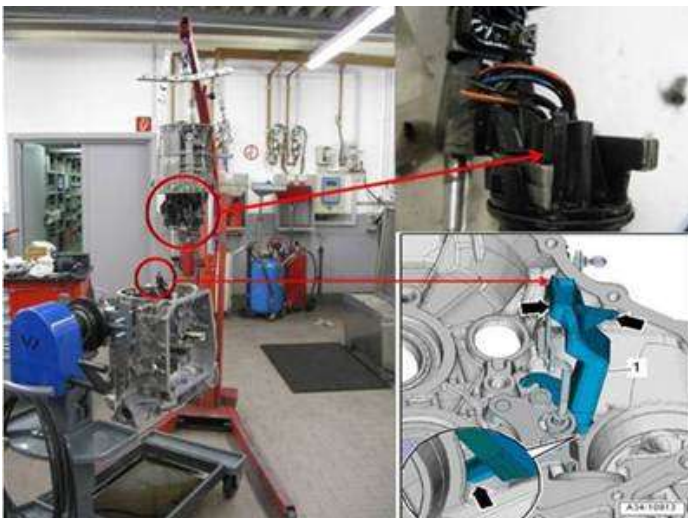
**Figure 2.** Caution points: drip tray Sensor module connector.

**When removing and fitting the intermediate housing make sure that the sensor module (plug, lugs) does not get damaged by the oil deflector. This can be achieved by carefully removing, placing on, observing and turning the parts.**

Use caution when lifting or lowering intermediate housing to avoid damage to components.

**Replace the shaft seal of the gearbox input shaft (double shaft seal) after assembling the gearbox housing according to the repair manual.**

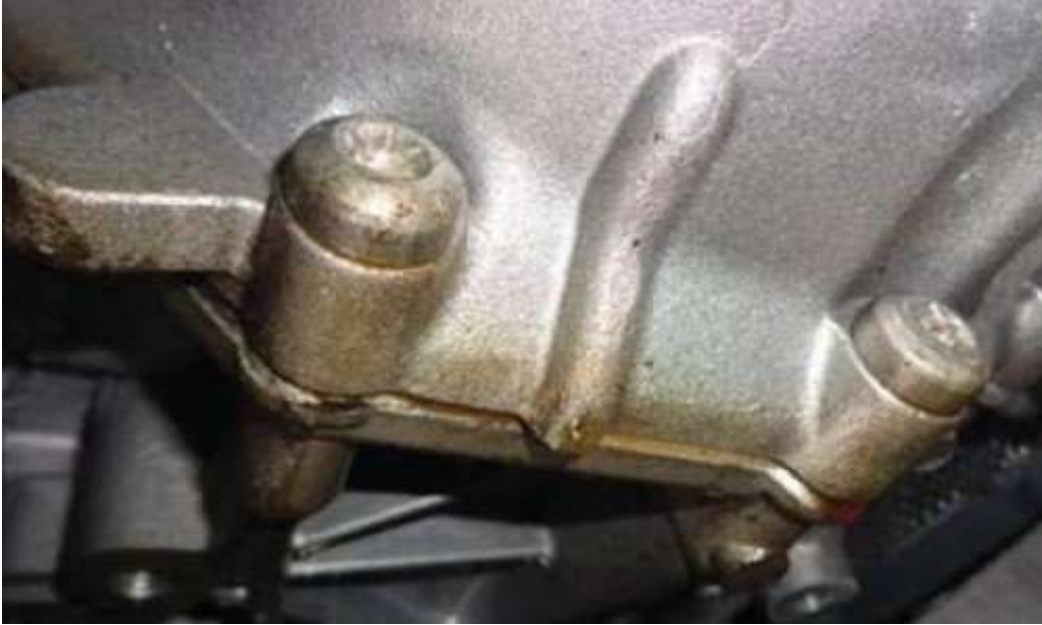
***Figure 3. Leak between intermediate housing and end cover***

If a leak is found between the intermediate housing and end cover the transmission must be sealed according to the repair manual.

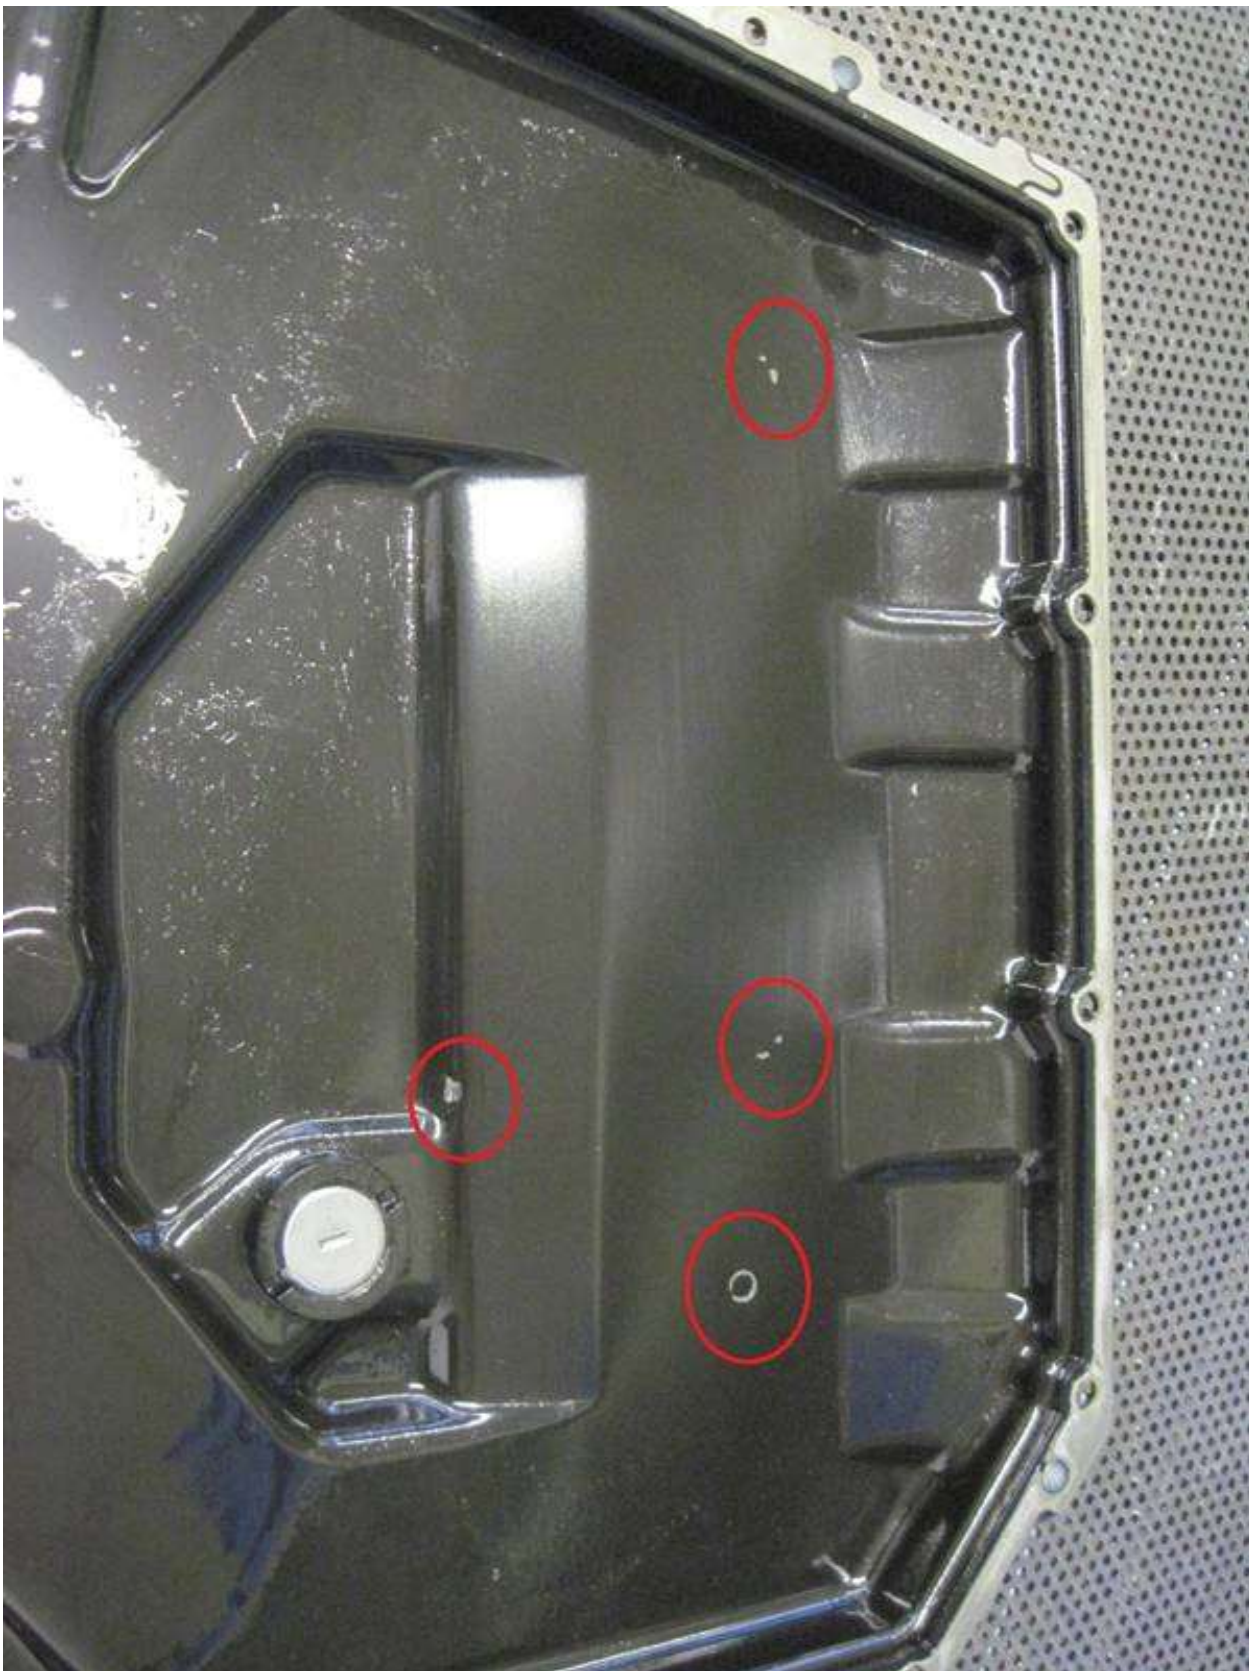
If a leak from between the transmission and intermediate housing can be ruled out, further leak locations are possible:

**Figure 4.** Damaged oil pan because of loose bolts.

- a) Leak from the oil pan seal.
  - b) Crack in the oil pan.
- 
- Remove the oil pan according to the repair manual and check the Mechatronics mounting bolts torque for a correct fit per the repair manual spec. Replace any loose bolts and tighten to the torque listed in the repair manual.
  - Check the inside of the oil pan for damage (caused by cracks or loose bolts) and replace if necessary.
  - If no damage on the oil sump is visible, it is enough to replace the oil sump seal.

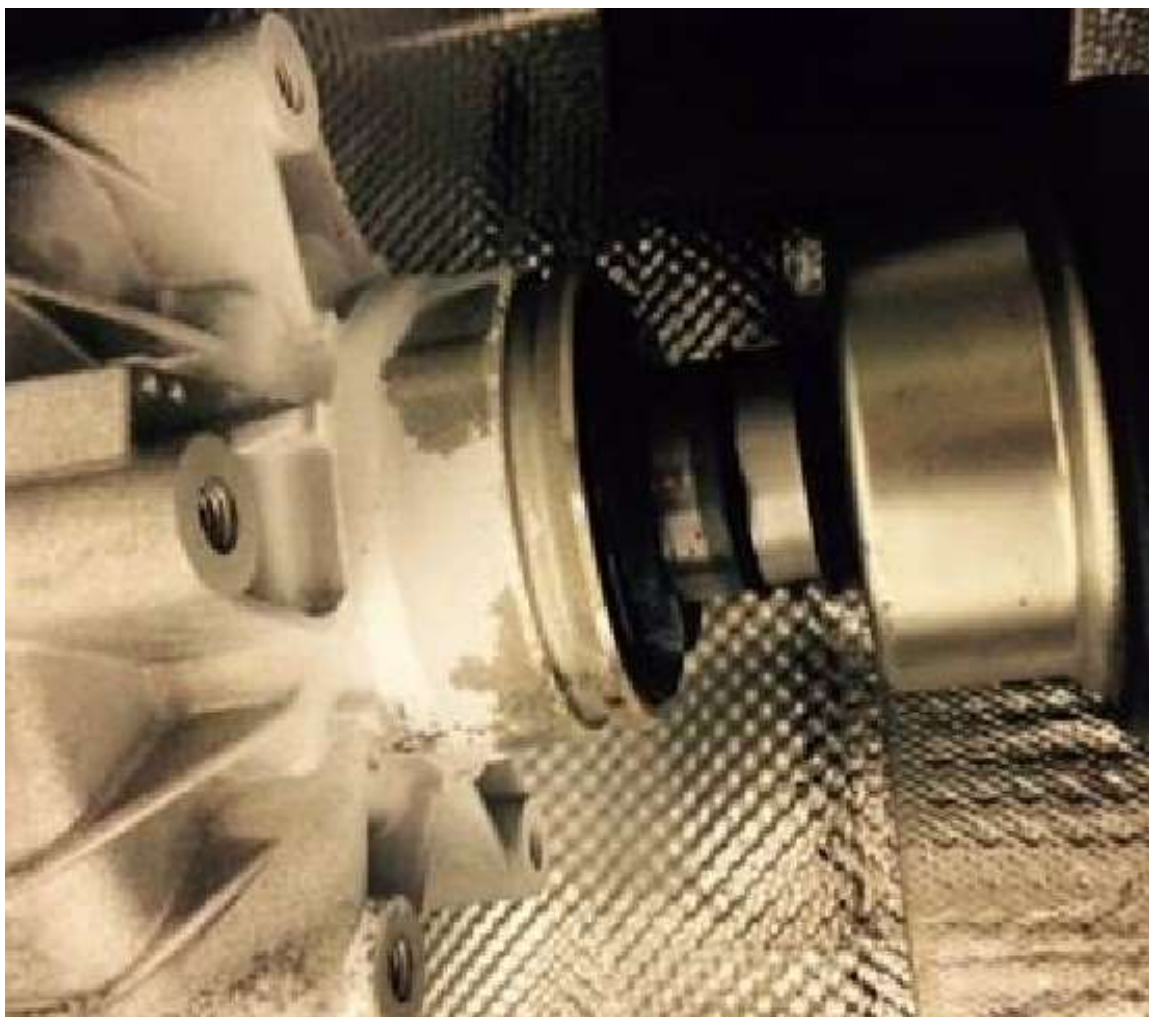
**Leak on self-locking center differential/front driveshaft flange:**

**Figure 5.** Gearbox leaks between self-locking center differential and driveshaft.

If a leak is found between the self-locking center differential and driveshaft, replace the oil seal according to the repair manual.
