Technical Service Bulletin

| Topic | 42 Noises from the rear of vehicle - securing bump stops |
| Brand | Audi |
| Transaction No. | 2038689/9 |

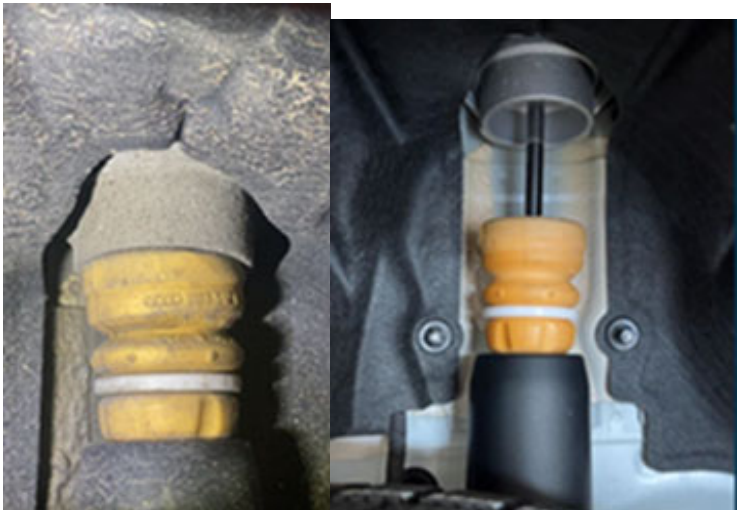
- The customer complains about rumbling or squeaking noises from the rear end of the vehicle.
- The bump stops of the shock absorbers are identified as the source of the noises, because they are not seated correctly in the shock absorber mounting or have fallen out.

With the redevelopment of the suspension, the hardness of the bump stops has increased, making it more difficult to press them into the mountings.

If the additional spring is not correctly pushed back into the shock absorber mounting during the pre-delivery inspection, it may drop onto the shock absorber tube and result in noises.

Secure the bump stops correctly. Assembly lever T40401 (SET 900) can be used to do this (see illustration below). A tire assembly paste can be used as an aid. The bump stops must be pressed all the way in.
