## Technical Service Bulletin

Transaction No.: **2048360/6**

91 Emergency call function (SOS) fault, function partially available. Please contact workshop, DTC B105313

Release date: Mar 6, 2025

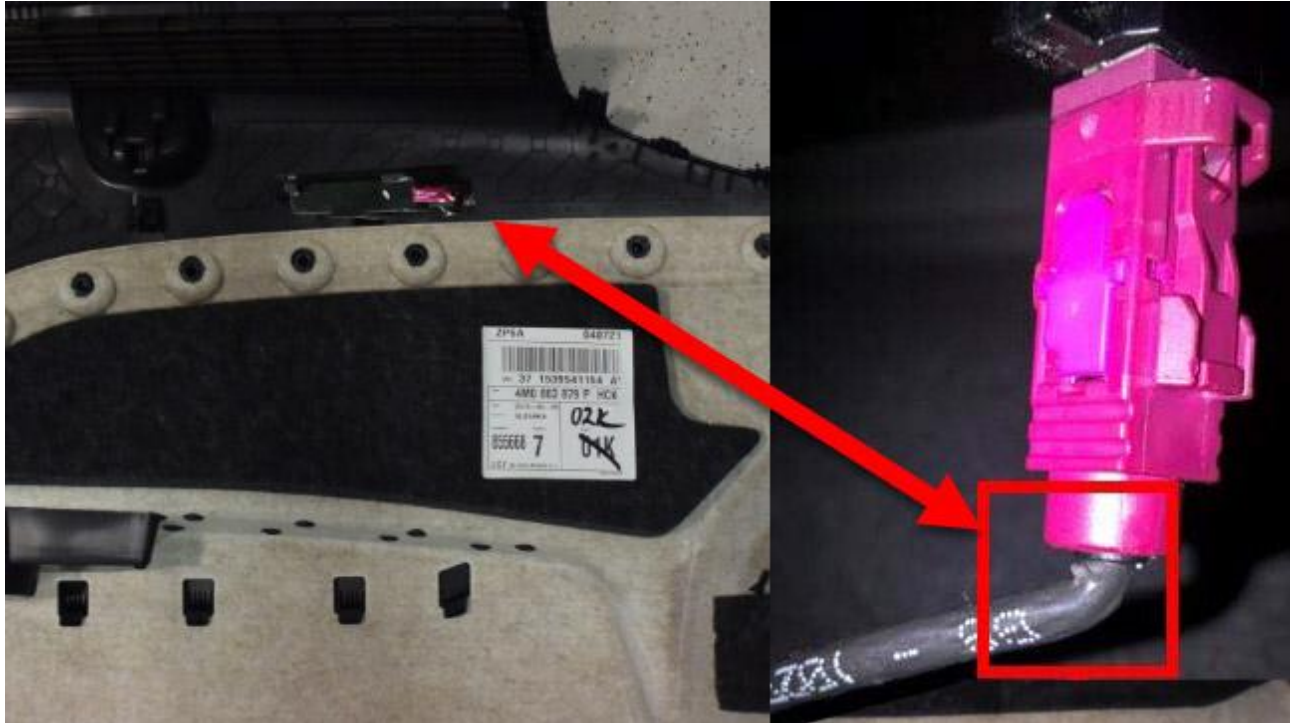
The contact on the wiring of the emergency call aerial may have been damaged in production. This can cause the concern specified above.

- Switch off the ignition
- Remove the left luggage compartment side trim panel according to repair manual.
- Perform a visual inspection of coaxial wiring, if wiring is under tension or kinked (Figure 2), continue with TSB.

**Figure 2.** Coaxial wire kinked at R263 SOS Antenna.

3. Repair existing coaxial harness:

The information in the manual for VAS 6720 on how repairs on the emergency call aerial wires are prohibited does not apply to repairs instructed by a TSB.
