Technical Service Bulletin

Topic	91 SOS warning displayed in instrument cluster, DTCs B105313 and B153313 stored in the data bus diagnostic interface
Market area	United States 444 Volkswagen of America, Inc. (6444)
Brand	Audi
Transaction No.	2054630/3
Level	EH
Status	Released for publishing
Release date	Mar 6, 2025

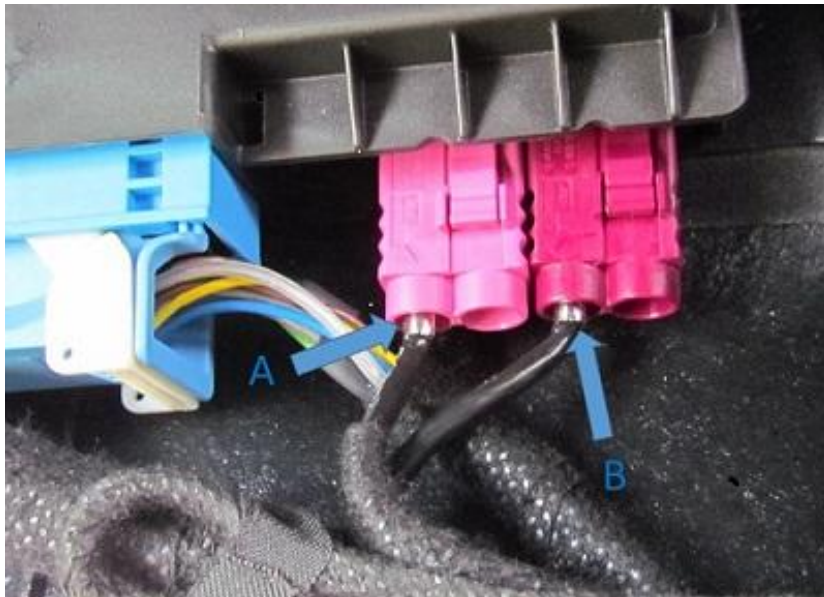
Figure 2 shows the connections on the gateway for a vehicle with additional aerial:

- Arrow **A** shows the connection for the additional emergency call aerial. (**PR number: IW3 or IW5 + 4GR or 4GY**).
- Arrow **B** shows the connection for the aerial in the dash panel. (**PR number: IW3 or IW5**)

Figure 2. GSM antenna location reference at the data bus on board diagnostic interface, J533 (address word 0019).

- If the **DTC “B105313 – GSM antenna open circuit”** is logged in vehicles **with or without** an additional aerial, the path must be checked at connection **A**.
- If the **DTC “B153313 – GSM antenna 2 open circuit”** is logged in vehicles **with** an additional aerial, the path must be checked at connection **B**.

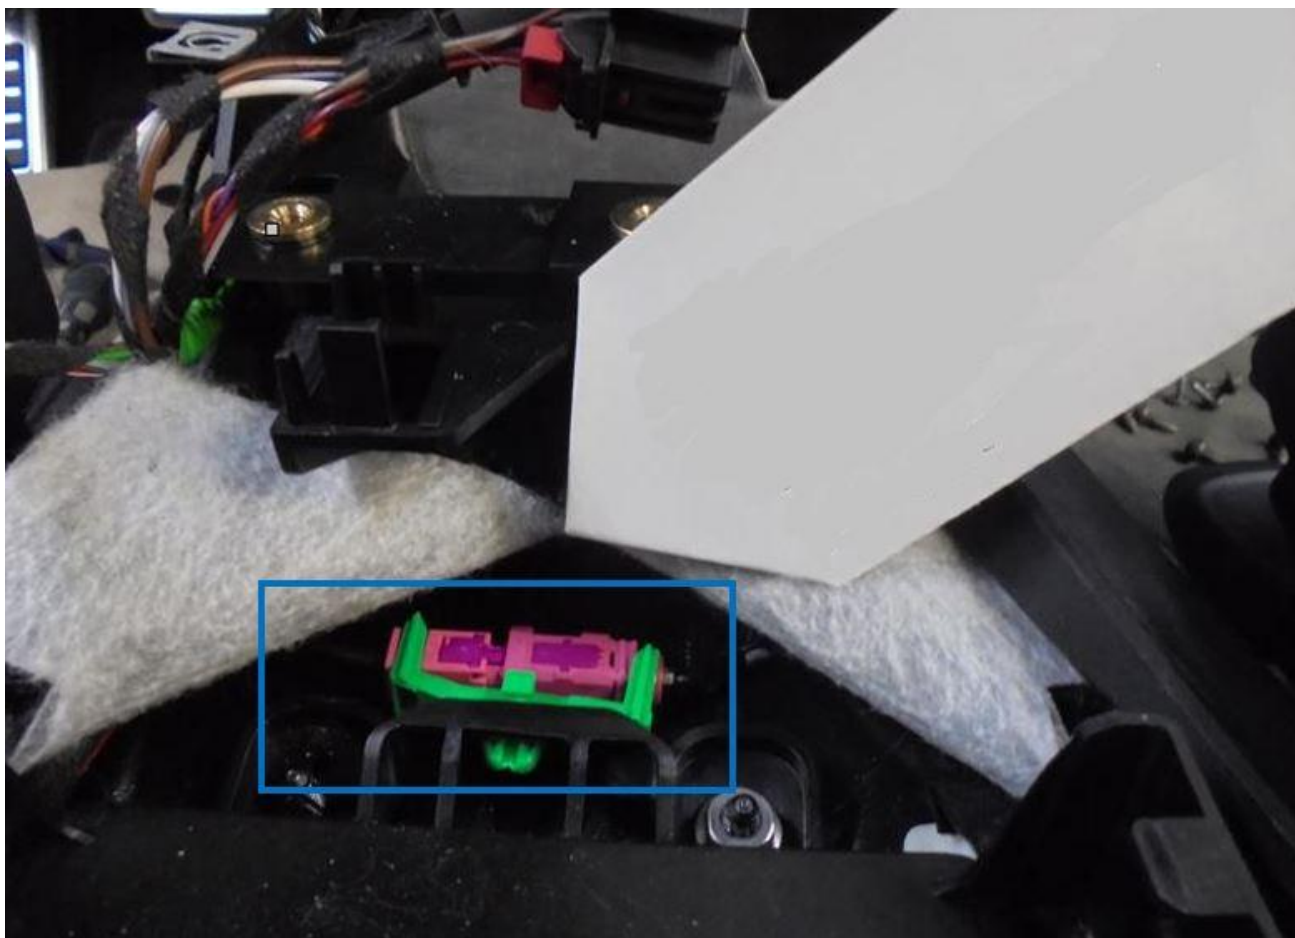
Figure 3. Loose plug on connector T2dx (see blue frame).

- Lock the connector and check that it is correctly locked by pulling it lightly.

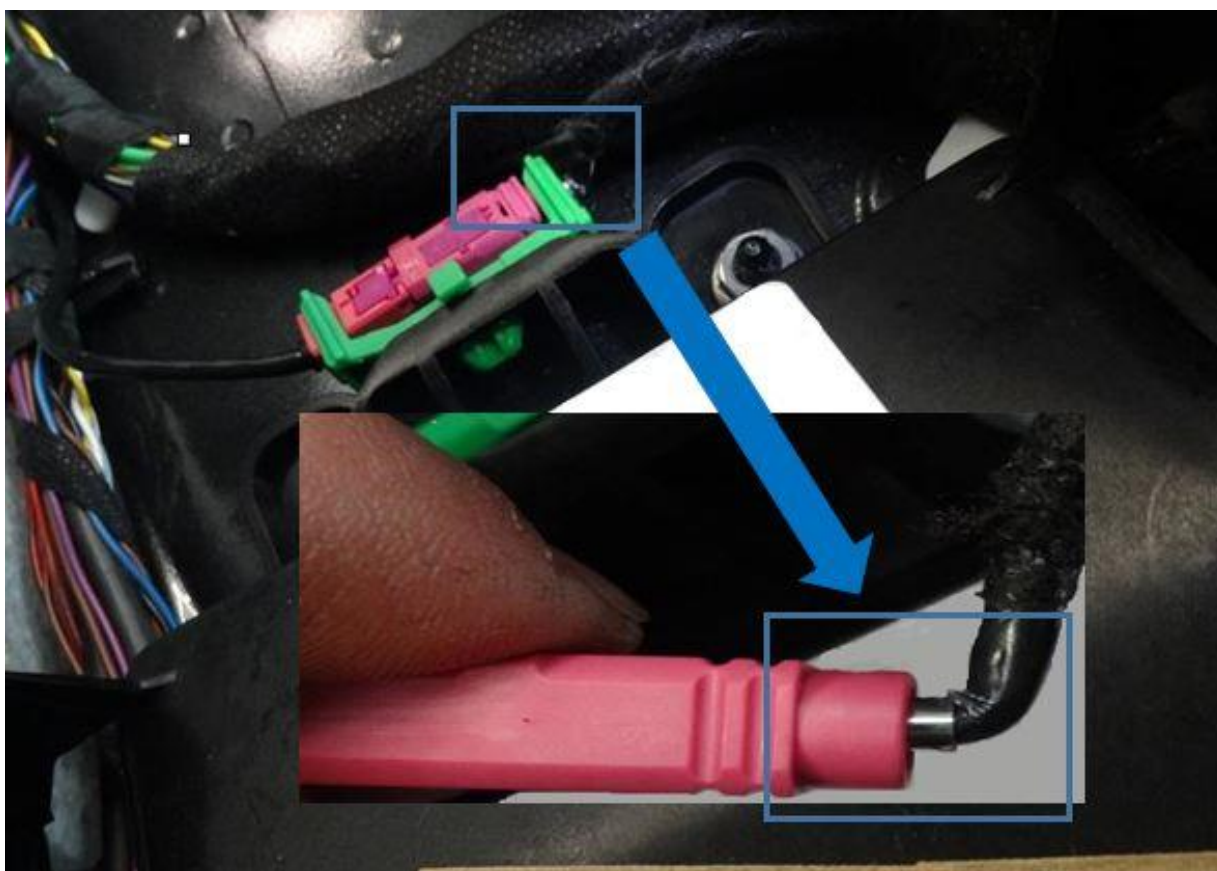
Figure 4. Kinked cable on the connector T2dkx (see zoomed in section, blue arrow).

If the cable is under tension or is kinked, replace both contacts on the connection using VAS 6720; if necessary, extend the cables using VAS 6720.
