Technical Service Bulletin

Topic	27 48V vehicle electrical system warning, DTC U046900 stored in the ECM
Market area	United States 444 Volkswagen of America, Inc. (6444)
Brand	Audi
Transaction No.	2058831/16
Level	EH
Status	Released for publishing
Release date	Mar 4, 2025

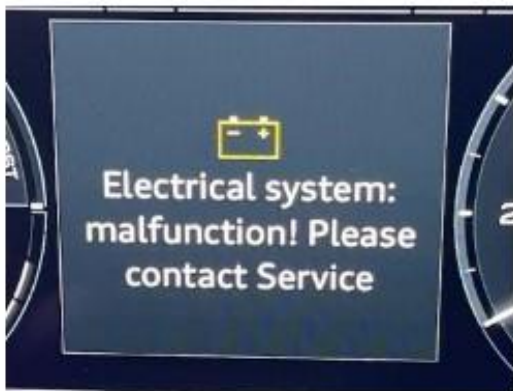
- The message “Electrical system: malfunction! Please contact Service” is displayed on the instrument cluster (Figure 1), in addition the battery symbol lights up in yellow or red.
- Yellow warning lamp related to the electrical system shown in the instrument cluster during driving.

Figure 1. Cluster Warning Message.
