Technical Service Bulletin

Topic	55 Tail light collides with rear lid, paint is coming off rear lid below tail light
Market area	United States 444 Volkswagen of America, Inc. (6444)
Brand	Audi
Transaction No.	2071125/2
Level	EH
Status	Released for publishing
Release date	Mar 10, 2025

Q4 e-tron

Q4 Sportback e-tron

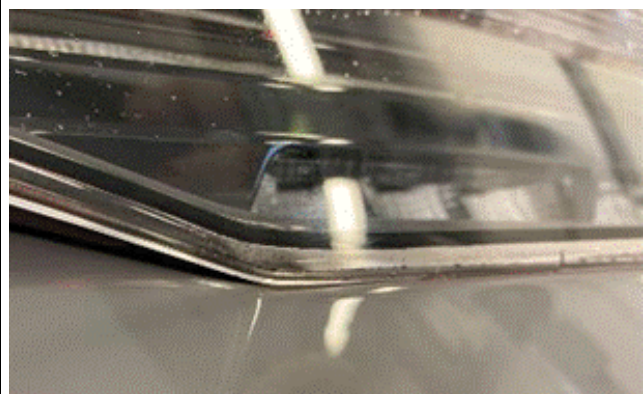
The gap between the taillight and rear lid is too small; this causes the taillight to chafe against the paintwork on the rear lid (refer to Figure 1).

Figure 1. Taillight chafing against the paintwork on the rear lid.

Any damage to the painted surface and/or corrosion protective surface on the rear lid will need to be repaired. Arrange this repair through your Audi Certified Collision Center. Before releasing the vehicle for the paint repair the buffers on the tail lamp will need to be modified to prevent subsequent paint damage.

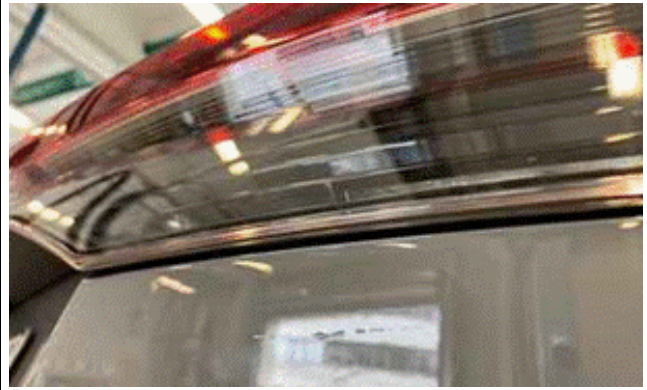
Optimization in contact area between taillight and rear lid
(Refer to Figure 2).

Figure 2. *Optimized contact area between taillight and rear lid.*

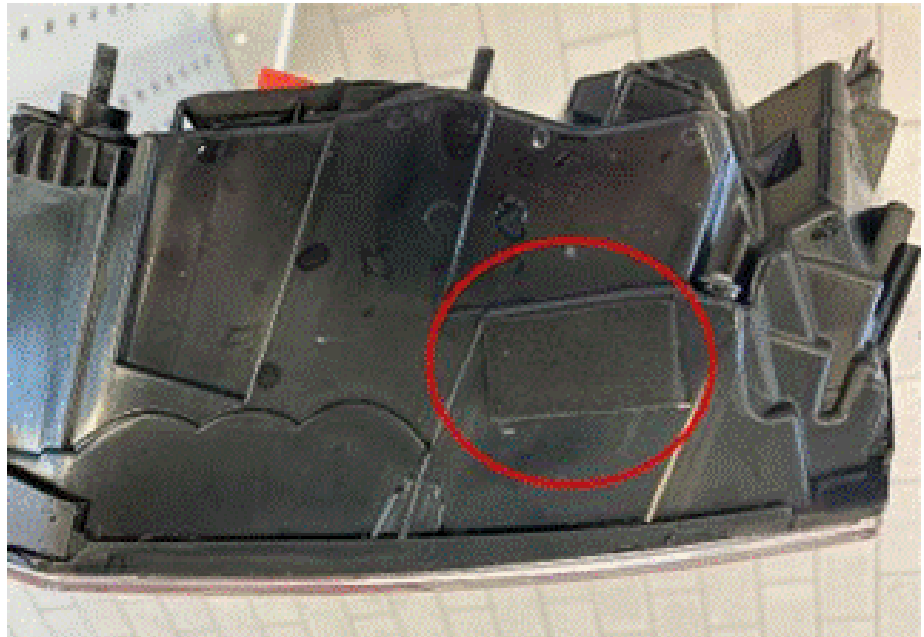
Figure 3. *Remove the buffer foam from the taillight.*

1. After repairing the paintwork, modify the taillight.

Please remove the buffer foam from the taillight (refer to Figure 3).

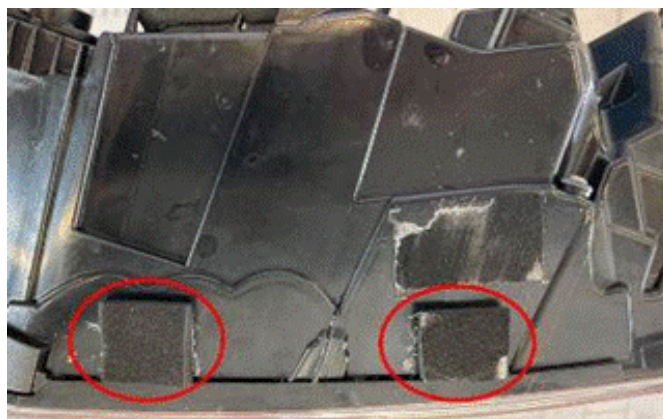
Figure 4. *Buffer foam in their new position.*

2. Cut the old buffer foam into two pieces and secure these in their new position with double-sided adhesive tape, e.g. AKL 440 02 (refer to Figure 4).

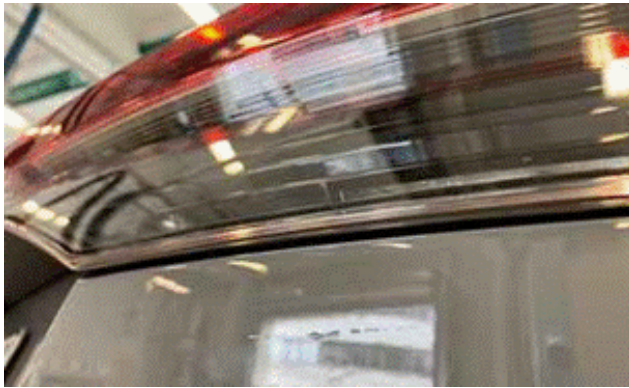
Figure 5. Gap between the taillight and the rear lid.

3. After installation, there must be a gap between the taillight and the rear lid (refer to Figure 5).
