Technical Service Bulletin

Topic	55 Taillight collides with rear lid, paint is coming off rear lid below taillight
Market area	United States 444 Volkswagen of America, Inc. (6444)
Brand	Audi
Transaction No.	2071125/3
Level	EH
Status	Released for publishing
Release date	Mar 18, 2025

Q4 e-tron

Q4 Sportback e-tron

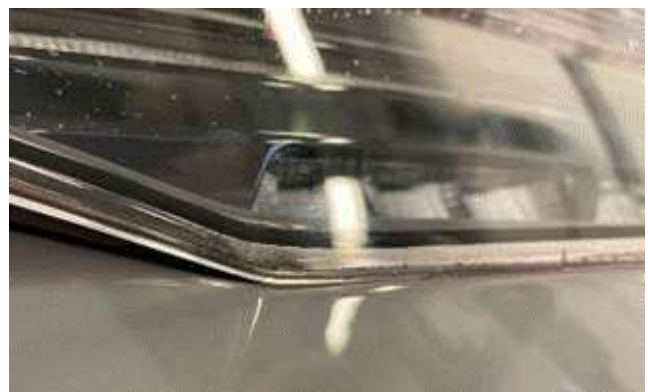
The gap between the taillight and rear lid is too small; this causes the taillight to chafe against the paintwork on the rear lid (refer to Figure 1).

Figure 1. Taillight chafing against the paintwork on the rear lid.

Any damage to the painted surface and/or corrosion protective surface on the rear lid will need to be repaired. Arrange this repair through your Audi Certified Collision Center. Before releasing the vehicle for the paint repair the buffers on the tail lamp will need to be modified to prevent subsequent paint damage.

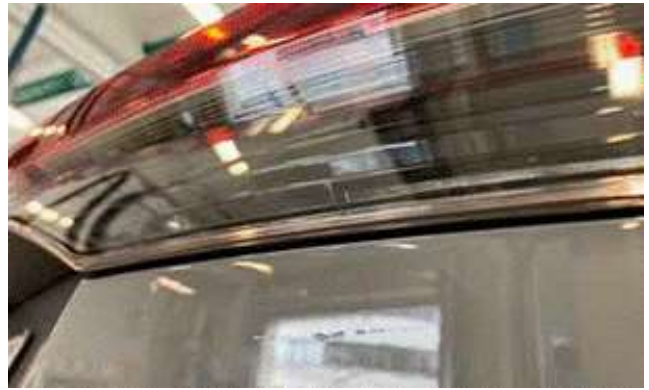
Optimization in contact area between taillight and rear lid (Refer to Figure 2).

Figure 2. Optimized contact area between taillight and rear lid.

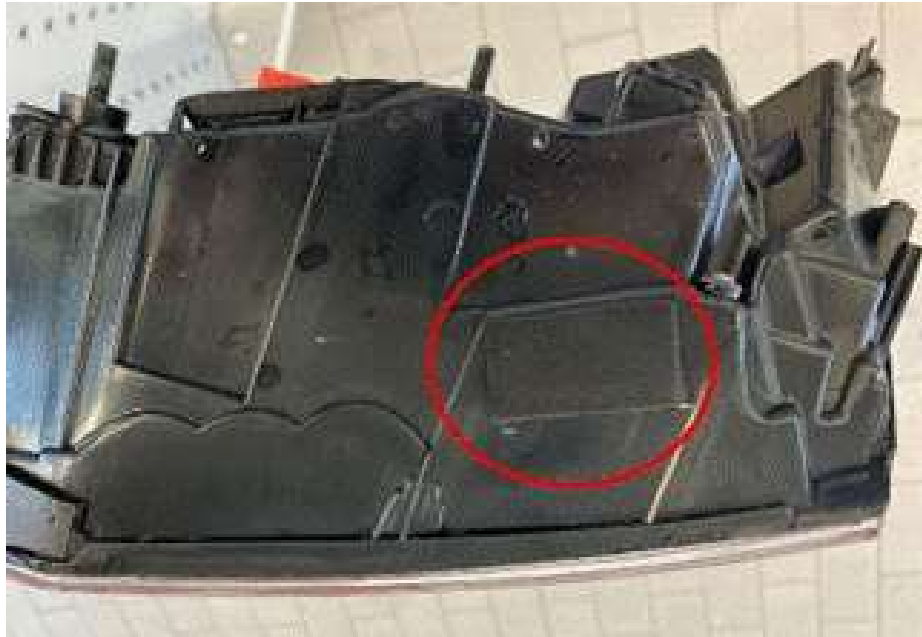
Figure 3. Remove the buffer foam from the taillight.

Please remove the buffer foam from the taillight (refer to Figure 3).

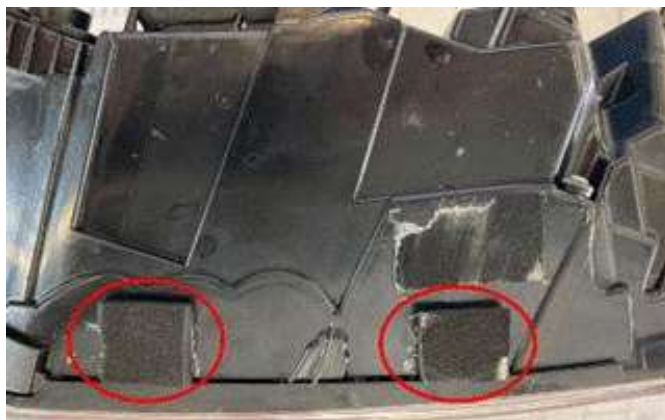
Figure 4. Buffer foam in their new position.

2. Cut the old buffer foam into two pieces and secure these in their new position with double-sided adhesive tape, e.g. AKL 440 025 (refer to Figure 4).

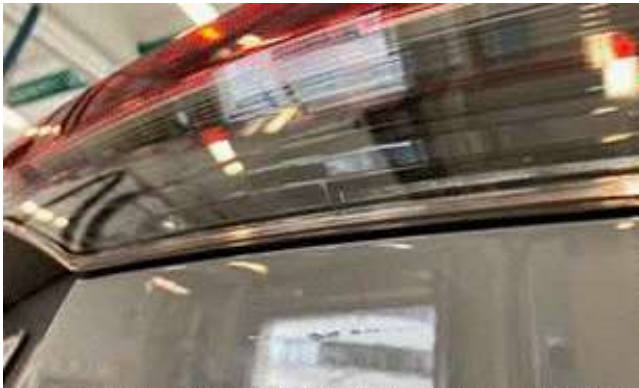
Figure 5. Gap between the taillight and the rear lid.

3. After installation, there must be a gap between the taillight and the rear lid (refer to Figure 5).
