## Technical Service Bulletin

<b>Topic</b>	93 Charging door does not open when button pressed - B1A8FF0, B1A89F0, B1A8AF3, B1A88F3
<b>Market area</b>	United States 444 Volkswagen of America, Inc. (6444)
<b>Brand</b>	Audi
<b>Transaction No.</b>	2071343/2
<b>Level</b>	EH
<b>Status</b>	Released for publishing
<b>Release date</b>	Mar 31, 2025

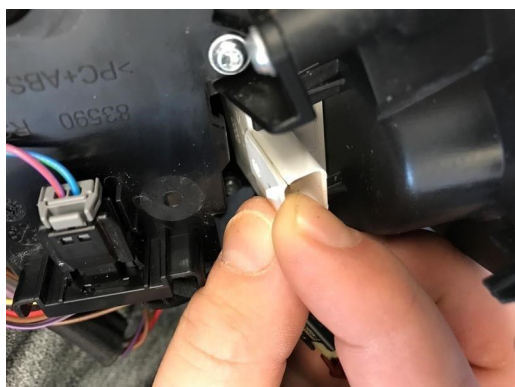
Quality issues in the production process may lead to a crack in the connector point of the charging indicator (Figure 1). Moisture can reach the contact pins in the charging indicator connector via this crack. As a result, a bypass can occur between the ground contact pin and the LIN contact pin. This leads to a communication fault between the components of the charging door and the charging unit for high-voltage battery. In this circumstance, the electric operation of the charging door does not work.

**Figure 1:** Crack in the connector point of the charging indicator.

After July 2020, the charging indicator connector and the connector housing are sealed during production to prevent moisture ingress.

If the connector point is cracked or the pins are oxidized (Figure 7), replace the damaged charging door unit as described under the heading **“Removing and installing charging door unit”** below.

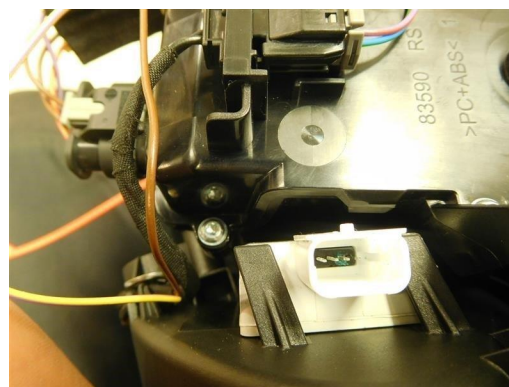
**Figure 2:** Evidence of water intrusion in the charging indicator connector.

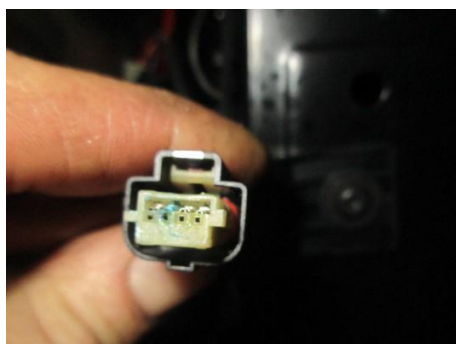
**Figure 3:** Evidence of water intrusion in the connector housing.

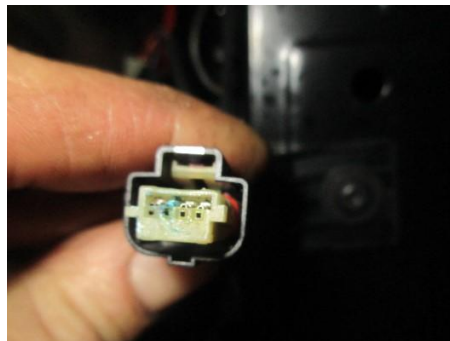
2. Check the contacts on the connector housing and on the charging indicator for oxidation.

**Figure 5:** Oxidation on the connector housing.

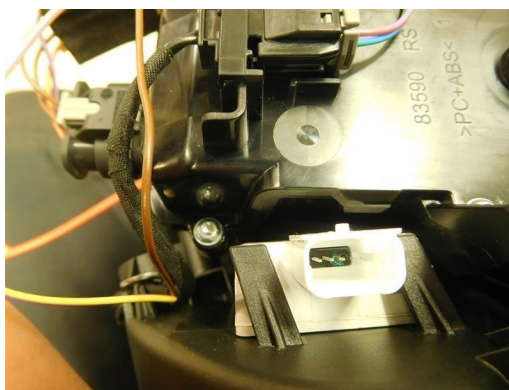
**Figure 7:** Oxidation of the pins on the charging indicator connector.

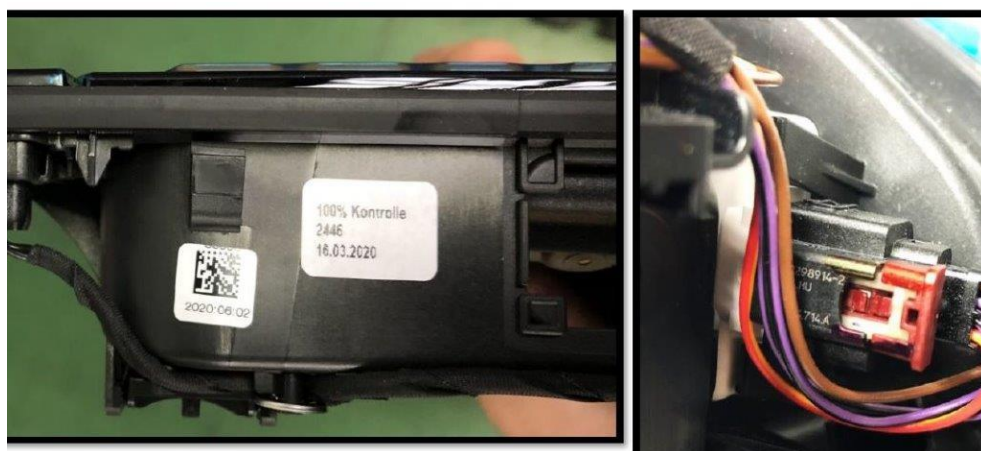
4. To avoid the need for repeat repairs, check whether the charging door supplied by the parts department already has a sealed charging indicator connector. This can be identified on the basis of the QR code sticker and the red line on the connector (Figure 8).

**Figure 8:** The charging indicator connector pictured is the updated part.

If this is not the case, seal the charging indicator connector on the new charging door unit with 1-component adhesive sealant (Part number D 469101A3) as described under the heading **“Sealing charging indicator connector”**.

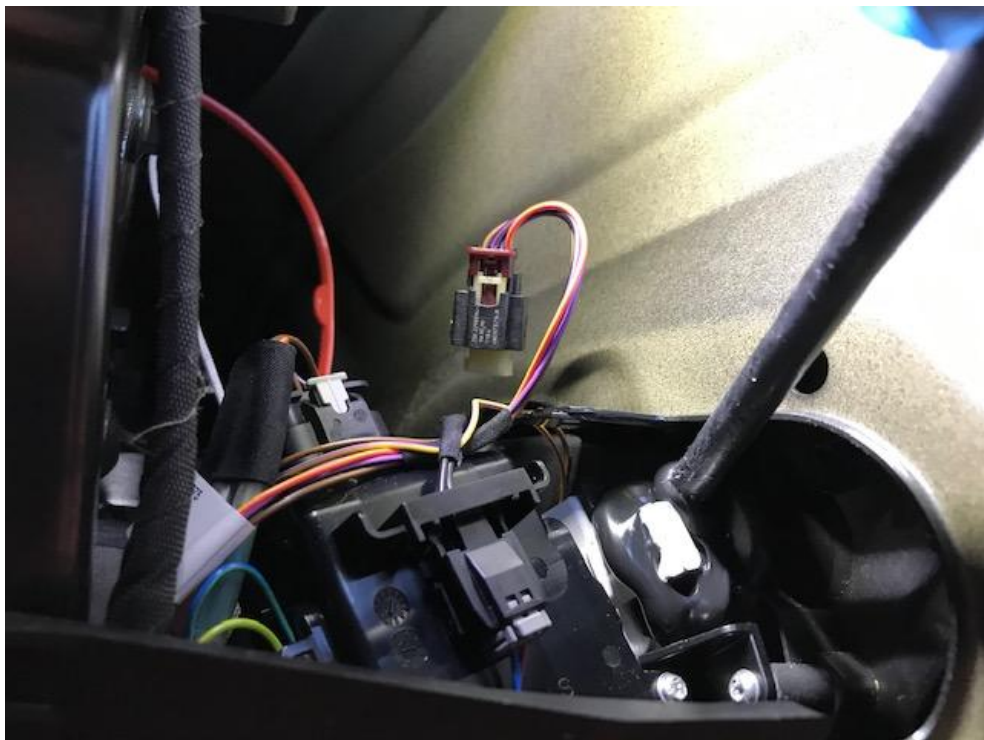
**Figure 23:** Sealant bead applied at the connector.

4. Apply a sealant bead (at least 8 mm thick) all around at the beginning of the connector point of the charging indicator (Figure 23).

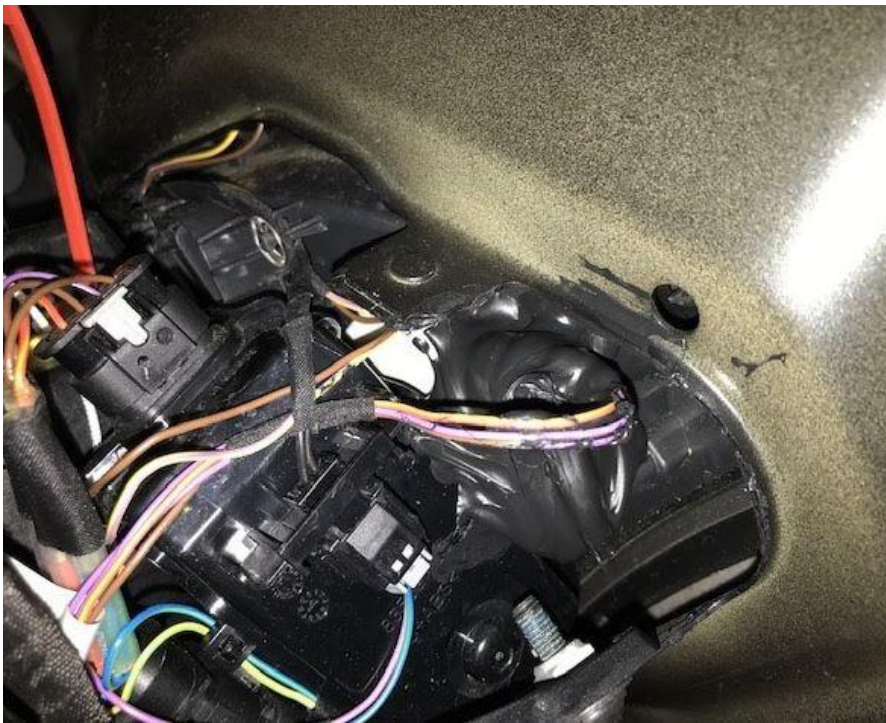
**Figure 25:** The entire connector and the connector point of the charging indicator must be covered with adhesive sealant.

The entire connector and connector point of the charging indicator and parts of the charging indicator must be covered with adhesive sealant to ensure protection against moisture ingress (Figure 25).
