## Technical Service Bulletin

<b>Topic</b>	87 No heating in rear of vehicle - DTC B108911
<b>Market area</b>	United States 444 Volkswagen of America, Inc. (6444)
<b>Brand</b>	Audi
<b>Transaction No.</b>	2072931/2
<b>Level</b>	EH
<b>Status</b>	Released for publishing
<b>Release date</b>	Mar 11, 2025

### Audi Q4 e-tron

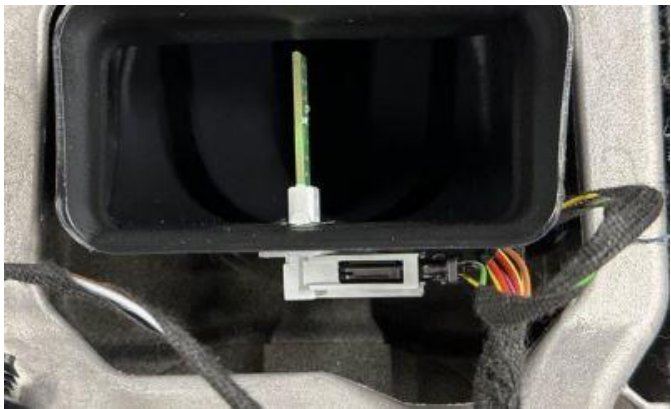
The customer complaint can be reproduced. The event memory entry **“B108911: Rear vent temperature sensor, short circuit to ground”** is logged in diagnostic address 0008. When moving the vent temperature sender clear, it was discovered that the wire leading to the sender was trapped or screwed in.

Electrical wire to vent temperature sender crushed or screwed in due to incorrect installation of the component.

Due to incorrect installation of the vent temperature sender, there is an excess length of wire for the component. This means there is a risk of the wire getting trapped or screwed in and therefore of damage to the wire. On vehicles with this complaint, it is therefore particularly important to ensure that the vent temperature sender and the wire are fitted correctly in the vehicle during installation.

1. Figure 1 shows the incorrect installation of the temperature sender and the resulting excess length of wire.

**Figure 1.** *Installation in event of complaint.*

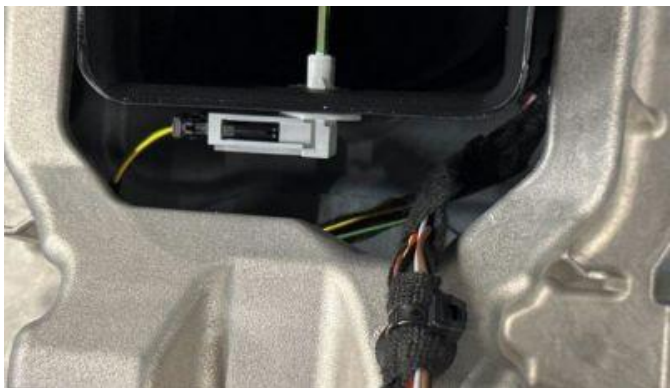
**Figure 2.** *Optimized installation.*

2. Figure 2 shows how the component with the electrical wire should be installed in the vehicle to minimize the risk of the wire being trapped or screwed in.
