## Technical Service Bulletin

<b>Topic</b>	66 Service info: paint peeling off black trims / trim strips
<b>Market area</b>	United States 444 Volkswagen of America, Inc. (6444)
<b>Brand</b>	Audi
<b>Transaction No.</b>	2074058/2
<b>Level</b>	EH
<b>Status</b>	Released for publishing
<b>Release date</b>	Mar 4, 2025

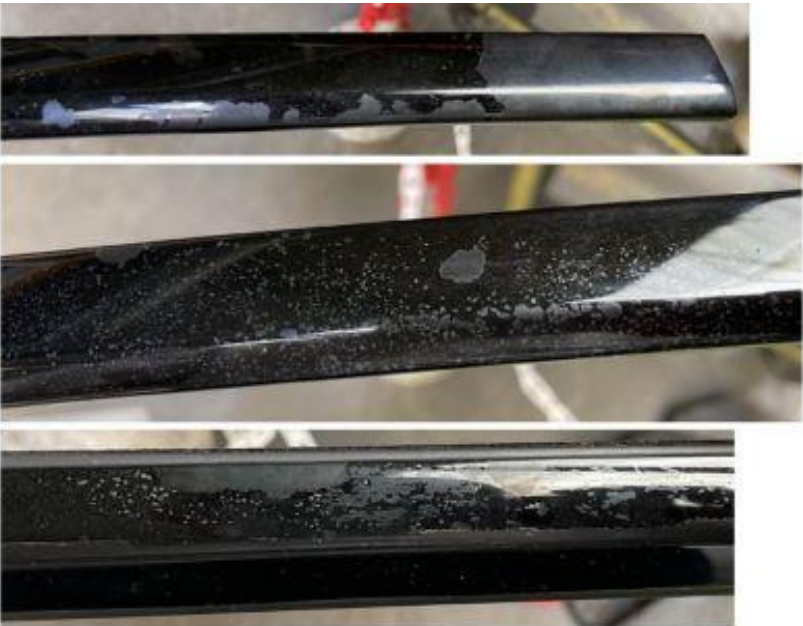
- 1. The following example photos show various damage on black trims / trim strips (Figure 1).

Figure 1. Examples of damage on black trims / trim strips.

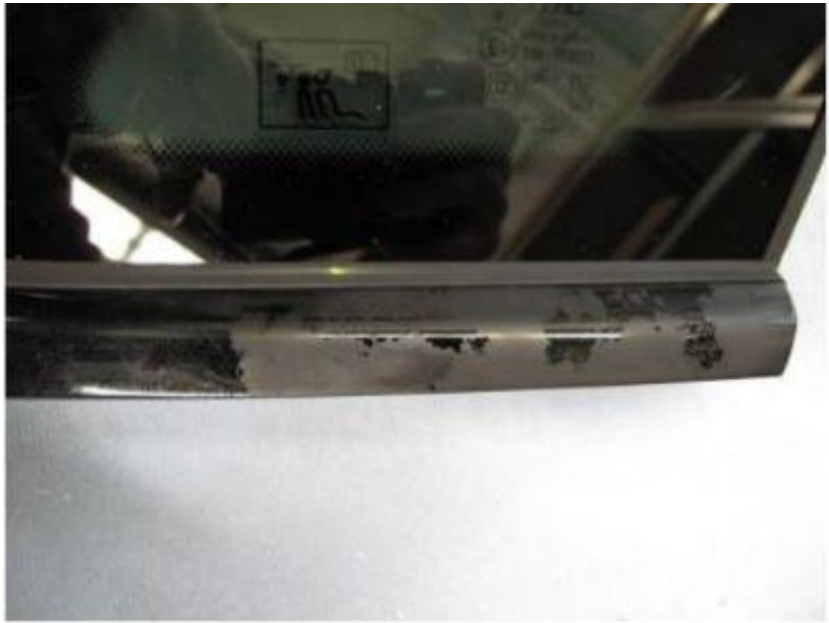
2. Coat peeled off (Figure 2).

**Figure 2.** Coat peeled off.

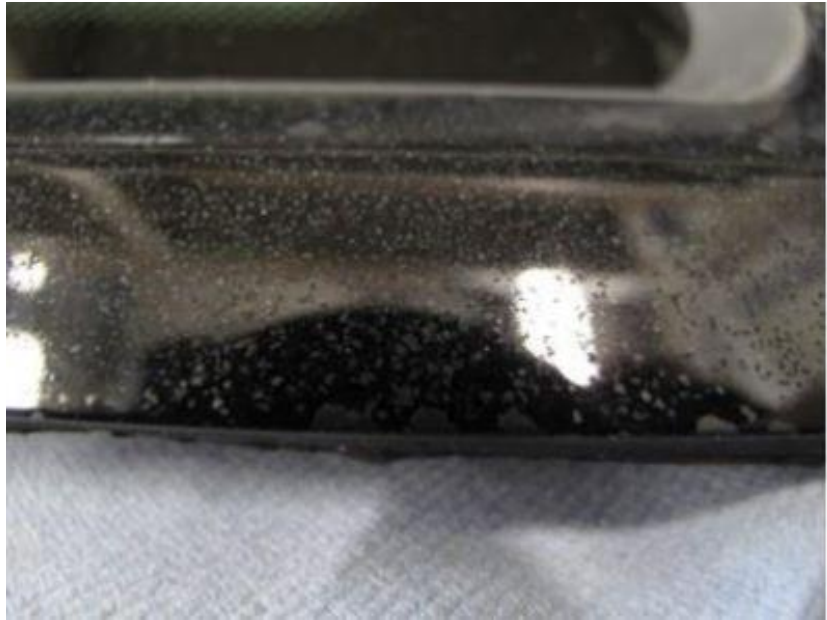
3. Spots of additional coating. A fine spray pattern caused by a cleaning agent can be seen (Figure 3).

**Figure 3.** Spots of additional coating.

Based on the laboratory analyses, the cause of the complaint is the use of a cleaning solution that is too aggressive for the application, often in conjunction with the application of pressure, such as from a high-pressure cleaner. Cleaning solutions such as industrial dirt remover, or insect remover and the various consistencies of those solutions, can attack the additional coating. Depending on how the cleaning solutions are applied, the time they are applied to the components, as well as the subsequent cleaning using a high-pressure cleaner, they can cause irreversible damage to the coating. Using energy-dispersive x-ray analysis, the damaged surfaces were analyzed on a molecular level. Traces of phosphorus (P) and fluorine (F) were detected. These elements are not contained in the conventional anodizing and additional coating layers but can often be found in commercially available cleaning solutions, such as industrial dirt and insect removers, as well as wheel cleaners.

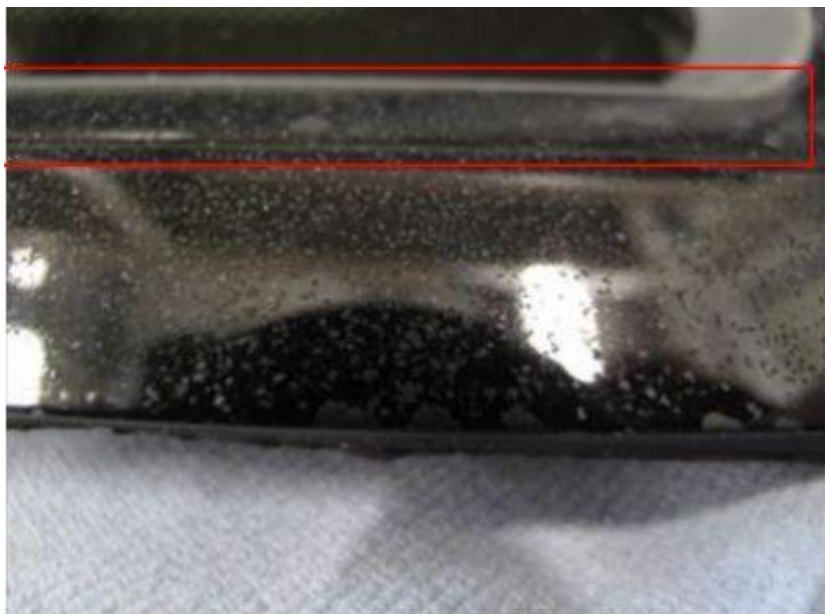
4. Figure 4 clearly shows marks forming on the neighboring rubber components, outside of the trim strips, caused by an applied liquid.

**Figure 4.** Marks forming caused by applied liquid.

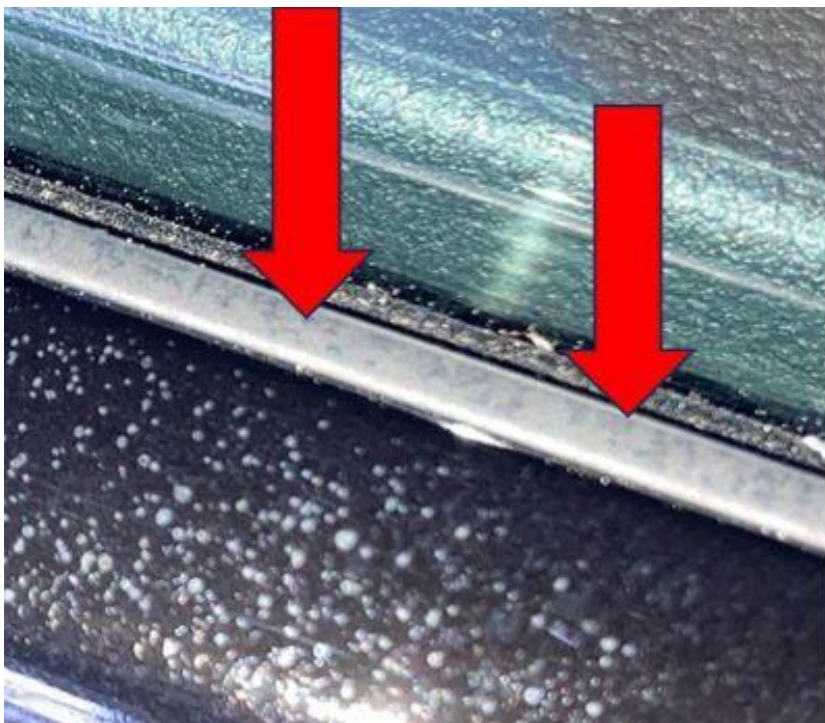
5. Figure 5 clearly shows marks forming on the neighboring rubber components caused by an applied liquid.

**Figure 5.** Marks forming caused by applied liquid.

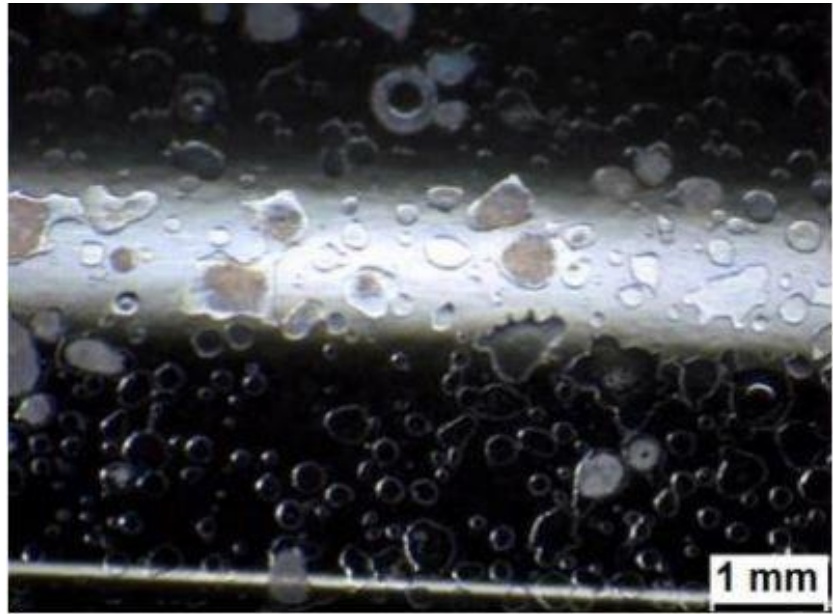
6. Figure 6 shows spots of swelling as viewed under a stereo microscope.

*Figure 6. Spots of swelling as viewed under a stereo microscope.*
