Technical Service Bulletin

Topic	19 Engine: cooling system - engine overheats, red coolant temperature warning, MIL on - 4.0 ltr. V8 TFSI; P029900
Market area	United States 444 Volkswagen of America, Inc. (6444)
Brand	Audi
Transaction No.	2074303/7
Level	EH
Status	Released for publishing
Release date	Mar 18, 2025

19 Engine: cooling system - engine overheats, red coolant temperature warning, MIL on - 4.0 ltr. V8 TFSI; P029900

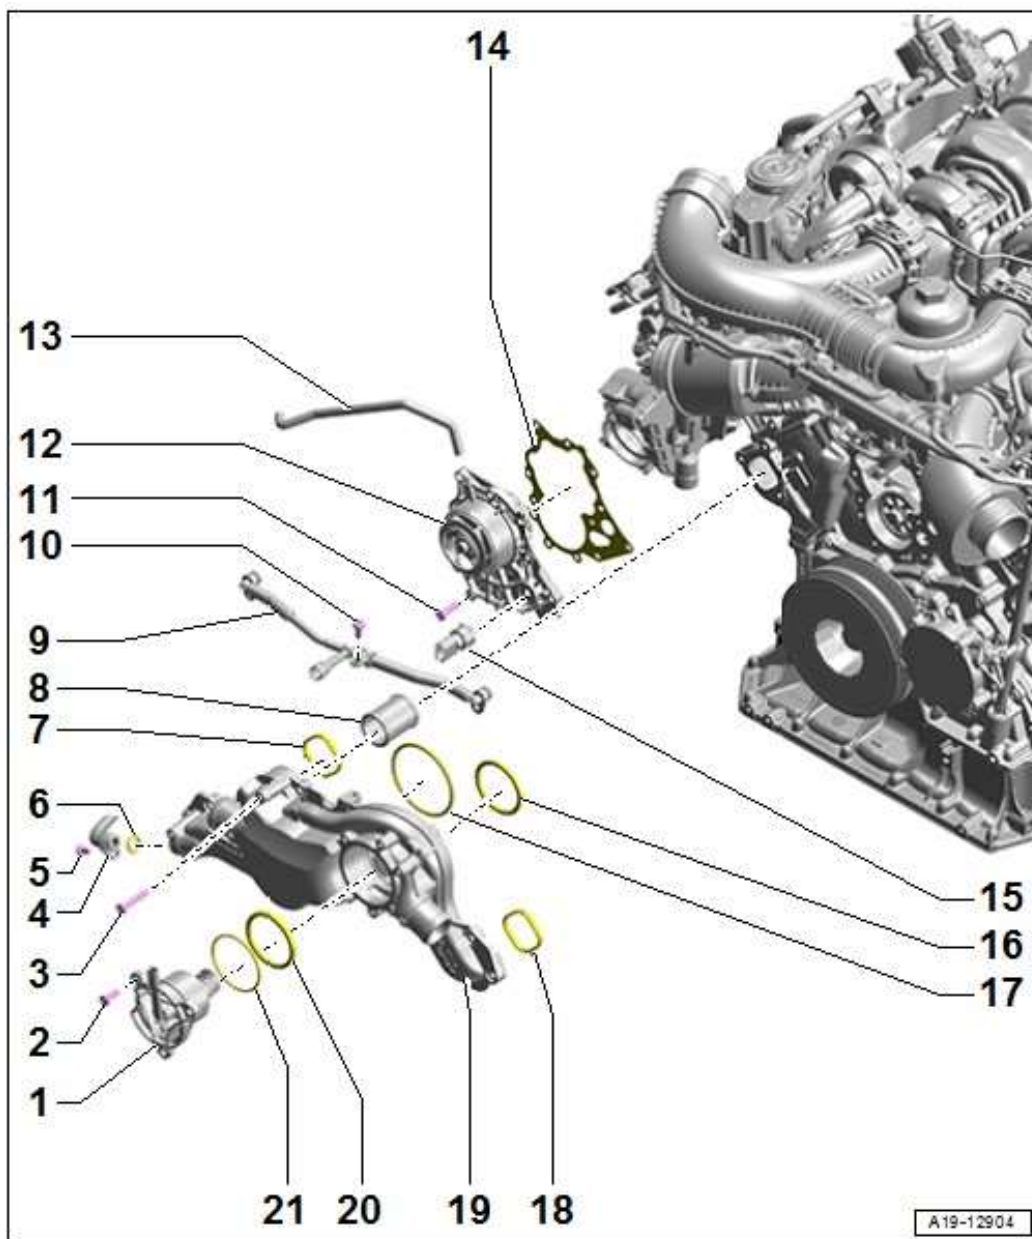
When N649 is activated, it switches a vacuum to the mechanical coolant pump. This pushes a locking sleeve over the pump impeller, which can cause coolant to stagnate.

When N649 is not activated, no vacuum is switched to the mechanical coolant pump, and the coolant pump is not covered. In this case, the coolant is pumped through the coolant pump impeller.

Figure 1. Assembly overview – coolant pump/thermostat incl. switchable mechanical coolant pump, number 12.

Remove the vacuum hose on the mechanical coolant pump (number 13 in Figure 1).

Check whether this results in lower engine coolant temperatures.

If the coolant temperature drops, replace the electric changeover valve for the switchable mechanical coolant pump N649 according to the Workshop Manual.

Also check whether there are traces of coolant in the vacuum hose between the mechanical coolant pump and N649, or in the vacuum connection of N649. If there are traces of coolant, please also replace the switchable mechanical coolant pump and the vacuum hose between the mechanical coolant pump and N649 according to the Workshop Manual and provide images.

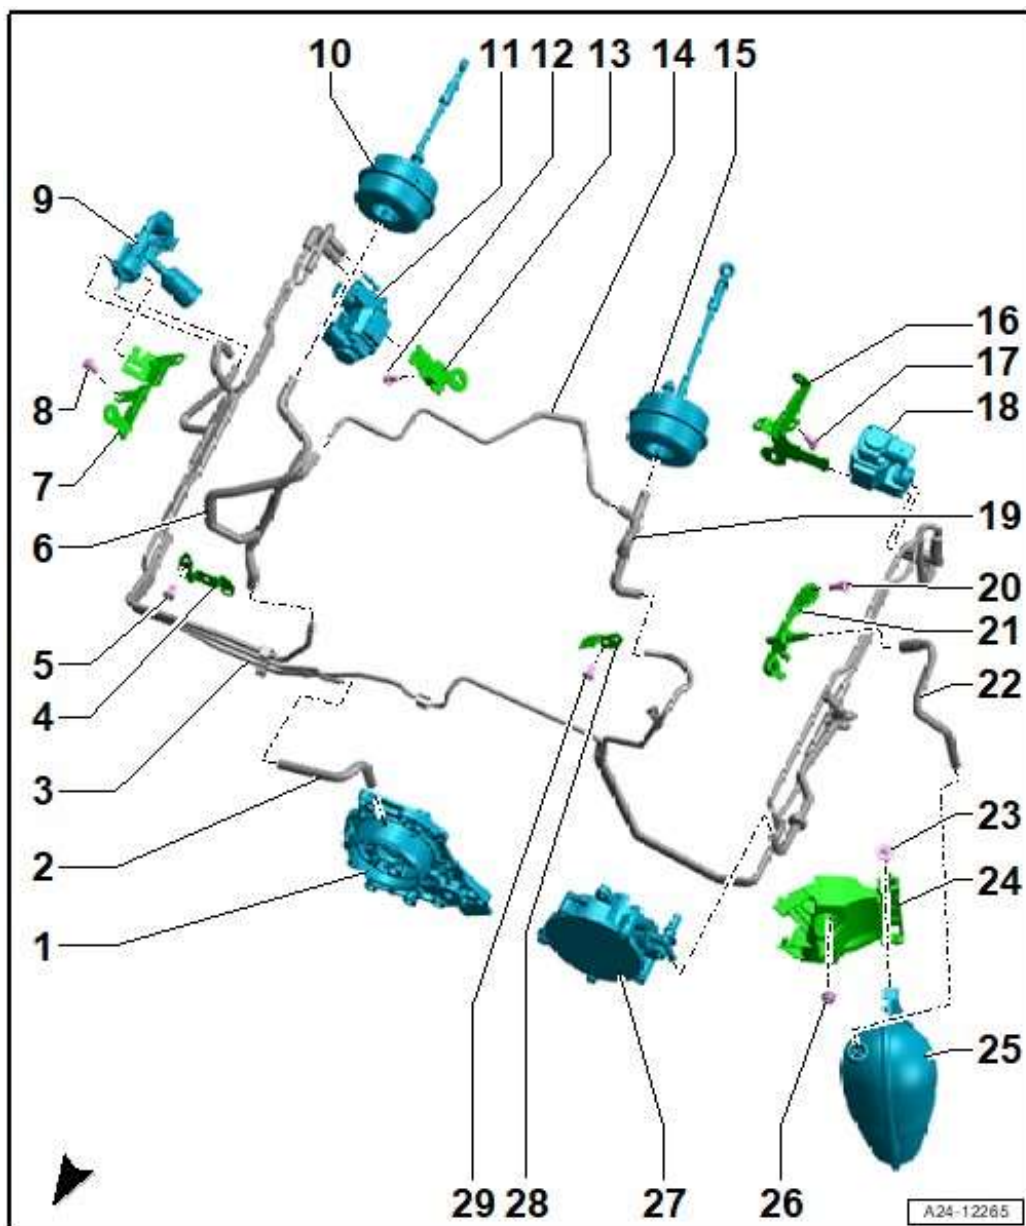
Figure 2. Assembly overview – vacuum system incl. N649, number 9.

Check the vacuum system for leaks. If a leak is detected on N649, replace N649 according to the Workshop Manual.

Also check whether there are traces of coolant in the vacuum hose between the mechanical coolant pump N649, or in the vacuum connection of N649. If there are traces of coolant, please also replace the switchable mechanical coolant pump and the vacuum hose between the mechanical coolant pump and N649 according to the Workshop Manual and provide images.
