## Technical Service Bulletin

<b>Topic</b>	27 Valeo 48V starter generator (BSG) DTCs P0A1A00 P19F800
<b>Market area</b>	United States 444 Volkswagen of America, Inc. (6444)
<b>Brand</b>	Audi
<b>Transaction No.</b>	2076994/2
<b>Level</b>	EH
<b>Status</b>	Released for publishing
<b>Release date</b>	Mar 6, 2025

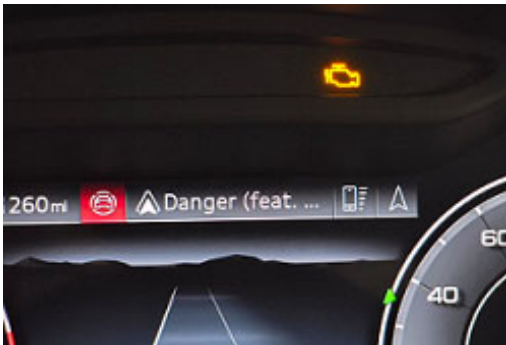
Engine warning lamp (MIL) is on (Figure 1).

**Figure 1.** MIL is illuminated.

The software for the Starter Generator, C29 (address word 00CC) needs to be updated.

2. Update the Starter Generator, C29 (address word 00CC) using the SVM action code as listed in the table below, if necessary:
