Technical Service Bulletin

Topic	64 Wind noise at front window guide
Market area	United States 444 Volkswagen of America, Inc. (6444)
Brand	Audi
Transaction No.	2077162/1
Level	EH
Status	Released for publishing
Release date	Mar 6, 2025

Audi Q7

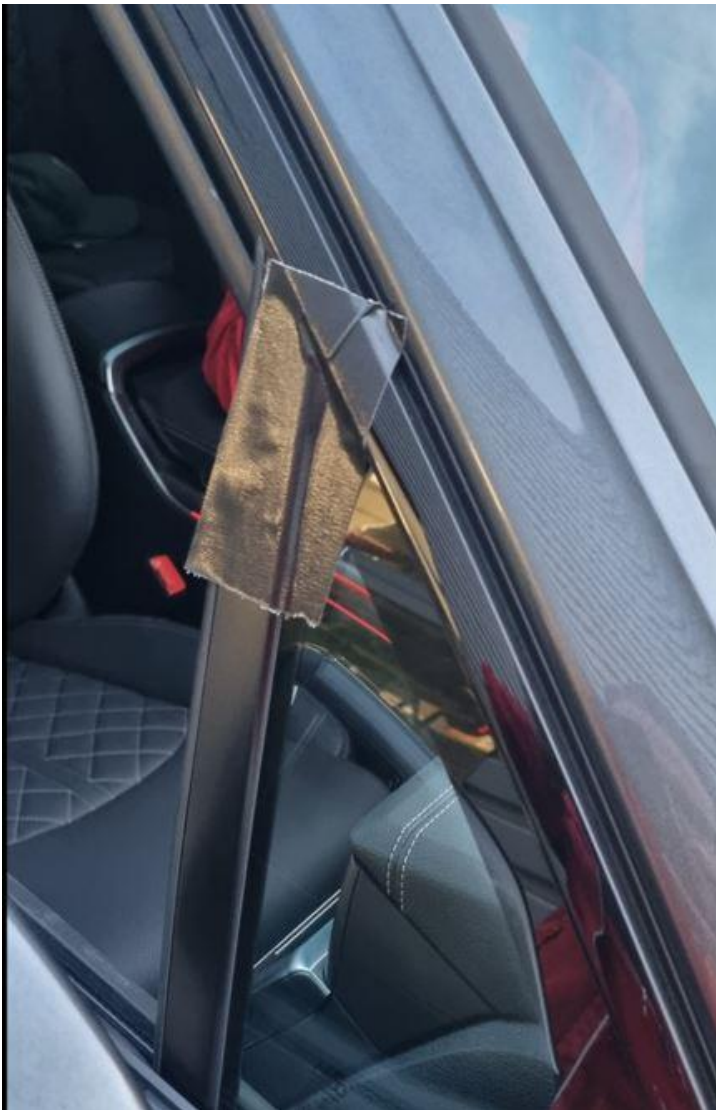
- The customer statement can be reproduced. The issue can be traced to the window guide area between the quarter window by the front door and the window guide.

A foam piece is fitted in the transition area between the window guide and the door in the vicinity of the window guide (Figure 1). In the worst case, crushing of the foam piece could lead to wind noise.

Figure 1. Affected area (masked off).

Loosen the window guide in the transition area between the window guide/quarter window and the door according to the Workshop Manual.

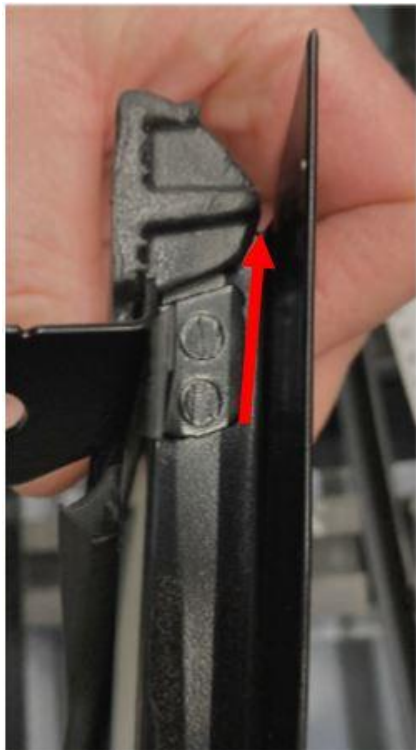
The following image shows the faulty location between the foam piece and the window guide. There is a gap between the foam piece and the guide (Figure 2).

Figure 2. Gap between foam piece and the guide.

Insert a butyl cord (40 mm x 2.5 mm) in the area where the foam piece is visible.

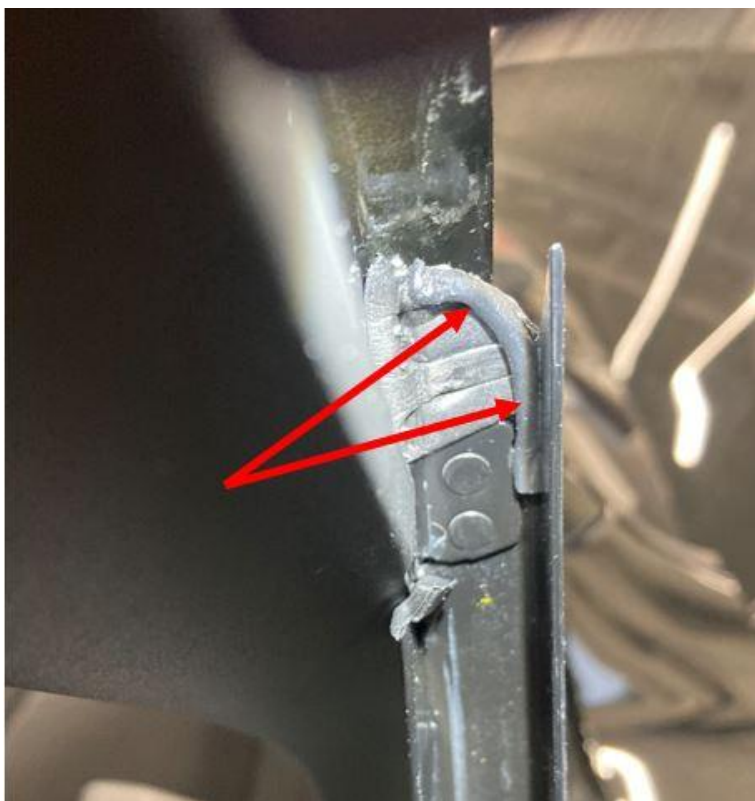
Figure 3. Press the butyl cord into the transition area between the foam piece and the door.

Press this butyl cord fully into the transition area between the foam piece and the door (Figure 3).

Fit the loosened window guide according to the Workshop Manual.
