<b>Topic</b>	91 PSS MIB3: Shortcuts at bottom of display greyed out intimermittently
<b>Market area</b>	United States 444 Volkswagen of America, Inc. (6444)
<b>Brand</b>	Audi
<b>Transaction No.</b>	2077425/1
<b>Level</b>	EH
<b>Status</b>	Released for publishing
<b>Release date</b>	Mar 31, 2025

91 PSS MIB3: Shortcuts at bottom of display greyed out intimermittently

Transaction No.: **2077425/1**

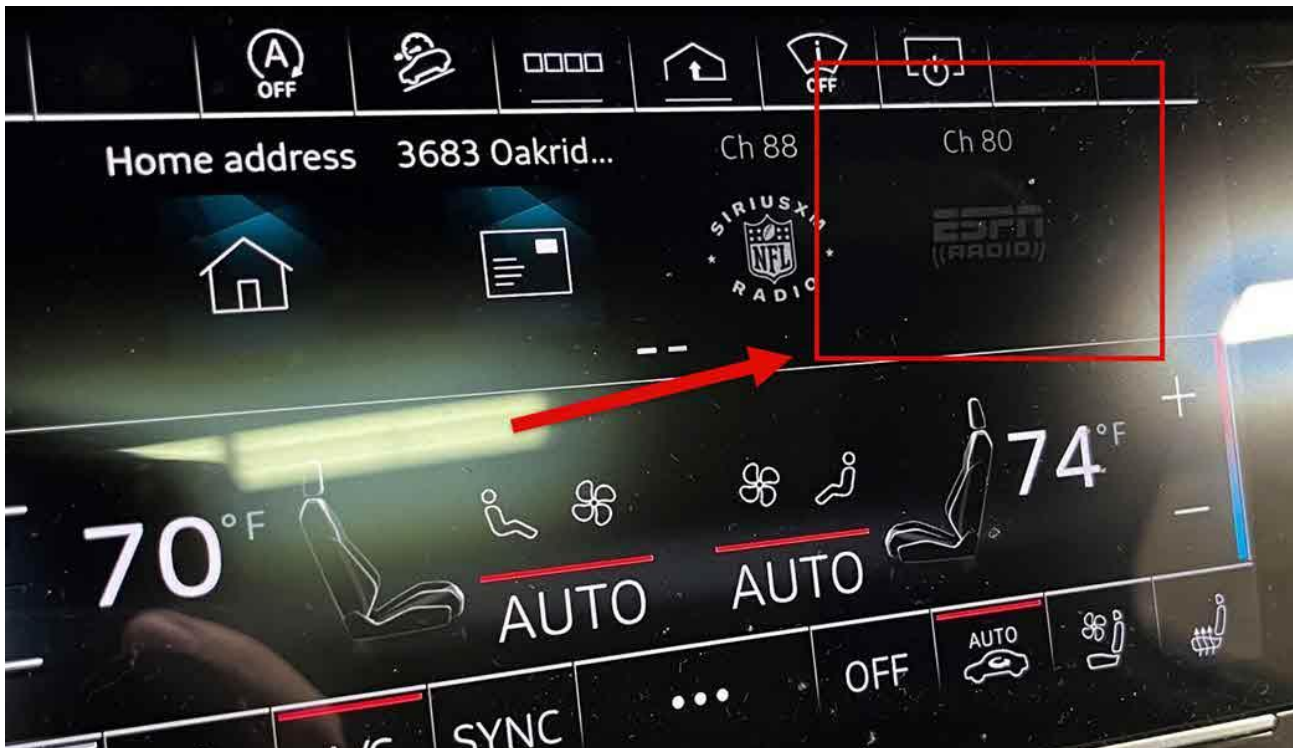
- Shortcuts to radio stations turn grey (Figure 1) after a while and they no longer work.
- Deleting the shortcuts and creating new ones restores functionality for a while.

**Figure 1.** Greyed out radio shortcut.

Software issue.

1. Explain to the customer that a solution is expected to be available by the timeframe projected in **TSB 2076404**.
2. Do not replace any components for this condition since this will not resolve the customer's concern.
3. Create a PSS record in the PSS application through the Pending Service Solutions (PSS) link in AccessAudi (under *Related Links >> Service*).
