Technical Service Bulletin

Topic	46 Cracks on friction ring surface on ceramic brake discs
Market area	United States 444 Volkswagen of America, Inc. (6444)
Brand	Audi
Transaction No.	2077435/1
Level	EH
Status	Released for publishing
Release date	Mar 26, 2025

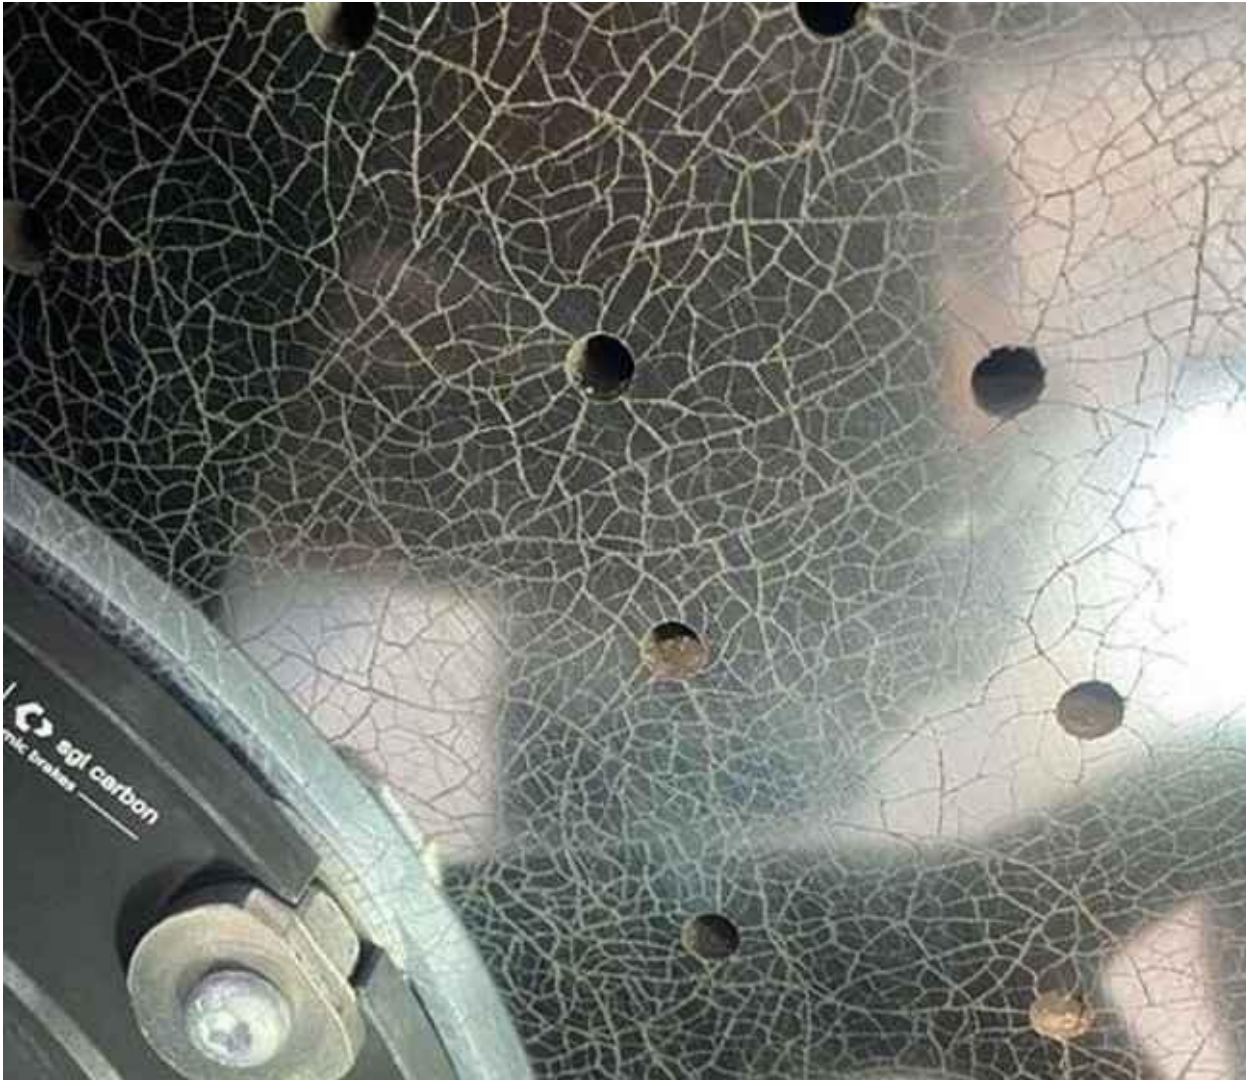
- Significant cracks on surface of the friction ring (Figure 1).

Figure 1. Cracks on the surface of the friction ring.

- The issue can be confirmed.
- No indication of significant thermal stresses.

The new generation of ceramic brake discs (CCB+) show more significant cracks on the surface of the friction ring. These cracks are formed during production when the material cools. The friction ring surface contracts more than the base material and these cracks are the result.

No measures required.

The functionality of the brake system is not affected by this.

There is no reason to replace parts.
