# Service Action

## Code: 38G3

**Subject** Transmission Control Module (TCM) Software

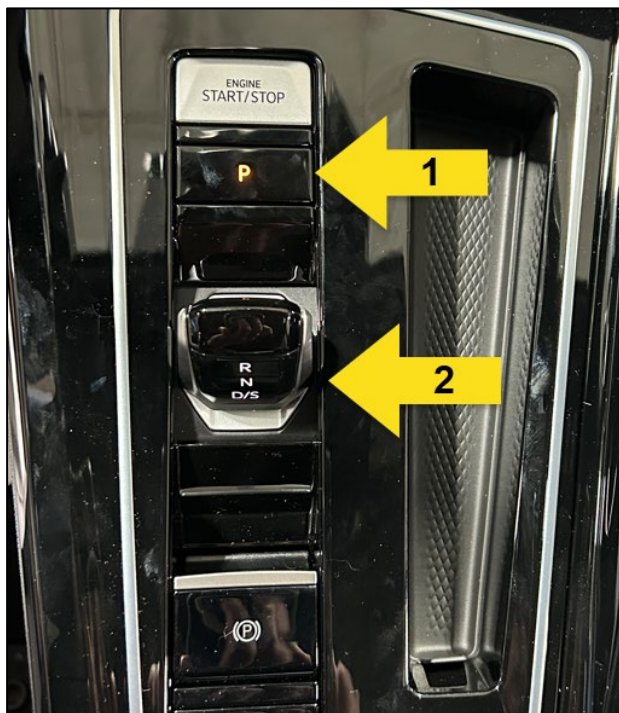
After the software update is completed, it is possible that a 12V battery draw is introduced. The root cause of this is still under investigation.

- After the flash is complete, remove the diagnostic head from the vehicle, disconnect the battery charger, roll down the driver's window and lock the vehicle.
- Wait 5 minutes.
- Observe the gearshift illumination.
- If the E816 Parking Lock Button <1> and Y5 Selector lever Transmission Range Display <2> lights are still illuminated, the 12V battery draw is present.
- If the lights are not illuminated, the 12V battery draw should not be present.
