Service Action

Code: 38G3

Transmission Control Module (TCM) Software

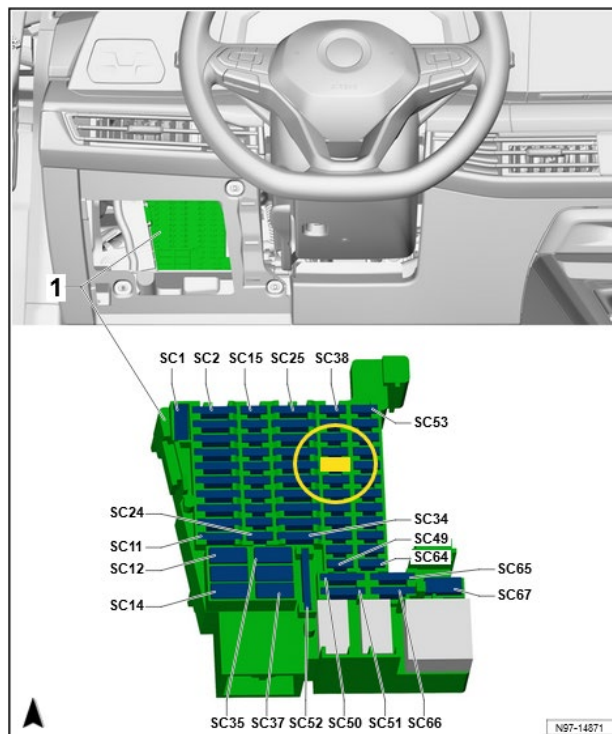
After the software update is completed, it is possible that a 12V battery draw is introduced. To prevent the draw, the fuse for the selector lever components must be removed and reinstalled.

- Remove fuse SC42 for five minutes and then reinstall it.
 - Reference "Component Locations: Fuses" in the Repair Manual/Wiring Diagram
