Condition

THIS IS A TECH TIP, NOT A TECHNICAL BULLETIN.

Applicable Vehicles					
Model(s)	Year	Eng. Code	Trans. Code	VIN Range From	VIN Range To
Atlas Atlas Cross Sport	2024 - 2025	2.0T (DRKB)	All	All	All

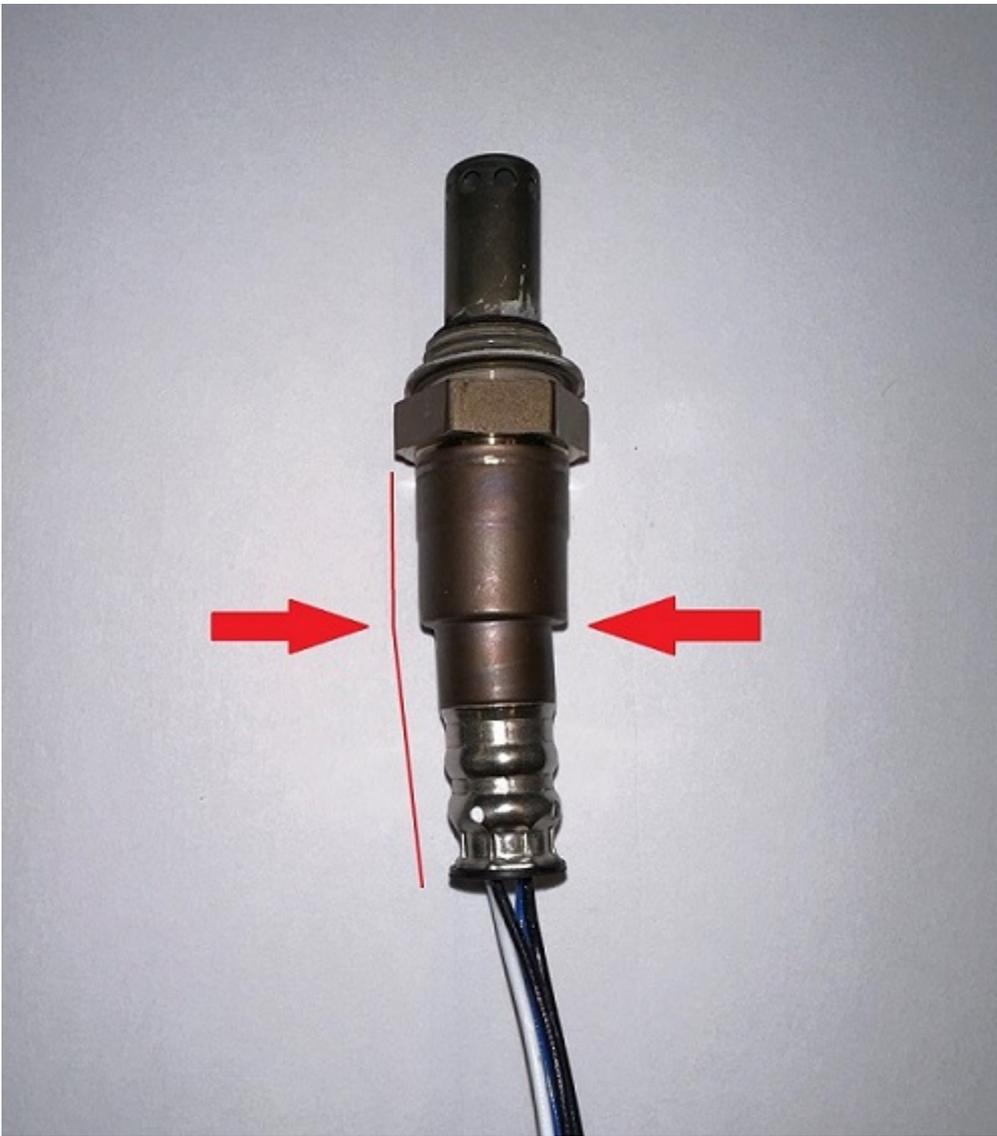
Figure 1.

Damage to the front O2 sensor during factory installation can cause erroneous readings that may result in drivability issues and/or a MIL on. (See Figure 1 below for an example.)

DTC	Description
P0087	Fuel Rail/System Pressure - Too Low
P0133	O2 Sensor Circ.,Bank1-Sensor1 Slow
P0171	Fuel Trim,Bank1 System too Lean
P2177	System too lean off idle, Bank 1

Visually inspect the front O2 sensor for signs of the upper housing being bent. If damage is found, replace the front O2 sensor.
