Condition

Applicable Vehicles					
Model(s)	Year	Eng. Code	Trans. Code	VIN Range From	VIN Range To
Jetta	2020 - 2021	1.4T DGXA	All	All	All

Customer states there is low or no heat output from the air vents under certain cold weather conditions.

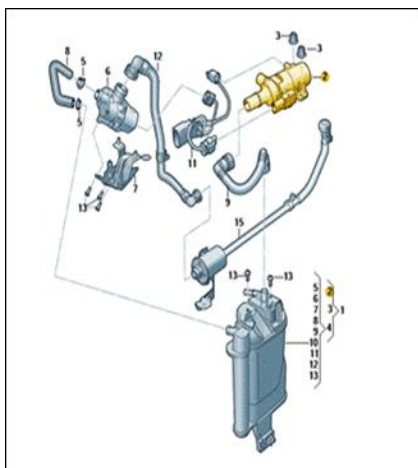
Figure 1.

In addition to the software improvement, there is also an improvement to the FTIV (fuel tank isolation valve/tank switch-off valve -N288-) (Figure 1.), which is necessary in preventing erroneous occurrences of the P2421 fault code.

The FTIV / Tank switch-off valve -N288- currently installed on the vehicle must be inspected, to verify whether an improved part has already been installed. The FTIV / Tank switch-off valve -N288 is mounted to the EVAP canister assembly, as shown below.

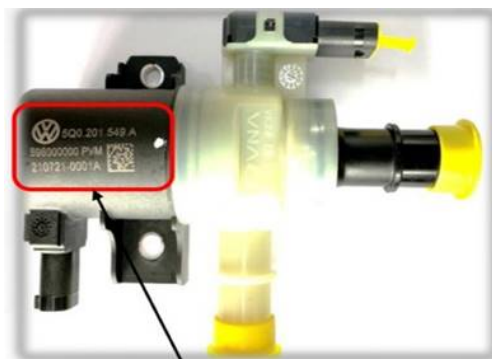
Figure 2.

Remove the EVAP canister assembly and inspect the face of the FTIV / Tank switch-off valve -N288. If the part is already updated, it will have a white paint marking or "02S" printed after the part number, as shown in Figure 2 and Figure 3.

- If the part has a white paint mark or "02S", the FTIV / Tank switch-off valve -N288- is already the updated component. In this case DO NOT replace it, and instead reinstall the EVAP canister assembly. Only the software update will be required.
- If there is no white paint mark or "02S" are visible on the FTIV / Tank switch-off valve -N288, the component must also be replaced in addition to the software update. Always refer to ETKA for the most up to date part number information.
