Condition

| Applicable Vehicles | | | | | |
|---|---|---|---|---|---|
| ID.4 | 2023 – 2025 | All | All | All | All |
| ID.Buzz | 2025 | All | All | All | All |

| Revision Table | | | |
|---|---|---|---|
| 2072064/3 | 3/26/2025 | 19-23-01 | Updated model year applicability and additional examples. |

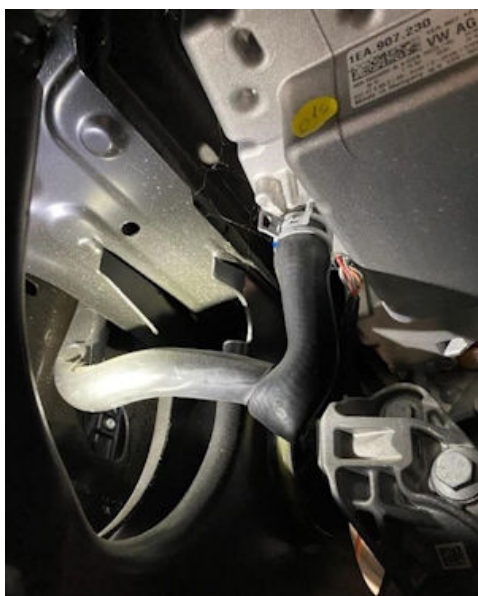
Field cases have been identified with coolant hoses twisted, kinked, and/or misrouted in various locations. This condition can lead to restricted or incorrect coolant flow, reduced power, and electrical system error messages.

Figure 1. Hose twisted at rear power electronics.

If a coolant hose is identified with a concern, then no parts replacement is necessary. Repair the identified concern, clear all relevant DTCs, and retest the vehicle.

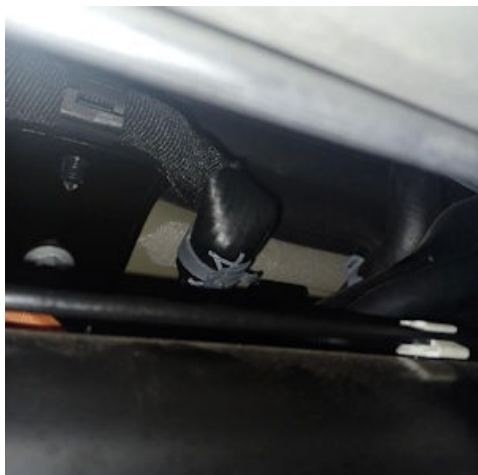
Figure 2. Hose twisted at rear power electronics.

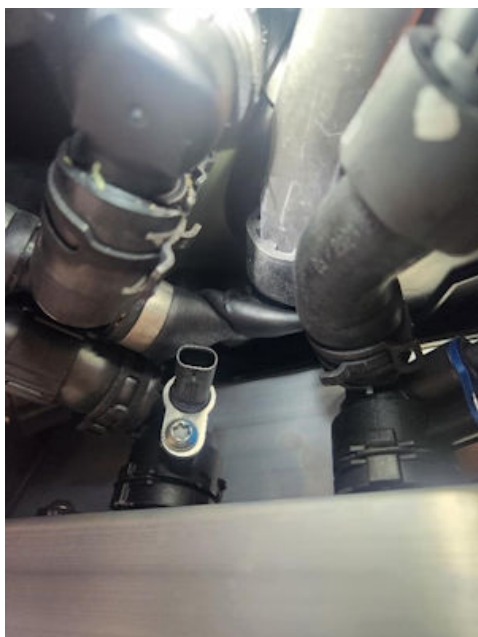
Figure 3. Hose twisted at front of high-voltage battery.

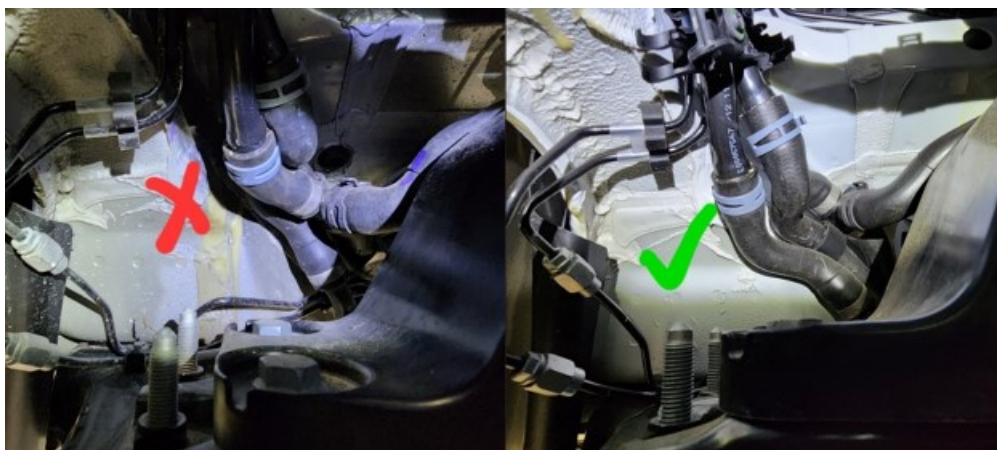
Figure 4. Hoses misrouted in right-front frame.

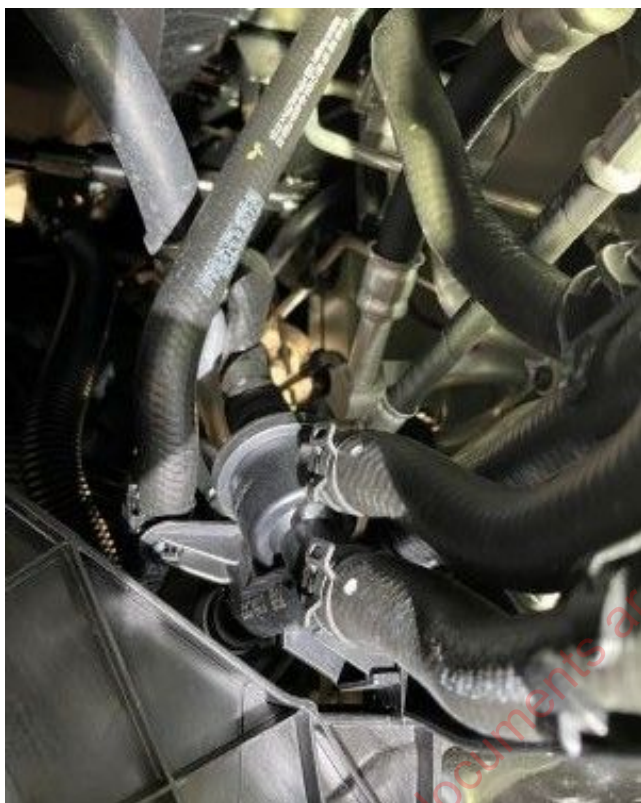
Figure 5. Hose twisted at thermostat.
