VW Model(s)	Year	Eng. Code	Trans. Code	VIN Range From	VIN Range To
Passat	2012-2019	All	All	All	All

Revision Table			
Instance number	Published Date	Version Number	Reason for Update
2028353/12	3/10/2025	40-19-01	Reference correction in warranty table.
2028353/1	1/19/2012	40-12-01	Original Publication.

Front suspension creaking noise during suspension cycles (going over speed bumps or entering on an inclined surface).

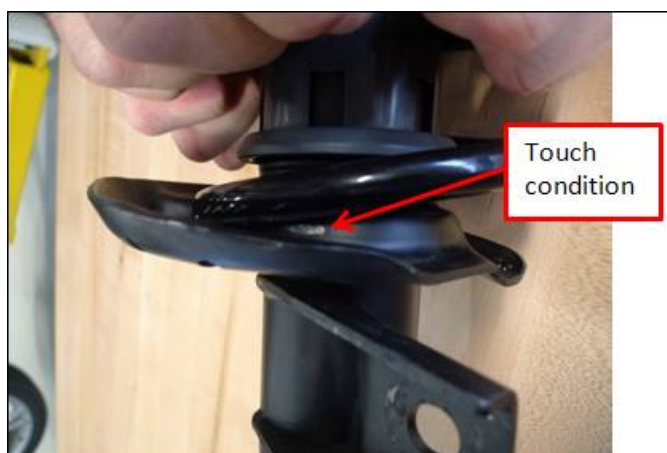
Figure 1

Coil Spring is not formed correctly and rubs against the perch of the strut.

A corresponding rub mark can be found on the coil spring using an inspection mirror.

- Verify if a car with the creaking noise has the contact mark (on one side or on both sides) as shown in figure 1.

- Remove affected suspension strut and disassemble, see Repair Group 40 in Elsa.
- Apply touch up paint to the contact area of the strut perch and allow required drying time.

Use Rustoleum Cold Galvanizing Compound # V2185838 (or similar obtained locally), 2 coats.

Cover with Rustoleum Flat Black Spray Paint # V2178838 (or similar obtained locally), 1 coat.

- Install new spring on suspension strut (per vehicle PR-codes).
